Program Bulletin

CUSTOMER SATISFACTION PROGRAM

SUBJECT: ENGINE FLYWHEEL / CLUTCH INTERFERENCE

MODELS: 2006 CHEVROLET CORVETTE EQUIPPED WITH 6.0L V8 (RPO LS2 - VIN U) OR 7.0L V8 (RPO LS7 – VIN E) ENGINE AND 6-SPEED (RPO MM6 or MZ6) MANUAL TRANSMISSION

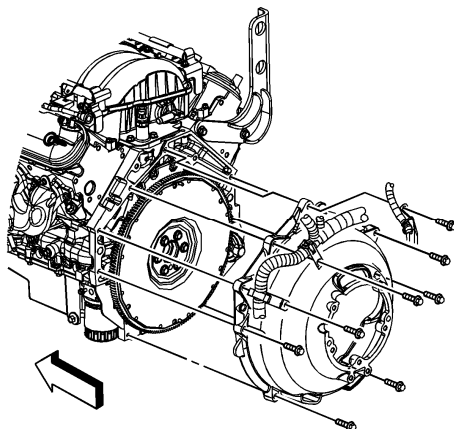
1696171

IMPORTANT: The bell housing must be removed from the engine before you can inspect the clearance between the rivet head on the clutch pressure plate cover and the raised step on the flywheel.

- a. Refer to *Clutch Assembly Replacement* procedure for the 6.0L (LS2) engine or 7.0L (LS7) engine in SI.
 - b. Perform the inspection after the bell housing has been removed from the engine. Do not remove clutch assembly before performing inspection.
1. Inspect the clearance between each rivet head and the raised step on the flywheel. There are three locations on the clutch pressure plate to inspect.
 - 1.1 Rotate the flywheel while it is attached to the engine to bring each rivet head into view.
 - 1.2 Use a feeler gauge with a stock thickness of 0.05 mm (0.002 inch) to determine if there is interference between each of the rivet heads and the flywheel step.
 - 1.3 Slide the feeler gauge horizontally along the shallow flywheel step.

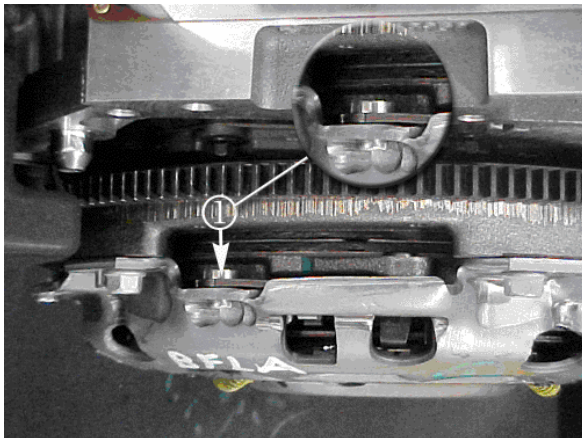
1793767

- The clearance between each of the three rivet heads (1) and flywheel step must be 6 mm (15/64 inch) or greater at all three locations. If the clearance between the rivet head (1) and the flywheel step is 6 mm (15/64 inch) or greater at all three locations, the flywheel does **not** require replacement. Reassemble the vehicle components and proceed to step 5. Refer to *Clutch Assembly* procedure for the 6.0L (LS2) engine or 7.0L (LS7) engine in SI.

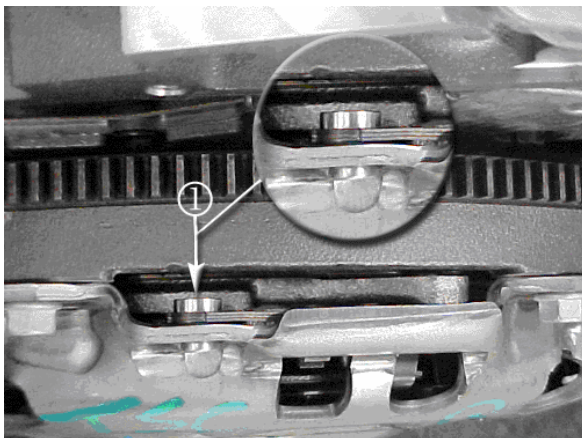
1793751

- If the clearance between the rivet head (1) and the flywheel step is **greater** than 0.05 mm (0.002 inch), but is **less** than 6 mm (15/64 inch) at any of the three rivet head (1) and flywheel step locations, replace the flywheel **only**. Perform service procedure steps 2, 3 and 5.

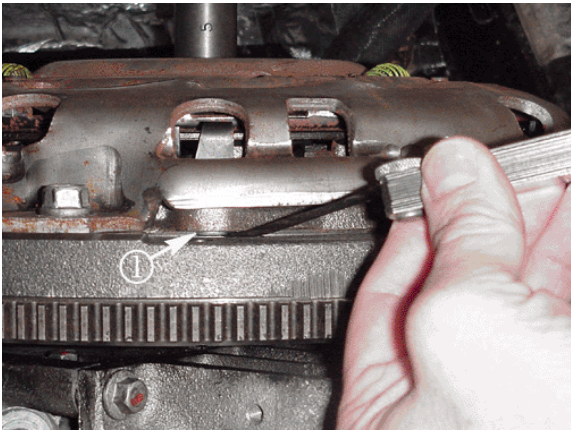
1793770

- If there is **less** than 0.05 mm (0.002 inch) clearance between any of the rivet heads (1) and flywheel step locations, the flywheel and clutch assembly must be replaced. Perform service procedure steps 2-5.

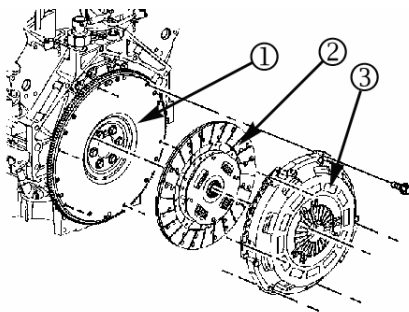
1793779

(1) Engine Flywheel (2) Clutch Driven Plate (Clutch Disc) (3) Clutch Pressure Plate
