Special Coverage Adjustment

16009 Primary Tank Inlet Check Valve Fuel and Vapor Leaks

Reference Number: N15202485

Release Date: October 2016
Revision: 00

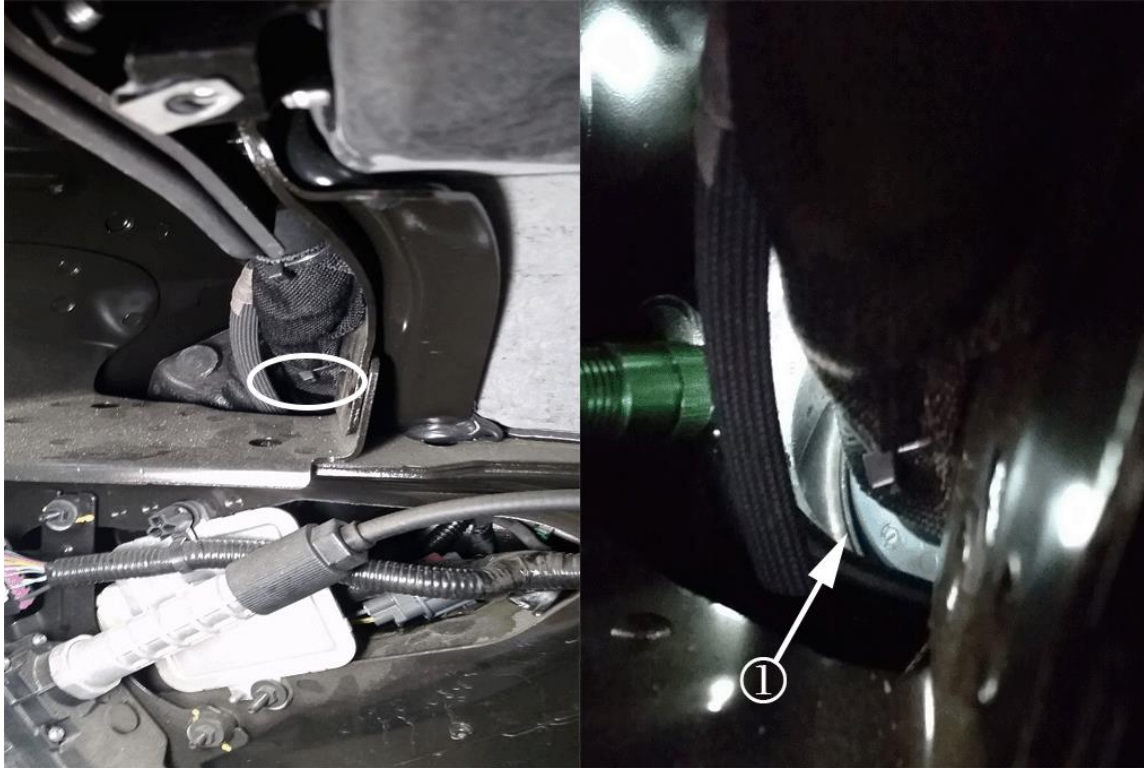
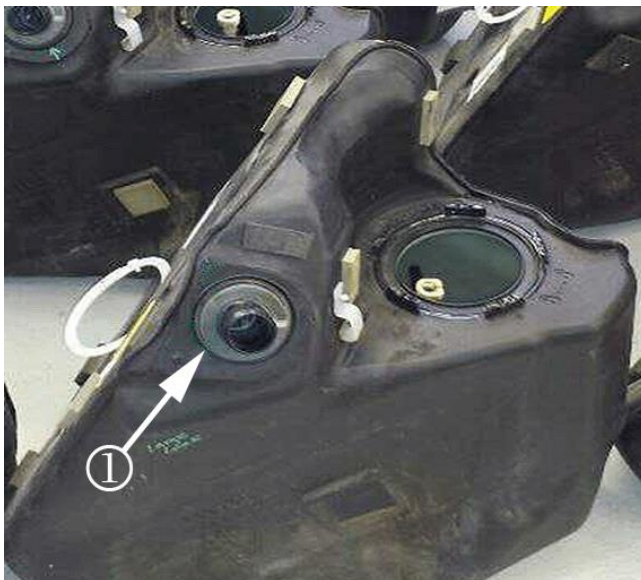
3. Inspect for an evaporative emission leak at the inlet check valve (1) on the left side fuel tank by performing an evaporative emission system test using the J 41413-200 Evaporative Emissions System Tester. Refer to *Evaporative Emission System Diagnosis* in SI.
 - If an evaporative emission leak is NOT detected at the inlet check valve on the left side fuel tank, no further action is required. Inform the customer that any additional diagnosis and repairs are not covered under this special coverage.
 - If an evaporative emission leak is detected at the inlet check valve on the left side fuel tank, replace the fuel tank – left side. Refer to *Fuel Tank Replacement - Left Side* in SI.
