Special Coverage Adjustment

17469 Fuel Leaks at the Primary Fuel Pump Module Flange

Reference Number: N172131680

Make	Model	Model Year		RPO	Description
		From	To		
Chevrolet	Corvette	2014	2017

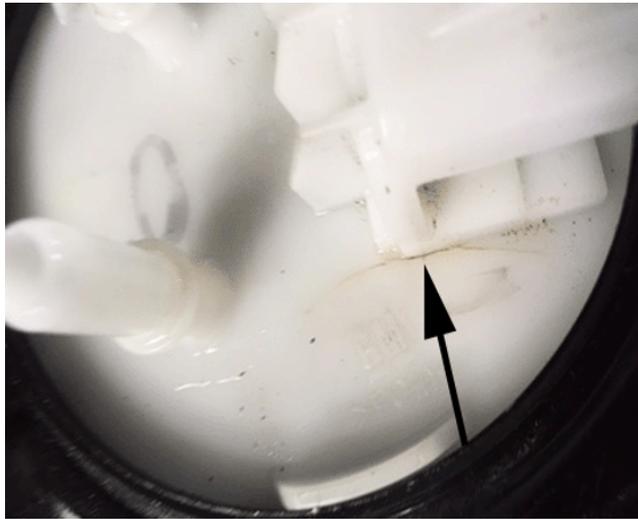
Condition	On some 2014-2017 model year Chevrolet Corvette vehicles, cracks on the top surface of the left fuel tank fuel pump module flange, may cause fuel odor, or a loss of fuel on the ground. A Check Engine lamp may illuminate if the fuel tank is less than half full.
Special Coverage Adjustment	<p>This special coverage covers the condition described above for a period of 10 years or 120,000 miles (193,000 km), whichever occurs first, from the date the vehicle was originally placed in service, regardless of ownership.</p> <p>For vehicles covered by Vehicle Service Contracts, all eligible claims with repair orders on or after April 18, 2018, are covered by this special coverage and must be submitted using the labor operation codes provided with this bulletin. Claims with repair orders prior to April 18, 2018, must be submitted to the Service Contract provider.</p> <p>Vehicle owners or lessees who paid for repairs referenced in this Special Coverage ("Customers") are eligible for reimbursement of their reasonable and customary expenses in accordance with the procedures specified below. The conditional right to reimbursement is provided by GM solely in the interest of customer satisfaction and is personal to Customers. <i>Customers may not assign and GM does not consent to any assignment of any Customer's right to submit reimbursement claims, or to receive reimbursement, or any other rights granted by this Special Coverage to any third party, including but not limited to service contract providers, and this Special Coverage is not intended to and does not confer any third party beneficiary, subrogation or contribution rights, or any other rights to reimbursement, against GM, whether in law, equity or otherwise, on any third parties.</i></p>

3. Inspect the fuel pump module for cracks near the connector, as shown above.
 - If NO cracks are found, no further action is necessary. Inform the customer that further repairs and diagnosis are not covered under this special coverage. The time required to remove the fuel tank and do the evaporative emission test will still be covered, however, any additional diagnosis, labor, or parts required to fix the vehicle are not covered under this special coverage.
 - If cracks are found, replace the Fuel Tank Fuel Pump Module. Refer to *Fuel Tank Fuel Pump Module Replacement* in SI.
4. Reinstall the fuel tank. Refer to *Fuel Tank Replacement – Left Side* in SI.

Correction	Dealers are to replace the fuel pump module upon confirmation of the fuel pump module flange leak. The repairs will be made at no charge to the customer.
