Product Safety Recall

N202311160 Drivers May Overlook Open Hood Alerts

Release Date: August 2020

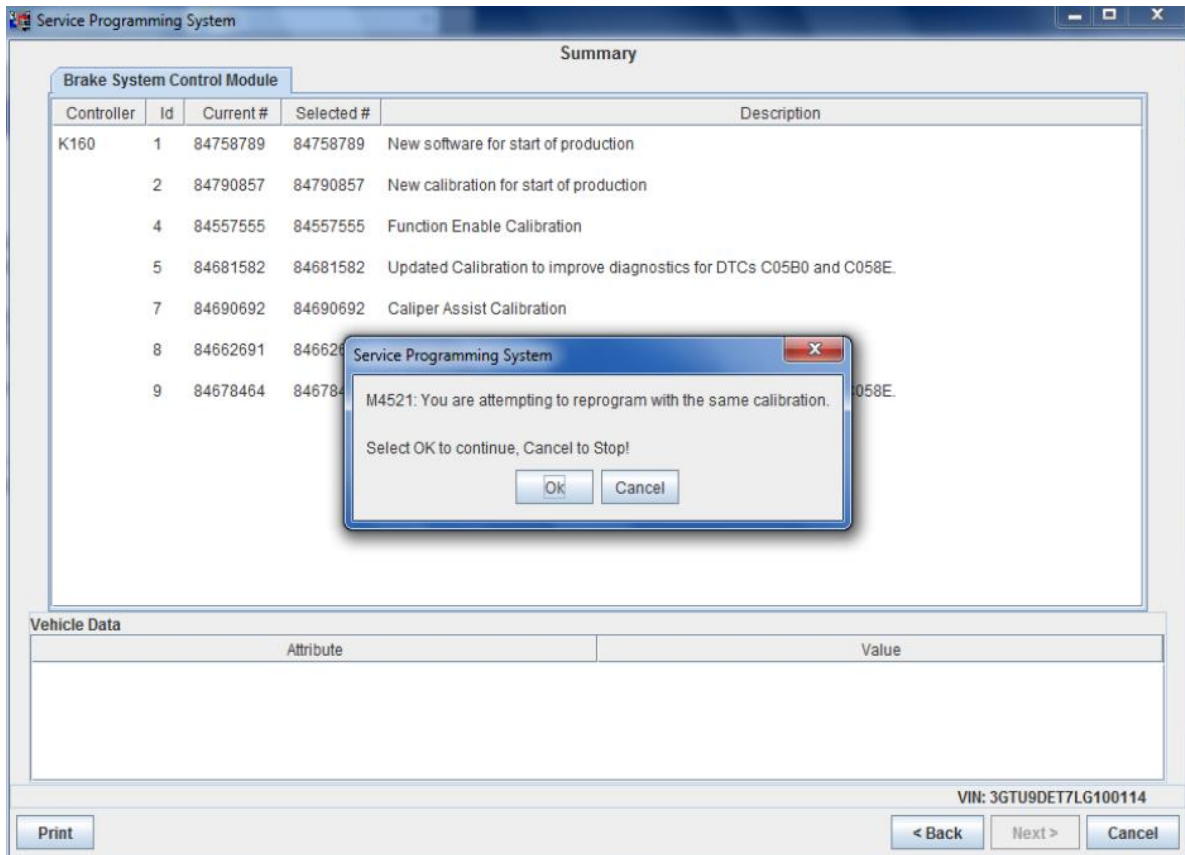
5431207

Important: If the Same Calibration/Software Warning is noted on the SPS Summary screen, select OK and follow screen instructions. After a successful programming event, the WCC is located in the Service Programming System dialogue box of the SPS Summary screen. No further action is required. Refer to the Warranty section of the bulletin.

1. Reprogram the body control module. Refer to *K9 Body Control Module: Programming and Setup* in SI.

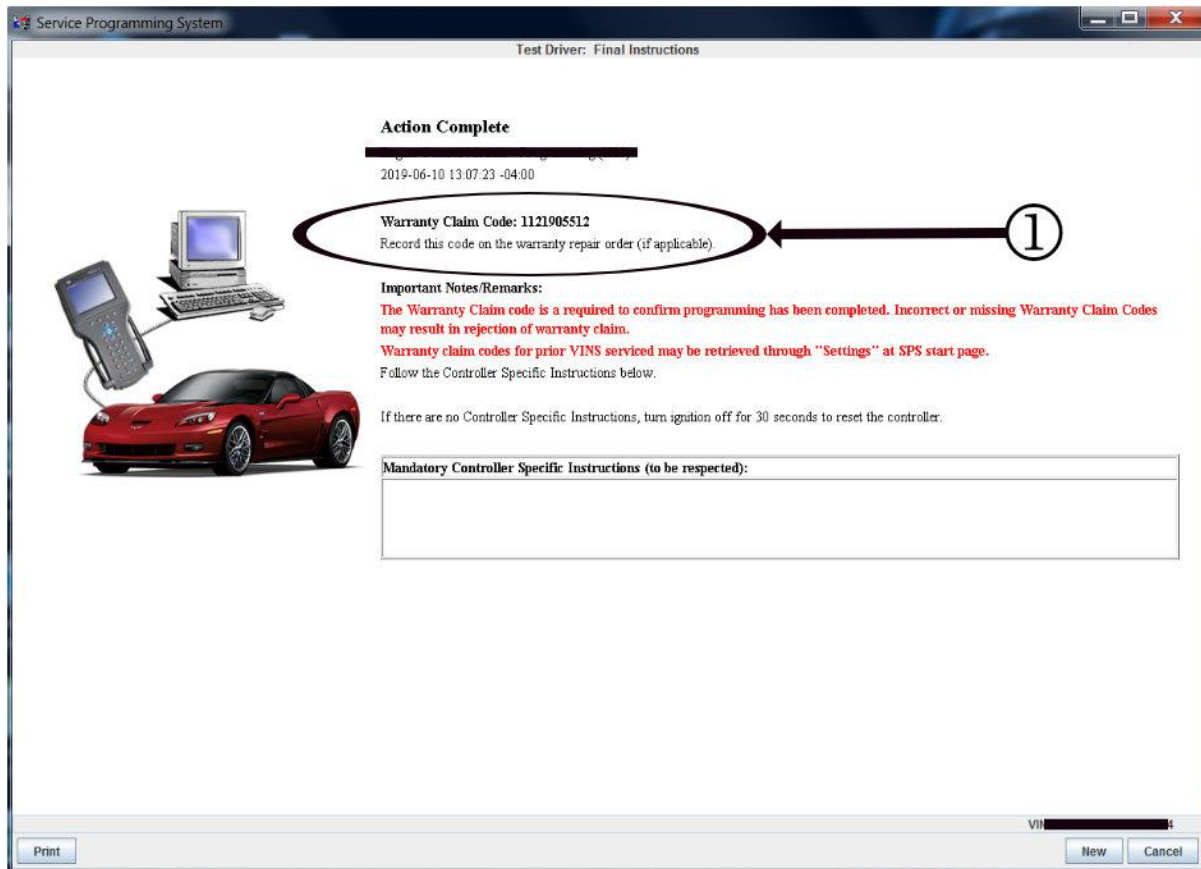
5431209

Important: To avoid warranty transaction rejections, you **MUST** record the warranty claim code provided on the SPS Warranty Claim Code (WCC) screen on the job card. Refer to callout 1 above for the location of the WCC on the SPS screen.

- Record SPS Warranty Claim Code on job card for warranty transaction submission.
- After the BCM (body control module) has been updated, drive the vehicle to relearn the tire pressure monitor sensors. If the vehicle is not driven, the IPC will show “dashes” instead of the actual tire pressure.
- Inform the customer that the key FOB operation has been updated. To open the hood using the key FOB, press and release the button followed by pressing and holding to open.
