Program Bulletin

CUSTOMER SATISFACTION PROGRAM

SUBJECT: PAINTED ROOF ADHESIVE SEPARATION

**MODELS: 2005-2006 CHEVROLET CORVETTE
WITH PAINTED ROOF**

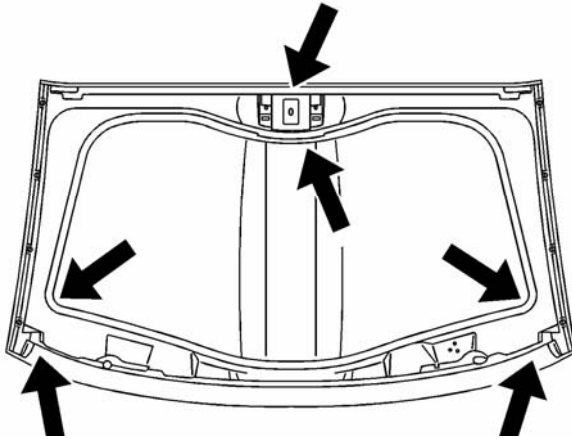
1748402

4. Inspect for proper adhesion by inserting a feeler gage between the panel and the frame. Particular attention should be paid to the areas around the rear latch and the front corners.
 - If the feeler gage does not identify any area without proper adhesion, proceed to the next step.
 - If the feeler gage does identify an area without proper adhesion, replace the roof panel (do not continue with this procedure). The following SI procedures may be used:
