1954 Corvette: Service Bulletin: Engine Valve Noise

Model and Year: 1954 Powerglide Engines **Source:** Chevrolet Technical Service Bulletin

Bulletin No: DR - 168

Date: April 8, 1954

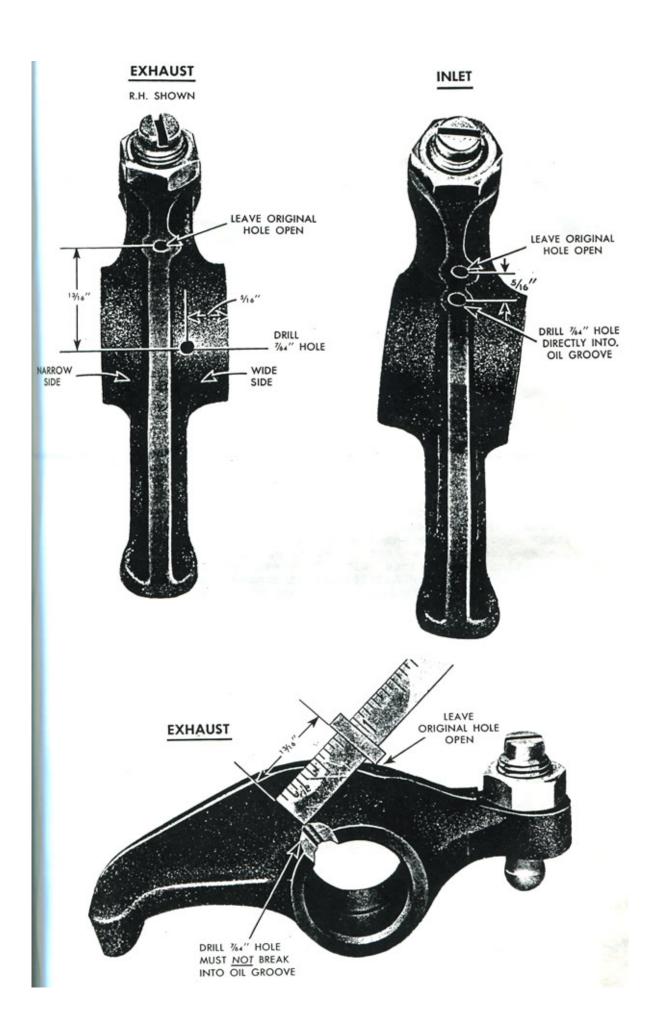
In cases where valve squawk exists on 1954 Powerglide Engines, the rocker arms may be drilled as outlined below to provide additional lubrication between the rocker arm and valve stem also a slight increase at the valve stem and guide.

Valve noise varies somewhat with different driving speeds. During extended periods of idling a valve squawk may occur which cannot be eliminated without the possibility of excessive oil consumption and eventual sticking of the valves.

<u>Inlet</u>

Identification - reinforcing rib on each side of arm.

Drill an additional 7/64" hole in the rib 5/16" toward the rocker arm pad from the original oil hole.

This hole should be drilled directly into the oil groove.

Exhaust

Drill an additional 7/64" hole in the wide side of the rocker arm bearing boss, measuring 13/16" in a straight line toward the pad from the existing oil hole and 5/16" in from the edge on the wide side of the bearing boss.

<u>Caution:</u> This hole should be drilled straight in but must not break into the oil groove in the rocker arm bearing.

Carefully remove all burrs on the inside so as not to effect the bearing area.

Do not close up the original oil holes in the rocker arms.

Torque rocker arm shaft bolts 25 to 30 ft./lbs.
