1954 Corvette: Service Bulletin: Engine Valve Noise

Subject: Engine Valve Noise

Model and Year: 1954 Powerglide Engines

Bulletin No: DR - 168

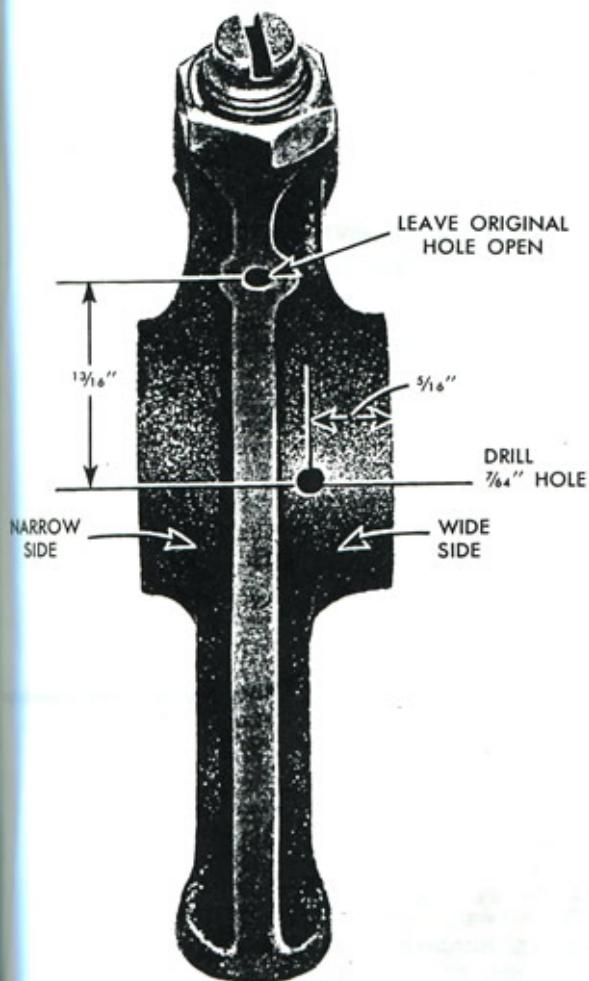
EXHAUST

In cases where valve squawk exists on 1954 Powerglide Engines, the rocker arms may be drilled as outlined below to provide additional lubrication between the rocker arm and valve stem also a slight increase at the valve stem and guide.

Drill an additional 7/64" hole in the wide side of the rocker arm bearing boss, measuring 13/16" in a straight line toward the pad from the existing oil hole and 5/16" in from the edge on the wide side of the bearing boss.

Caution: This hole should be drilled straight in but must not break into the oil groove in the rocker arm bearing.

Carefully remove all burrs on the inside so as not to effect the bearing area.

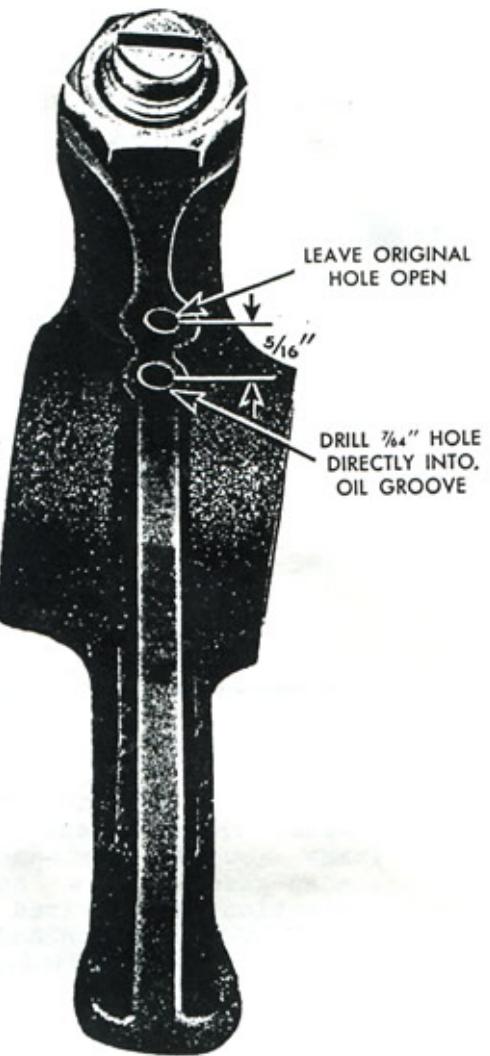
INLET

Identification - reinforcing rib on each side of arm.

Drill an additional 7/64" hole in the rib 5/16" toward the rocker arm pad from the original oil hole.

This hole should be drilled directly into the oil groove.
