1954 Corvette: Service Bulletin: Engine Valve Noise

Model and Year: 1954 Powerglide Engines

Source: Chevrolet Technical Service Bulletin

Bulletin No: DR - 168

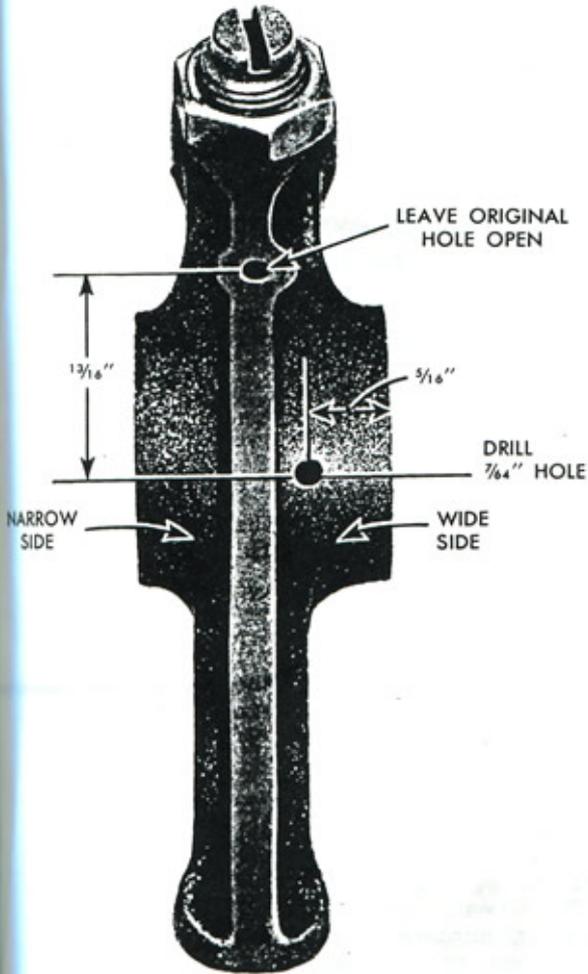
EXHAUST

R.H. SHOWN

Drill an additional $7/64$ " hole in the wide side of the rocker arm bearing boss, measuring $13/16$ " in a straight line toward the pad from the existing oil hole and $5/16$ " in from the edge on the wide side of the bearing boss.

Caution: This hole should be drilled straight in but must not break into the oil groove in the rocker arm bearing.

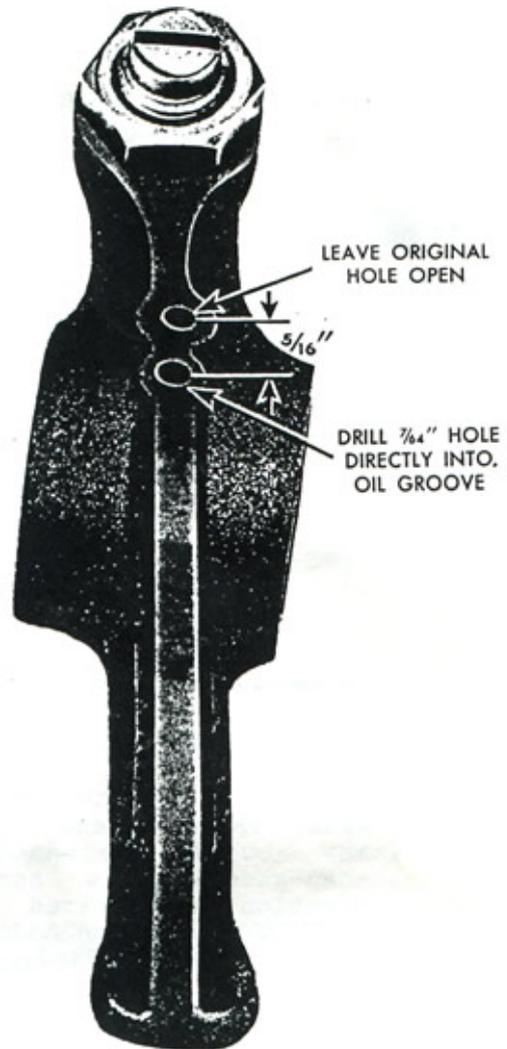
INLET

Identification - reinforcing rib on each side of arm.

Drill an additional $7/64$ " hole in the rib $5/16$ " toward the rocker arm pad from the original oil hole.

This hole should be drilled directly into the oil groove.
