2014 - 2015 Corvette: GM TechLink: 6.2L Engine Bell Housing Rattle

Subject: 6.2L Engine Bell Housing Rattle

Model and Year: 2014 - 2015 Corvette Equipped with LT1

Date: November 7, 2014

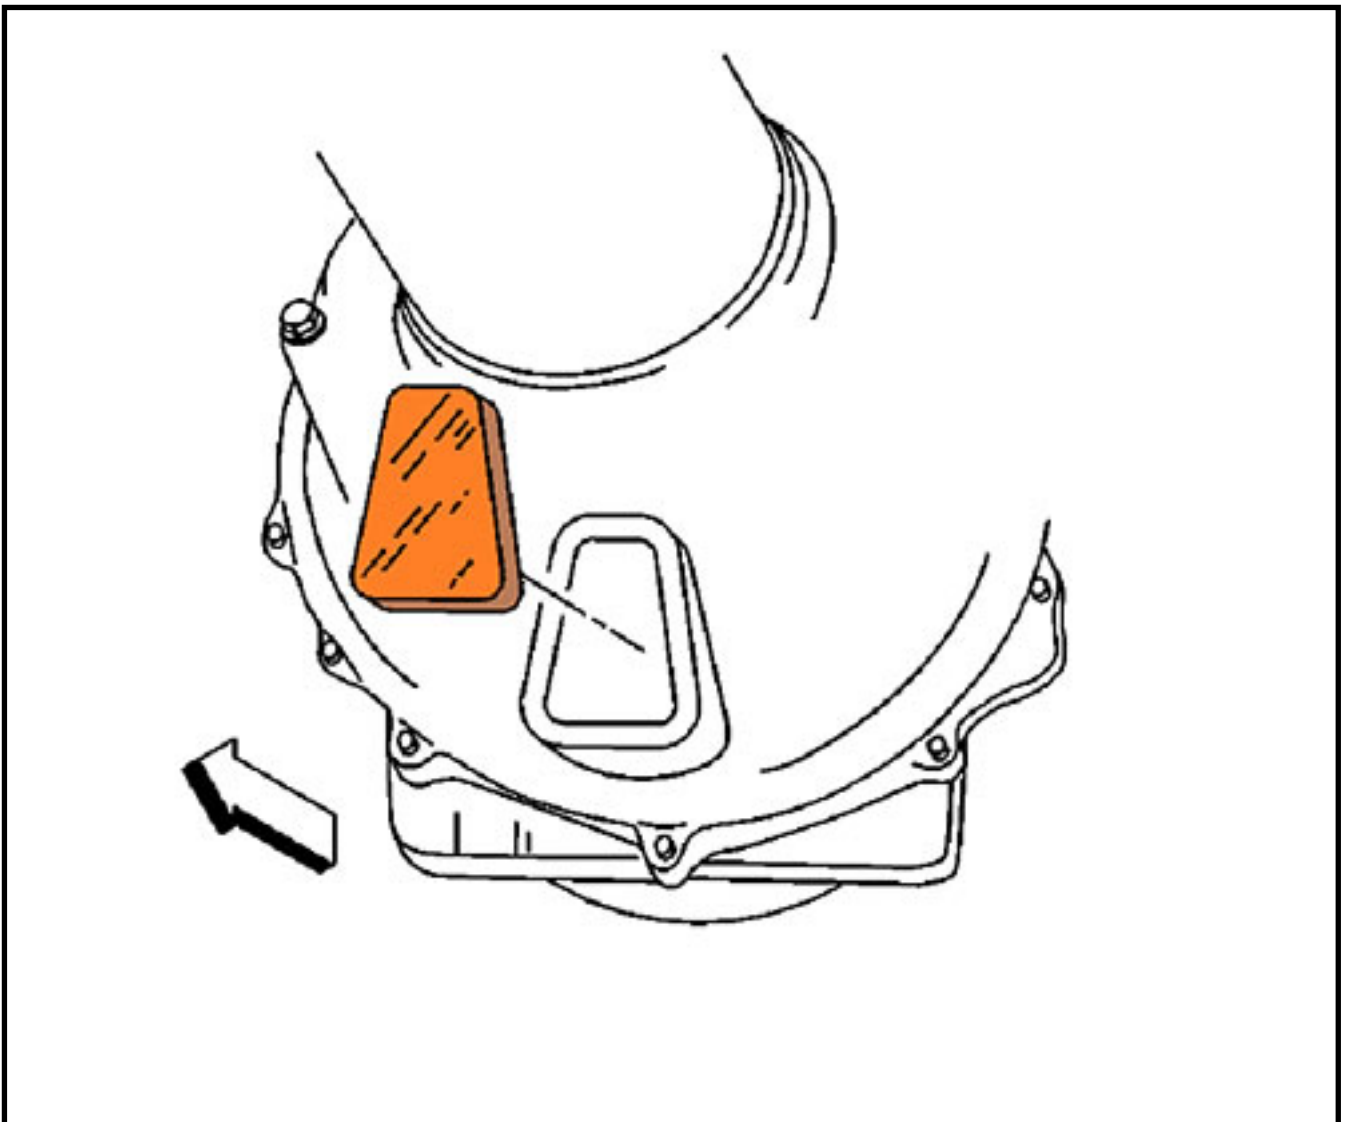
Unlike the flex plate rattle, a DSA rattle noise typically occurs at or just off idle and will be louder when observed via the rear bell housing access plug. (Fig. 8)

When performing repairs for a flex plate rattle or DSA rattle, refer to the

latest information in the Service Information:

- #13-04-17-001 – Driveline Support (Torque Tube) / Propeller Shaft Input to Front Hub Bearing Alignment
- Document ID 3973764 – Driveline Support Assembly Replacement (with Automatic Transmission)
