2014 - 2015 Corvette: GM TechLink: 6.2L Engine Bell Housing Rattle

Subject: 6.2L Engine Bell Housing Rattle

Model and Year: 2014 - 2015 Corvette Equipped with LT1

Date: November 7, 2014

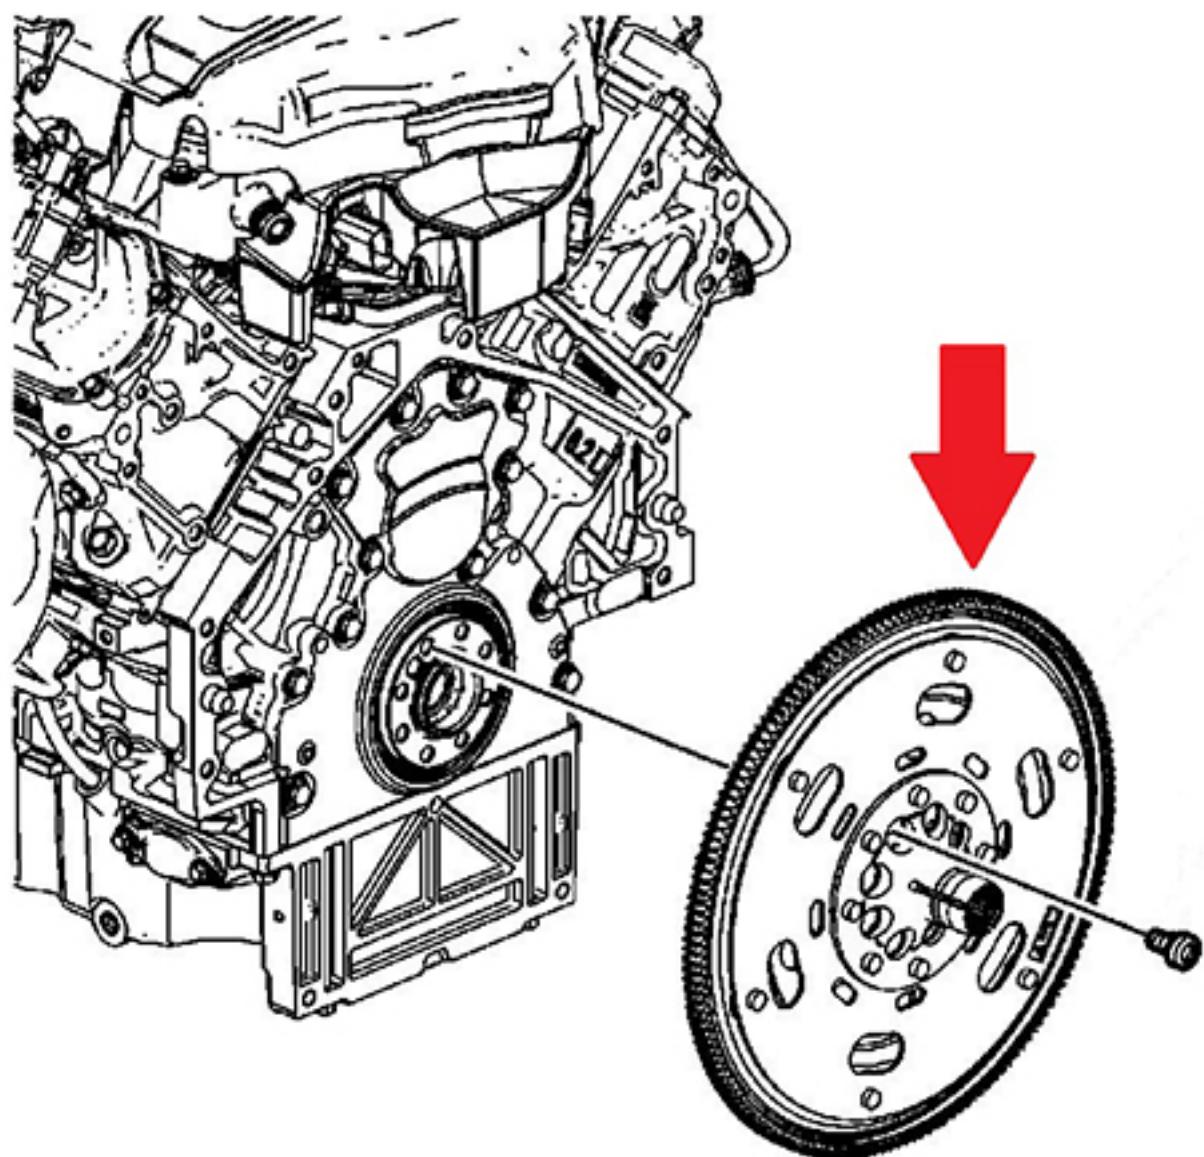
A rattle noise at the engine bell housing may be heard on some 2014-2015 Corvettes built with the 6.2L engine (RPO LT1) and an automatic transmission.

If it's determined that the rattle noise is coming from the flex plate (Fig. 7), raise the vehicle on a hoist and pull the front bell access cover. The noise will be coming from the hole.

TIP: Check that the pinch clamp bolt is tight before replacing the front flex plate. The loose bolt condition results in the same noise. This is an easy check before starting a major service procedure.

Do not reinstall the old flex plate even if it looks OK as the cause of the rattle may not be visible.

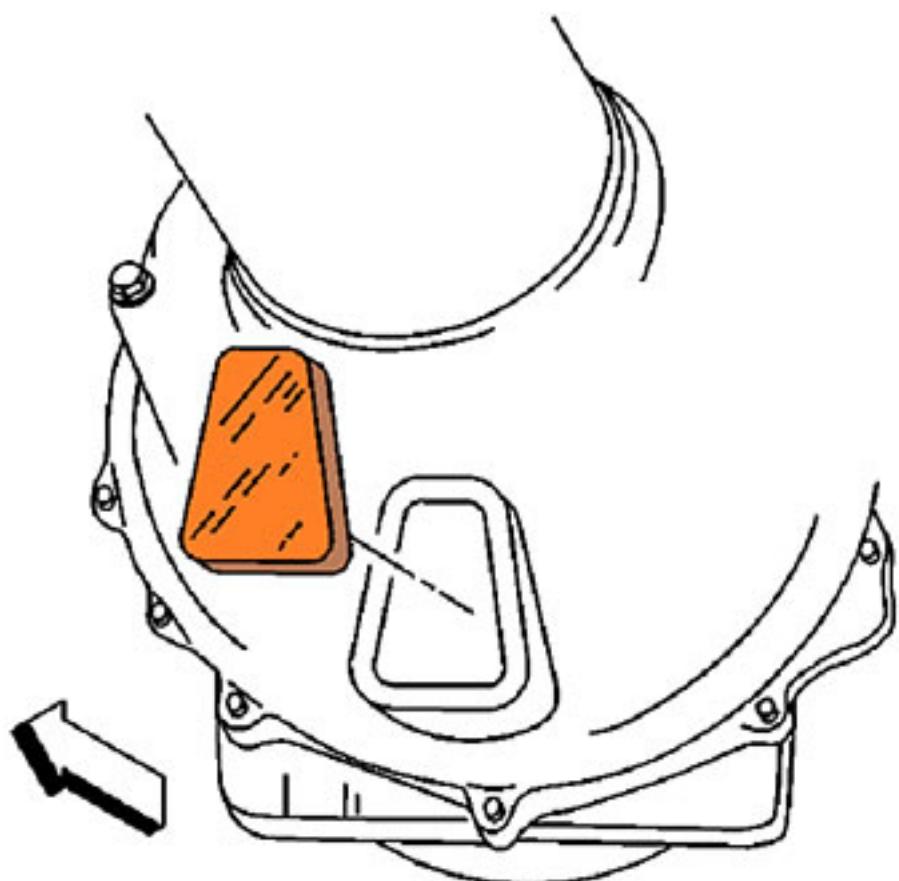
Unlike the flex plate rattle, a DSA rattle noise typically occurs at or just off idle and will be louder when observed via the rear bell housing access plug. (Fig. 8)
