# 2014 - 2015 Corvette: GM TechLink: 6.2L Engine Bell Housing Rattle

**Subject:** 6.2L Engine Bell Housing Rattle

**Model and Year:** 2014 - 2015 Corvette Equipped with LT1

**Date:** November 7, 2014

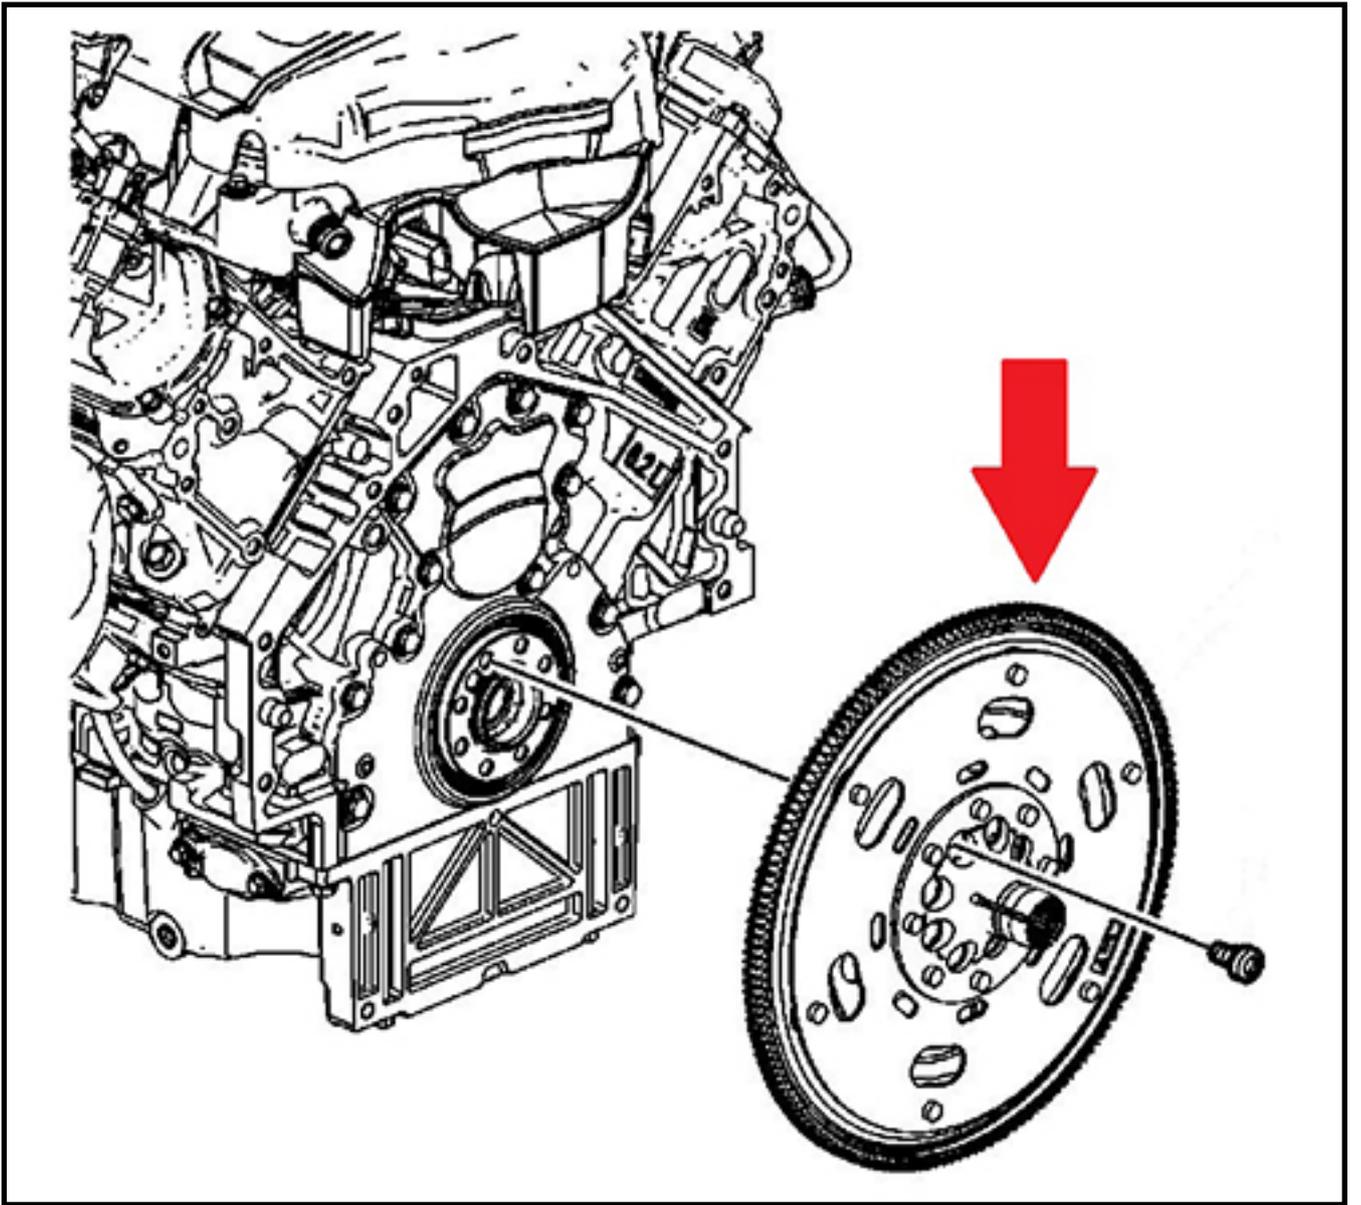
A rattle noise at the engine bell housing may be heard on some 2014-2015 Corvettes built with the 6.2L engine (RPO LT1) and an automatic transmission.

If it's determined that the rattle noise is coming from the flex plate (Fig. 7), raise the vehicle on a hoist and pull the front bell access cover. The noise will be coming from the hole.

**TIP:** Check that the pinch clamp bolt is tight before replacing the front flex plate. The loose bolt condition results in the same noise. This is an easy check before starting a major service procedure.

Do not reinstall the old flex plate even if it looks OK as the cause of the rattle may not be visible.

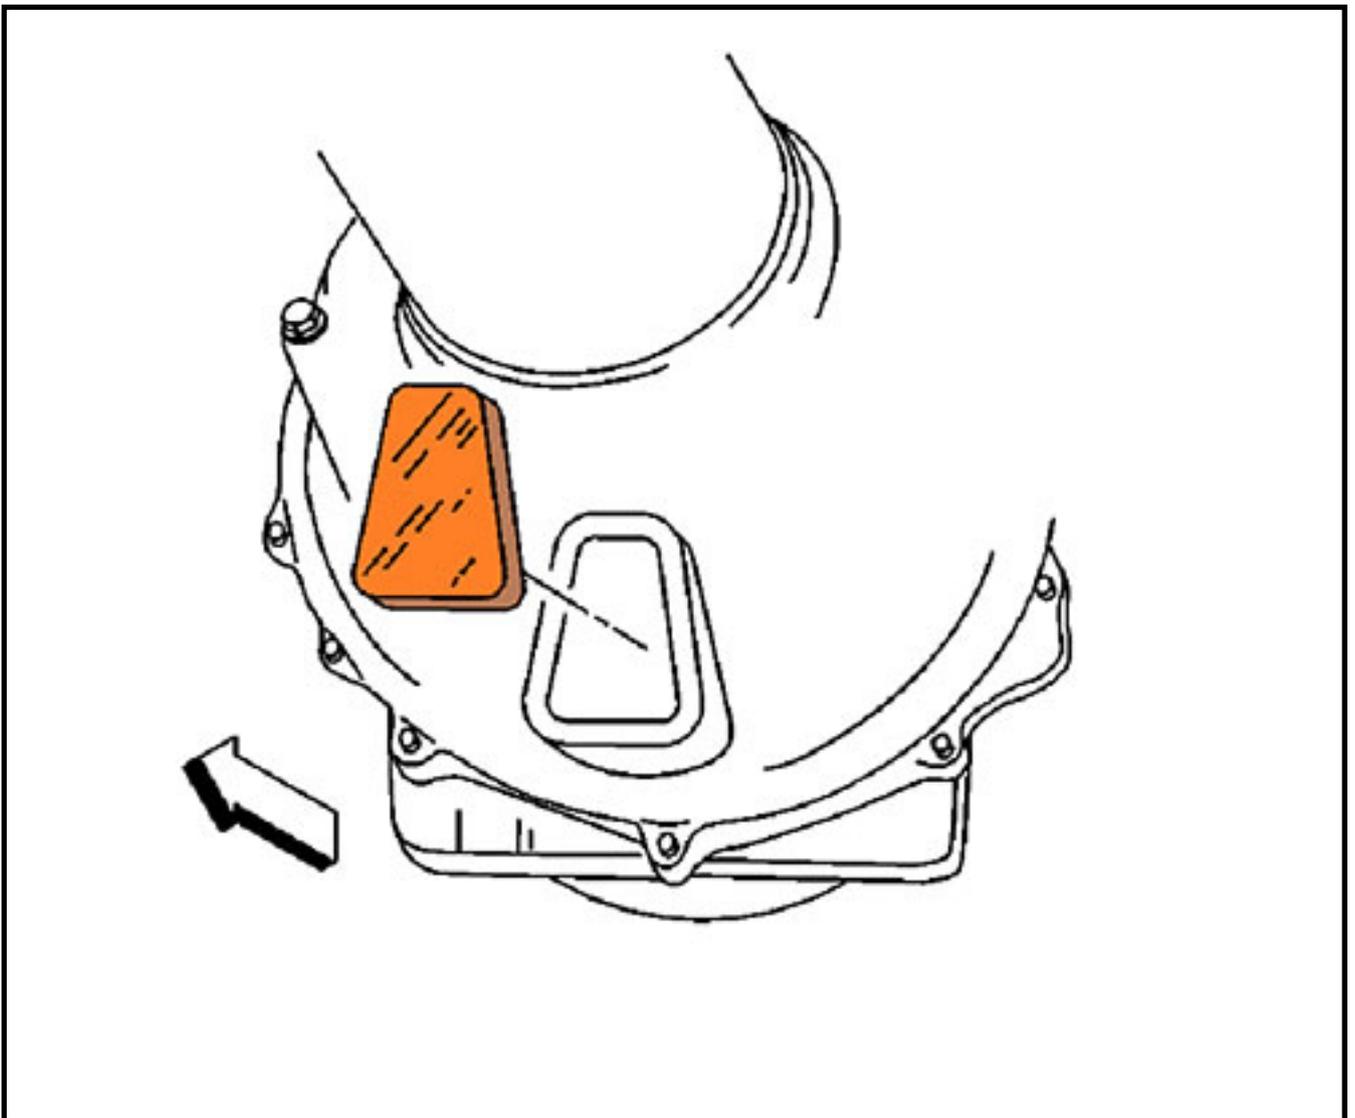
Unlike the flex plate rattle, a DSA rattle noise typically occurs at or just off idle and will be louder when observed via the rear bell housing access plug. (Fig. 8)

When performing repairs for a flex plate rattle or DSA rattle, refer to the

latest information in the Service Information:

- #13-04-17-001 – Driveline Support (Torque Tube) / Propeller Shaft Input to Front Hub Bearing Alignment
- Document ID 3973764 – Driveline Support Assembly Replacement (with Automatic Transmission)
