2014 - 2015 Corvette: GM TechLink: 6.2L Engine Bell Housing Rattle

Subject: 6.2L Engine Bell Housing Rattle

Model and Year: 2014 - 2015 Corvette Equipped with LT1

Date: November 7, 2014

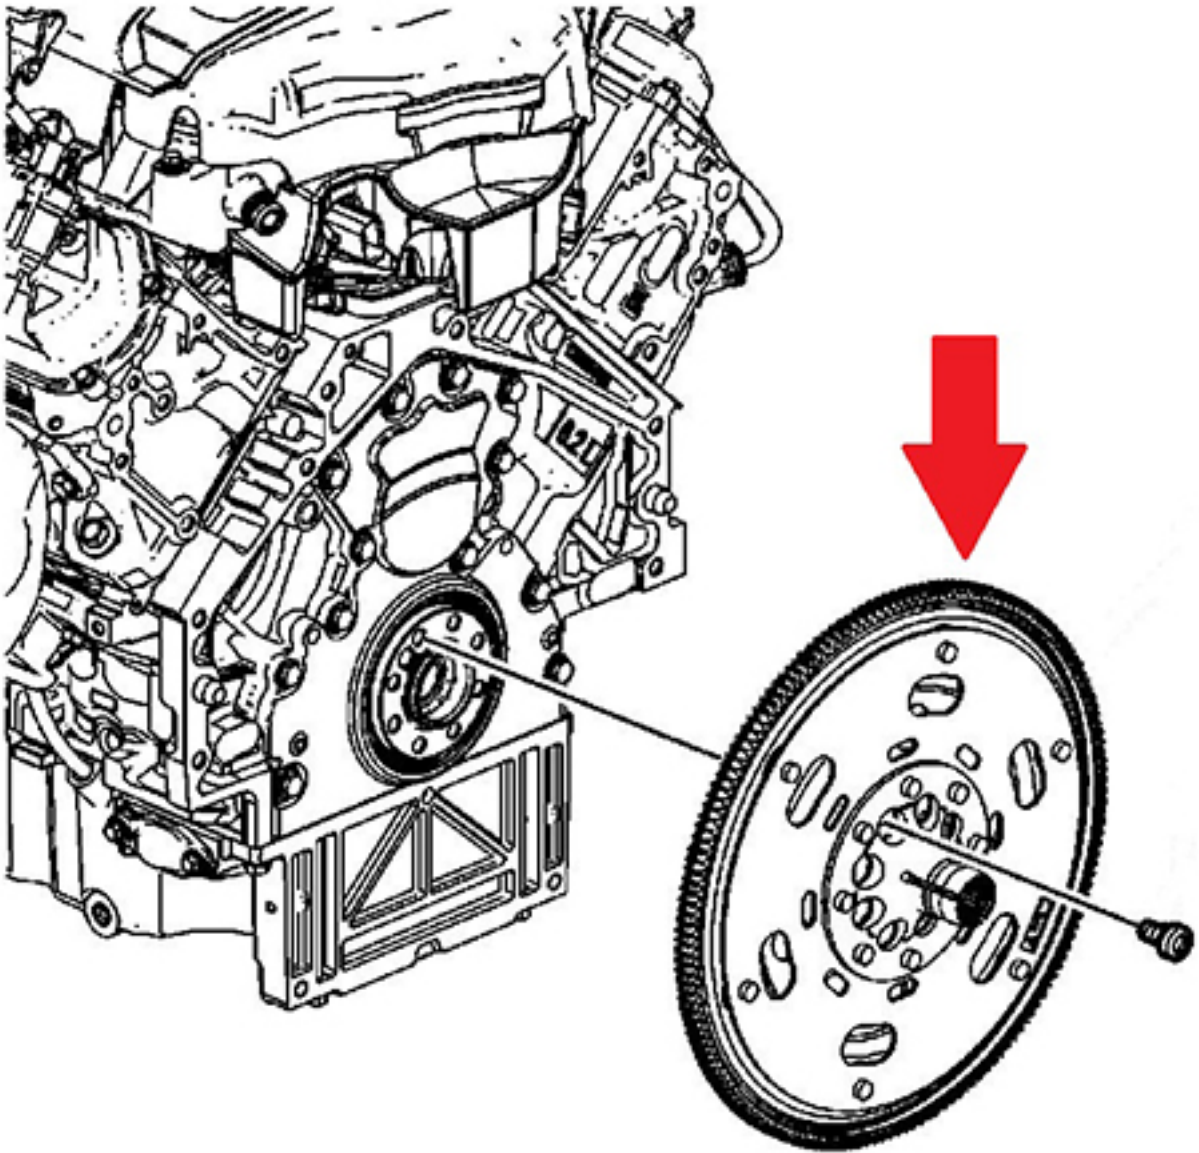
If it's determined that the rattle noise is coming from the flex plate (Fig. 7), raise the vehicle on a hoist and pull the front bell access cover. The noise will be coming from the hole.

TIP: Check that the pinch clamp bolt is tight before replacing the front flex plate. The loose bolt condition results in the same noise. This is an easy check before starting a major service procedure.

Do not reinstall the old flex plate even if it looks OK as the cause of the rattle may not be visible.

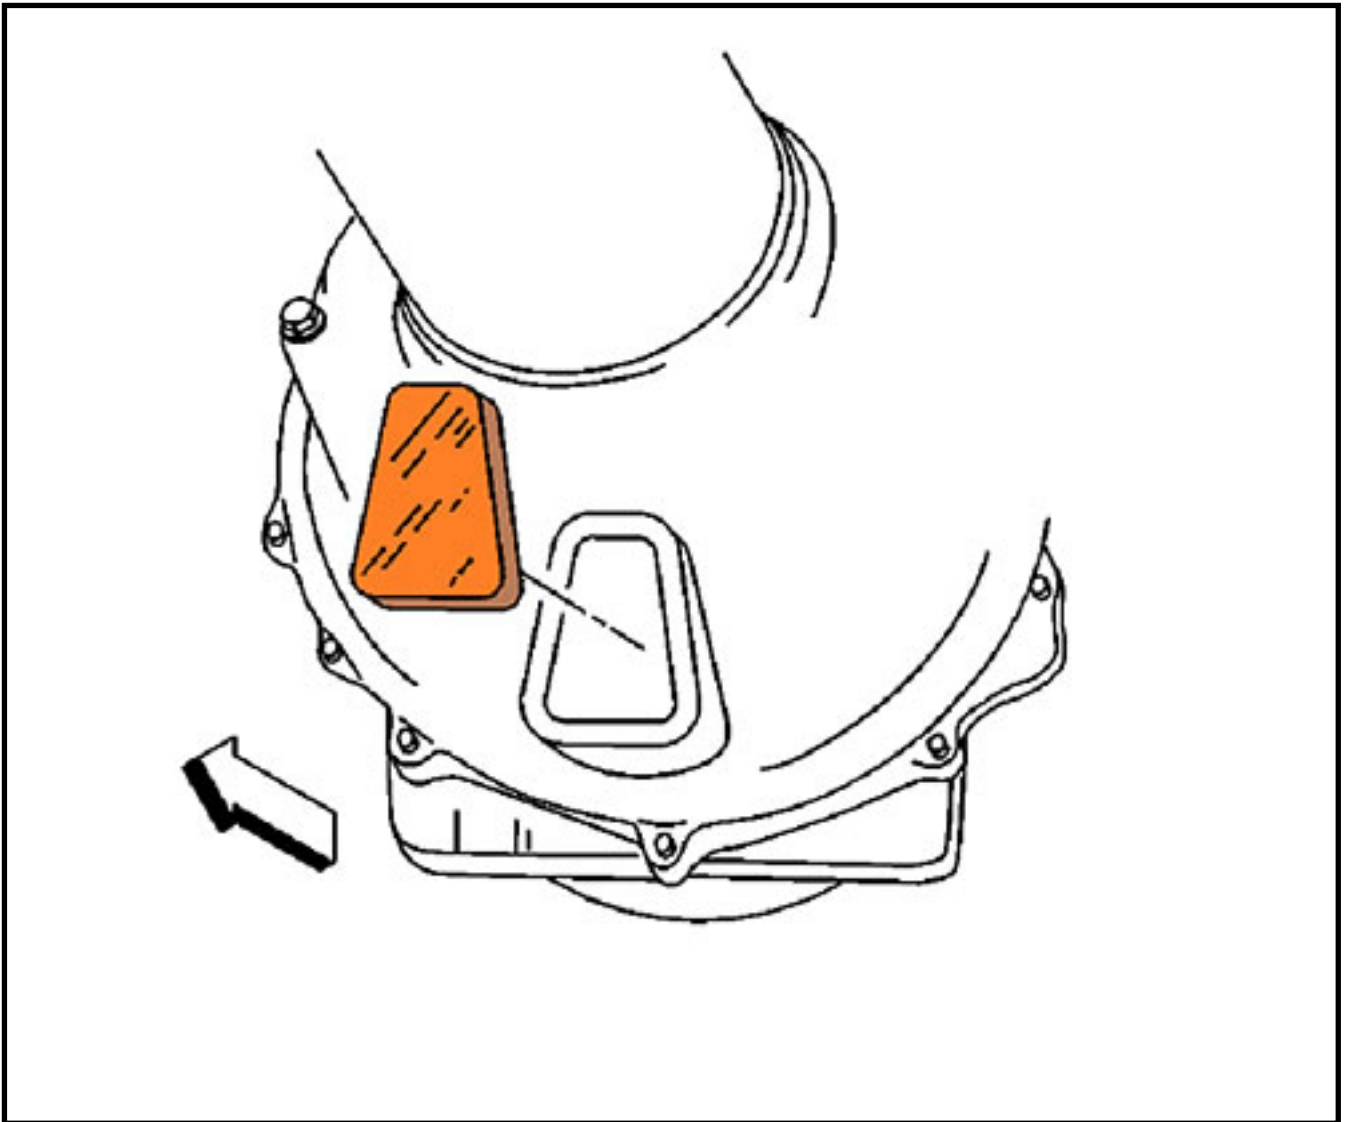
Unlike the flex plate rattle, a DSA rattle noise typically occurs at or just off idle and will be louder when observed via the rear bell housing access plug. (Fig. 8)

When performing repairs for a flex plate rattle or DSA rattle, refer to the

latest information in the Service Information:

- #13-04-17-001 – Driveline Support (Torque Tube) / Propeller Shaft Input to Front Hub Bearing Alignment
- Document ID 3973764 – Driveline Support Assembly Replacement (with Automatic Transmission)
