# 1970 Corvette: Service Bulletin: Water Pump Bearing and/or Shaft Failures

**Source:** Chevrolet Dealer Service Technical Bulletin

**Bulletin No:** 71-T-37

**Date:** June 23, 1971

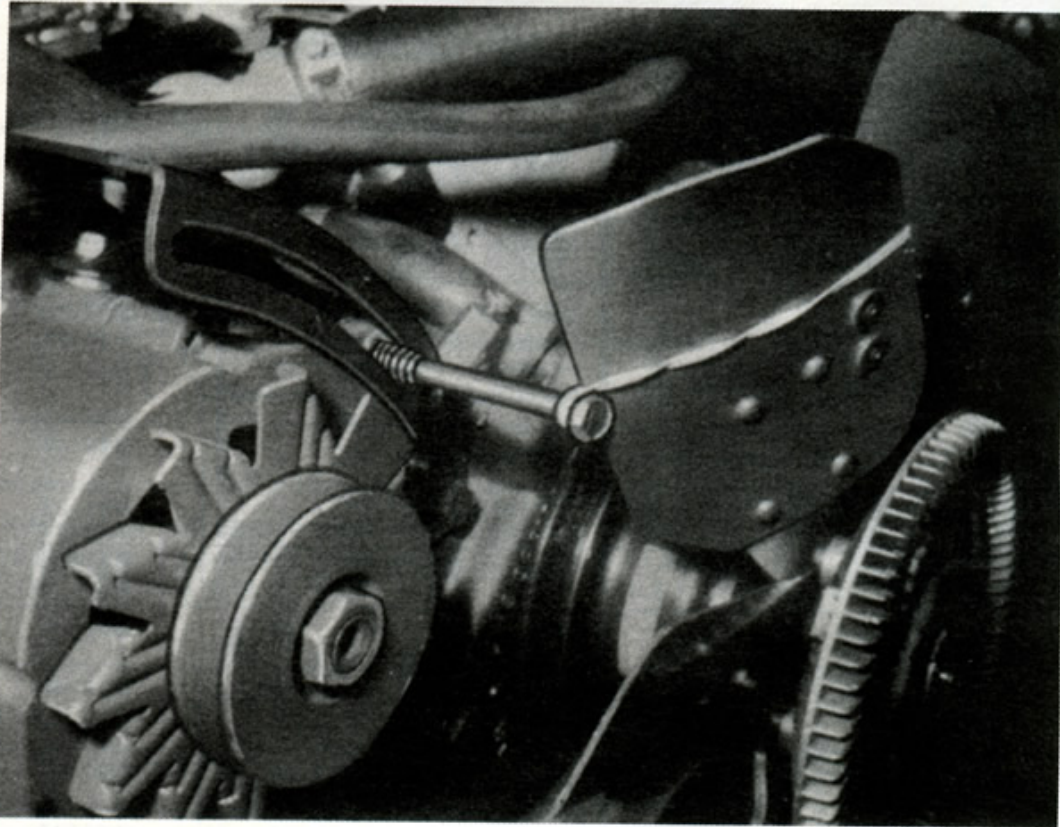
FIGURE-1

Investigation has shown that water pump bearing and/or shaft failures may occur if excessive run-out exists at the fan clutch.

- A. Secure the fan blade to prevent rotation. (See Figure 1).
- B. Mount a dial indicator (.001 graduations) to the engine and place the indicator pointer on the fan blade spider. Preferably on the longest
