# 1970 Corvette: Service Bulletin: Water Pump Bearing and/or Shaft Failures

**Source:** Chevrolet Dealer Service Technical Bulletin

**Bulletin No:** 71-T-37

**Date:** June 23, 1971

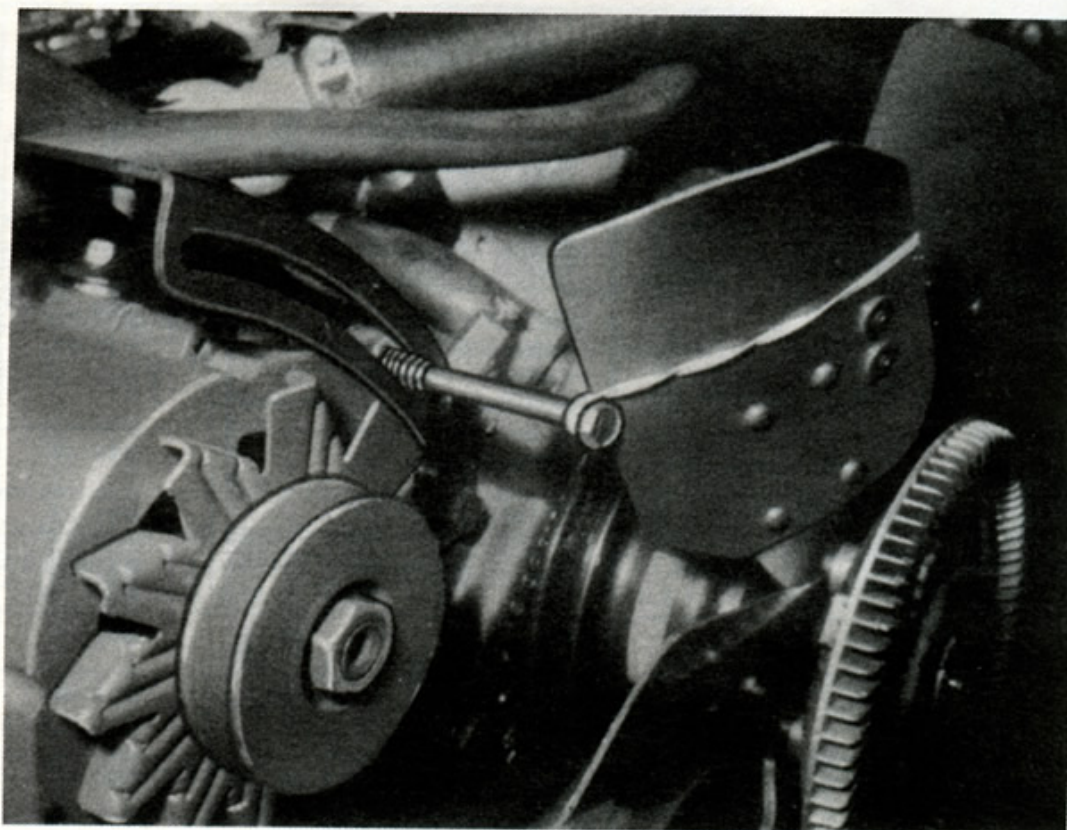
FIGURE-1

- A. Secure the fan blade to prevent rotation. (See Figure 1).
- B. Mount a dial indicator (.001 graduations) to the engine and place the indicator pointer on the fan blade spider. Preferably on the longest

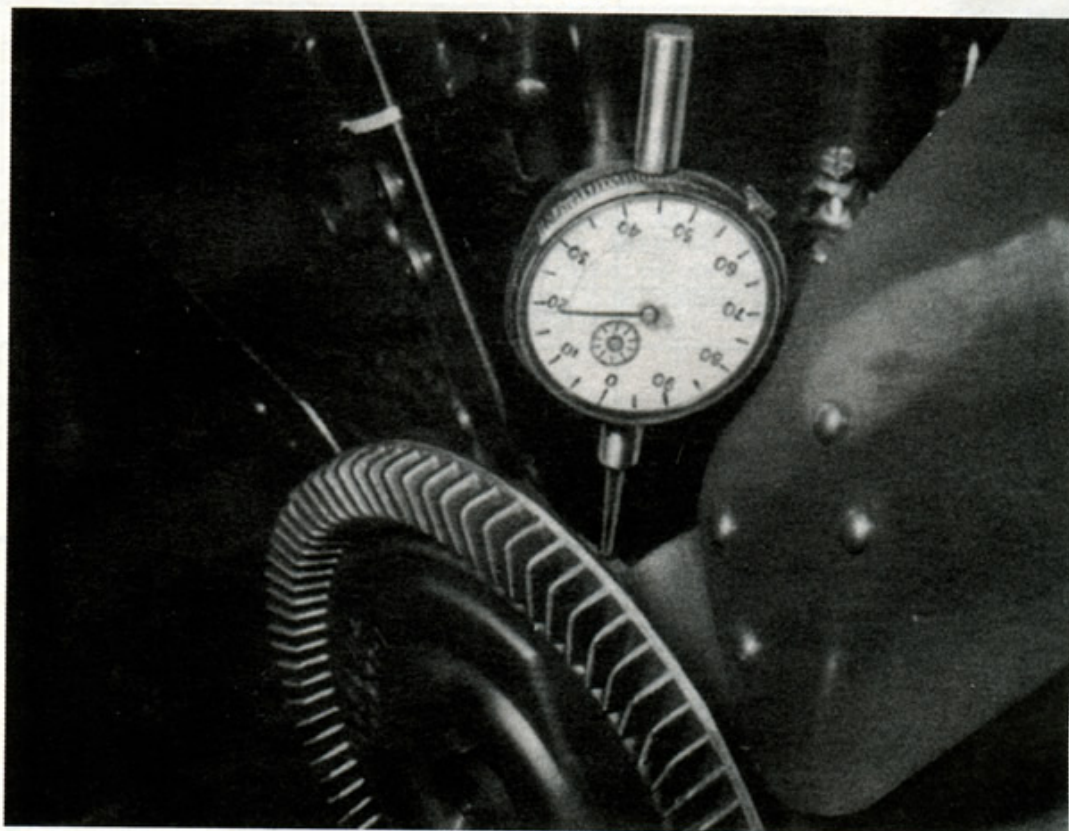
FIGURE-2

band or space on the spider. (See Figure 2).
