# 1970 Corvette: Service Bulletin: Water Pump Bearing and/or Shaft Failures

**Source:** Chevrolet Dealer Service Technical Bulletin

**Bulletin No:** 71-T-37

**Date:** June 23, 1971

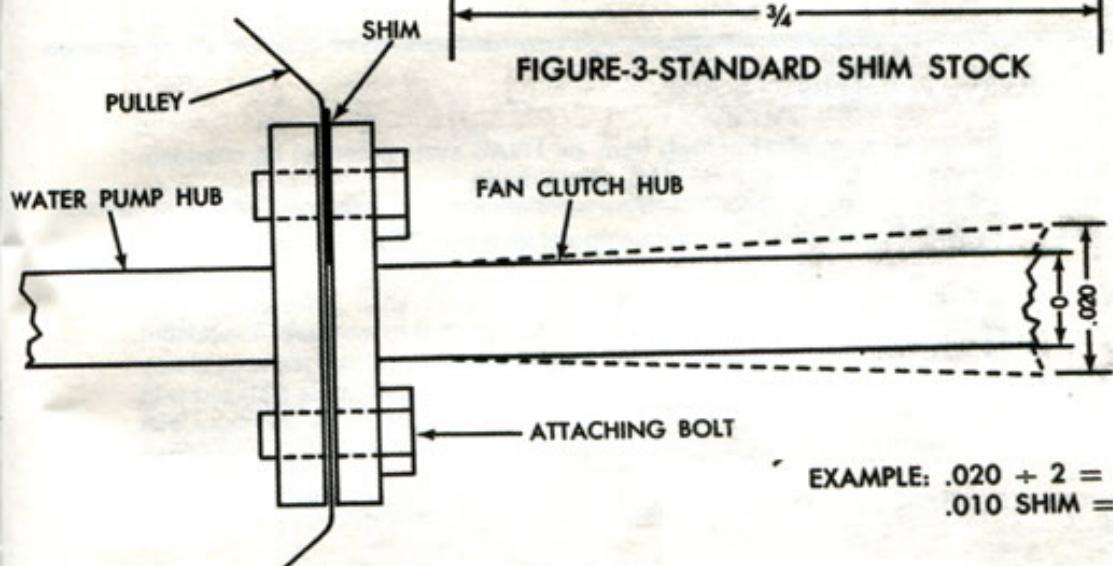
FIGURE-4

EXAMPLE:  $.020 \div 2 = .010$   
 $.010$  SHIM =  $-0$ —RUN OUT

TOTAL RUN-OUT  $\div 2$  = SHIM THICKNESS  
 TO OBTAIN ZERO ( $-0$ ) RUN-OUT

- C. Rotate the water pump pulley in one direction and note the total amount of indicator needle movement. This represents the total radial run-out. Mark the point on the pulley at which the highest reading is obtained.
- D. If the total indicator reading is less than .006 inch, the assembly is within specification. Install fan belt and adjust. If the total indicator run-out exceeds .006 inch, proceed to Step "E".
- E. Divide the total indicator reading in half and obtain this thickness from shim stock (1/2 x 3/4) and rework per Figure 3. Place this shim pack between the water pump pulley and fan clutch hub at the bolt closest to the point marked on the pulley in Step "C". If the mark on the pulley is between two bolts so that it is difficult to determine which bolt is closest, place two shim packs; one under each bolt on either side of the mark. (See Figure 4).

- a. When one shim pack is used, first, torque the bolt over which the shim pack has been placed; second, the bolt opposite the first; and finally, the other two. Recommended torque is 25 lbs. ft.
- b. When two shim packs are used, each bolt must be torqued partially; then to full torque alternating between opposite bolts; then the other two bolts in the same manner. Recommended torque is 25 lbs. ft.
