1963 Corvette: Service Bulletin: Interim Production Changes

Subject: Interim Production Changes
Model and Year: 1963 Corvette
Source: Chevrolet Technical Service Bulletin
Bulletin No: DR #569
Section: XV
Date: December 31, 1962

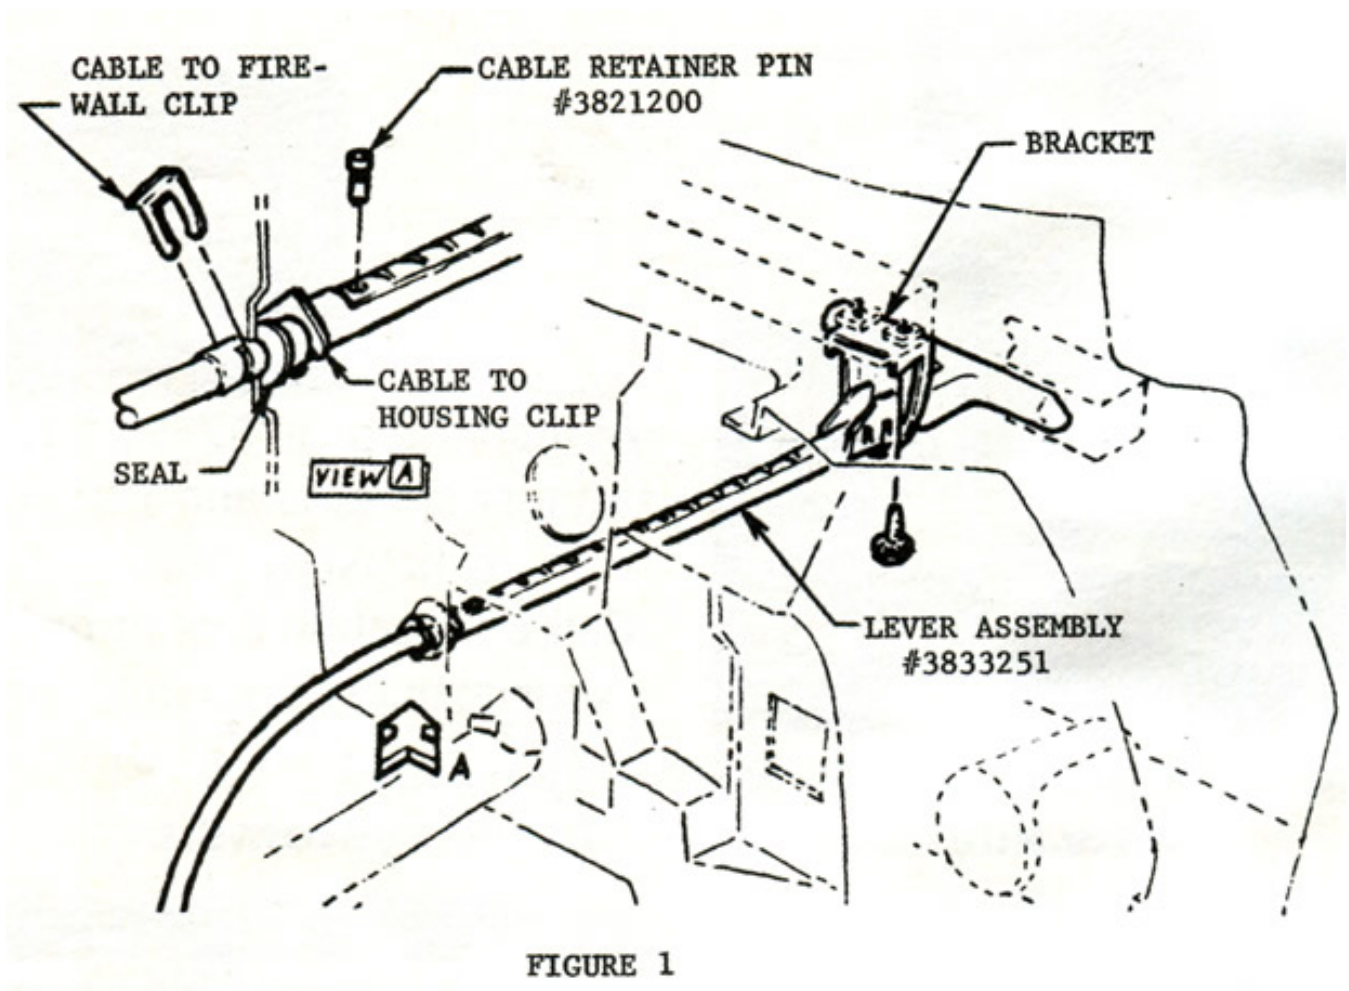
1. Effective with Serial No. S101893, a redesigned parking brake lever assembly entered Production. Early vehicles incorporate a lever assembly which may be difficult to release and in extreme cases, may actually jam making release impossible.
2. Vehicles with Serial No. S101847 through S102667, were built with a second design rear axle driveshaft flange that may not seat properly in the rear wheel drive spindle flange. An interference condition at this location could possibly lead to early failure of the rear wheel spindle flange attaching bolt bosses.

Lever Assembly should be replaced on all vehicles built prior to Serial No. S101893. Referring to Figure

1, proceed as follows:

1. Scrape sealer away from cable to firewall clip and remove clip.
2. Disconnect parking brake cable clip from steering gear retainer bolt.
3. Disconnect oil pressure line at gauge and pull line out of parking brake lever assembly bracket.

4. Remove two (2) bolts holding bracket to dash brace.
5. Pull complete lever and cable assembly to the rear, far enough to remove parking brake signal switch.

6. With handle all the way in, cable retainer pin will line up with hole in bottom of housing allowing pin to be driven out from bottom with a punch.
7. Remove cable to housing clip and separate cable from housing.

8. Install original seal on new lever assembly No. 3833251.
9. Reassemble by reversing the above steps using new cable retainer pin No. 3821200. NOTE:
Chamfered side of pin must face forward to actuate the parking brake signal switch properly.

10. Apply body sealer around cable at firewall to prevent water leaks.

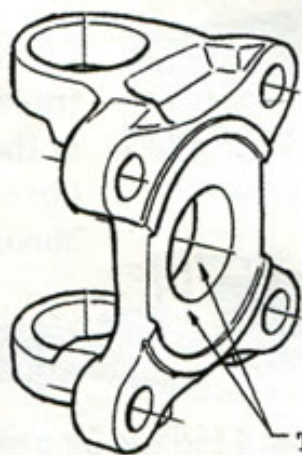
FIGURE 3 - DRIVESHAFT FLANGE

THESE SURFACES
MACHINED FOR
CLEARANCE

New machined Driveshaft Flanges No. 3832048, should be installed on all vehicles with Serial No.

S101847 through S102667 (Ref. Figs. 2 and 3).

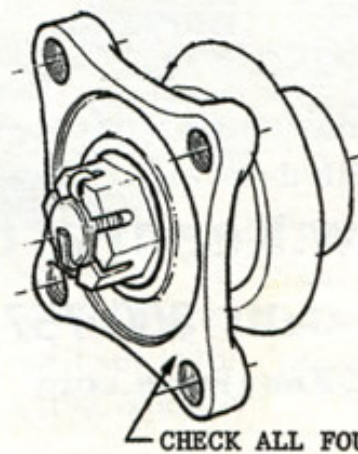
FIGURE 4 - SPINDLE FLANGE

CHECK ALL FOUR
BOSSES FOR CRACKS
IN THIS AREA

Replacement of the driveshaft flange is covered in the 1963 Corvette Shop Manual, Page 4-16. The rear wheel spindle flange attaching bolt bosses should be visually inspected while the axle driveshafts are out of the vehicle. Replace with new Spindle Flange Assembly No. 3830253 if any cracks are evident in the area indicated in Figure 4.

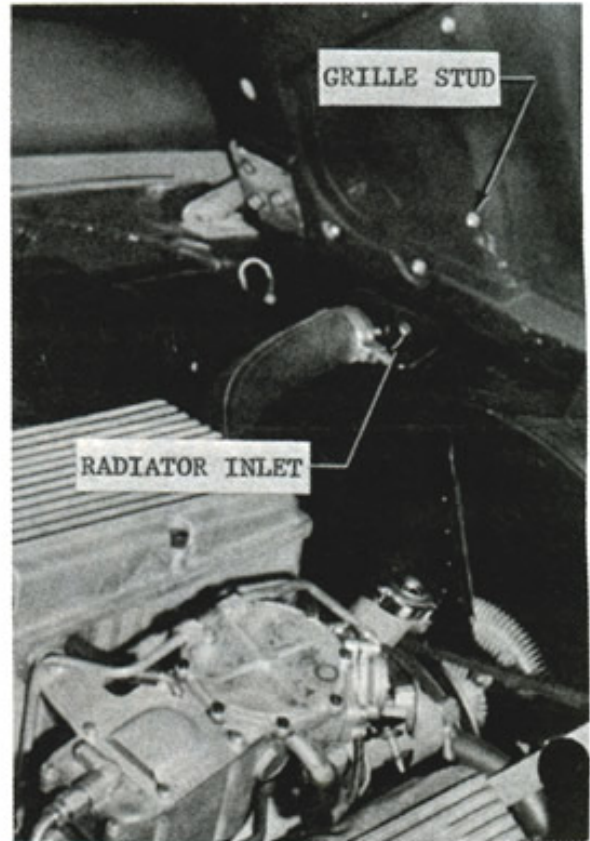
FIGURE 4

3. Vehicles prior to Serial No. S105362 may have interference between the radiator top tank inlet and one of the simulated hood grille attaching studs. Contact at this point might eventually rub through the radiator inlet causing loss of water and cooling system pressure.

All vehicles built prior to Serial Number S105362, may have interference between the hood simulated grille attaching stud indicated in Figure 4, and the radiator inlet. To eliminate possible radiator damage, the following steps should be followed:

1. File or grind stud off flush with lower face of nut.
2. Inspect radiator inlet for any signs of leakage in the area of stud contact.
3. Place a small thin piece of body sealer or clay on radiator inlet and close hood. Open hood and inspect sealer or clay to determine if metal to metal contact still exists. If necessary, carefully tap a small depression in radiator inlet using a ball peen hammer and recheck clearance with sealer or clay.
