1963 Corvette: Service Bulletin: Interim Production Changes

Subject: Interim Production Changes
Model and Year: 1963 Corvette
Source: Chevrolet Technical Service Bulletin
Bulletin No: DR #569
Section: XV
Date: December 31, 1962

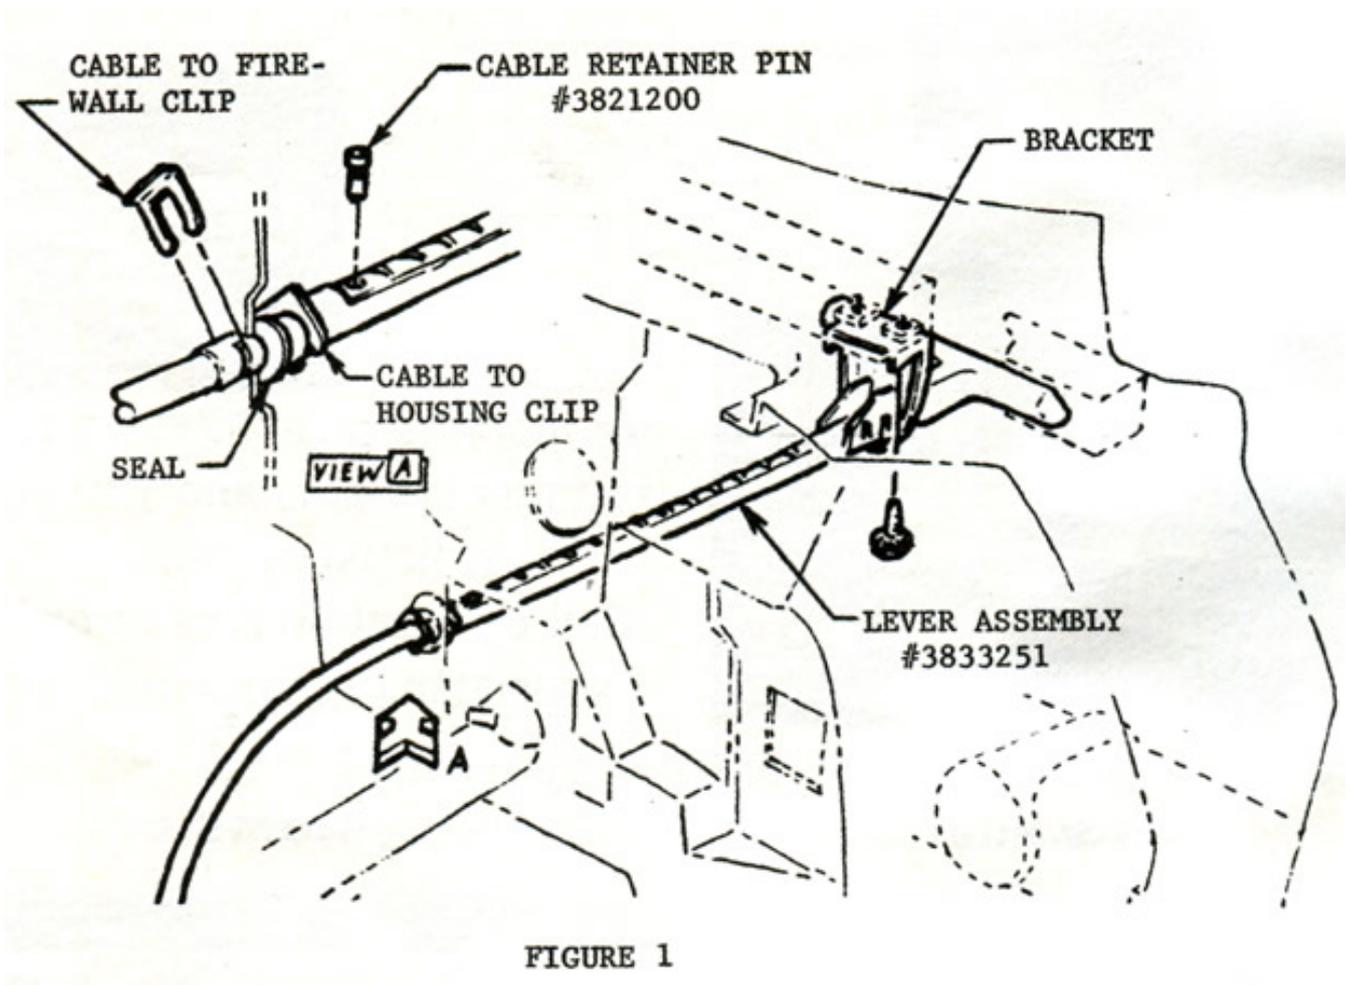
1. Effective with Serial No. S101893, a redesigned parking brake lever assembly entered Production. Early vehicles incorporate a lever assembly which may be difficult to release and in extreme cases, may actually jam making release impossible.
2. Vehicles with Serial No. S101847 through S102667, were built with a second design rear axle driveshaft flange that may not seat properly in the rear wheel drive spindle flange. An interference condition at this location could possibly lead to early failure of the rear wheel spindle flange attaching bolt bosses.

Lever Assembly should be replaced on all vehicles built prior to Serial No. S101893. Referring to Figure 1, proceed as follows:

1. Scrape sealer away from cable to firewall clip and remove clip.
2. Disconnect parking brake cable clip from steering gear retainer bolt.
3. Disconnect oil pressure line at gauge and pull line out of parking brake lever assembly bracket.
4. Remove two (2) bolts holding bracket to dash brace.
5. Pull complete lever and cable assembly to the rear, far enough to remove parking brake signal switch.
6. With handle all the way in, cable retainer pin will line up with hole in bottom of housing allowing pin to be driven out from bottom with a punch.
7. Remove cable to housing clip and separate cable from housing.
8. Install original seal on new lever assembly No. 3833251.
9. Reassemble by reversing the above steps using new cable retainer pin No. 3821200. NOTE: Chamfered side of pin must face forward to

actuate the parking brake signal switch properly.

10. Apply body sealer around cable at firewall to prevent water leaks.

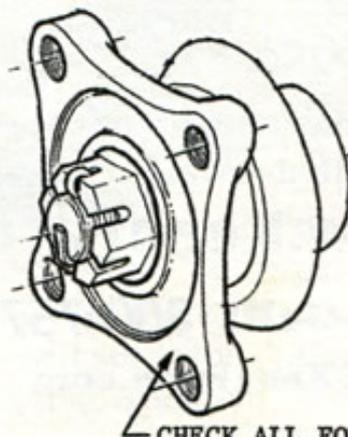
FIGURE 4 - SPINDLE FLANGE

Replacement of the driveshaft flange is covered in the 1963 Corvette Shop Manual, Page 4-16. The rear wheel spindle flange attaching bolt bosses should be visually inspected while the axle driveshafts are out of the vehicle. Replace with new Spindle Flange Assembly No. 3830253 if any cracks are evident in the area indicated in Figure 4.

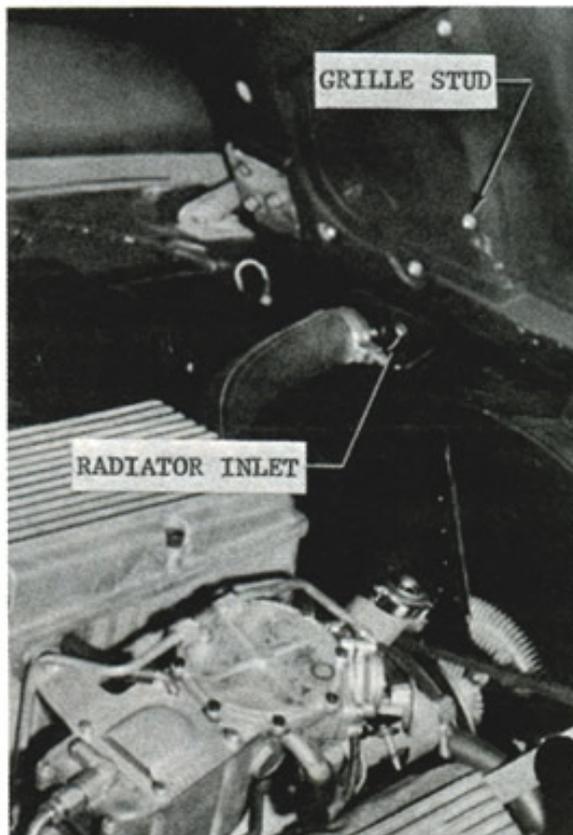
FIGURE 4

3. Vehicles prior to Serial No. S105362 may have interference between the radiator top tank inlet and one of the simulated hood grille attaching studs. Contact at this point might eventually rub through the radiator inlet causing loss of water and cooling system pressure.

All vehicles built prior to Serial Number S105362, may have interference between the hood simulated grille attaching stud indicated in Figure 4, and the radiator inlet. To eliminate possible radiator damage, the following steps should be followed:

1. File or grind stud off flush with lower face of nut.
2. Inspect radiator inlet for any signs of leakage in the area of stud contact.
3. Place a small thin piece of body sealer or clay on radiator inlet and close hood. Open hood and inspect sealer or clay to determine if metal to metal contact still exists. If necessary, carefully tap a small depression in radiator inlet using a ball peen hammer and recheck clearance with sealer or clay.
