1963 Corvette: Service Bulletin: Interim Production Changes

Subject: Interim Production Changes
Model and Year: 1963 Corvette
Source: Chevrolet Technical Service Bulletin
Bulletin No: DR #569
Section: XV
Date: December 31, 1962

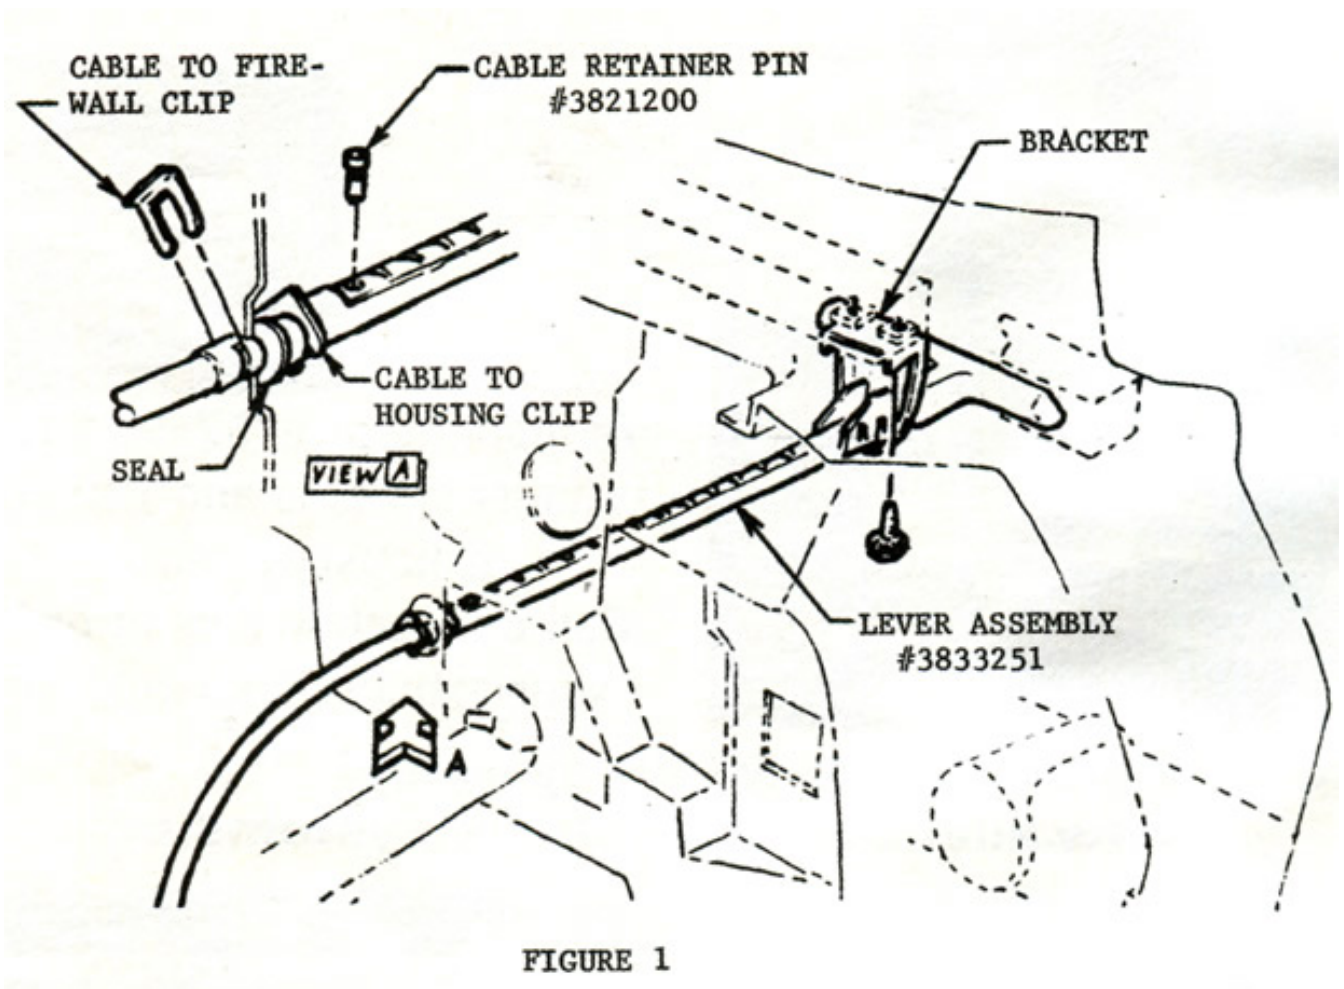
1. Effective with Serial No. S101893, a redesigned parking brake lever assembly entered Production. Early vehicles incorporate a lever assembly which may be difficult to release and in extreme cases, may actually jam making release impossible.
2. Vehicles with Serial No. S101847 through S102667, were built with a second design rear axle driveshaft flange that may not seat properly in the rear wheel drive spindle flange. An interference condition at this location could possibly lead to early failure of the rear wheel spindle flange attaching bolt bosses.

Lever Assembly should be replaced on all vehicles built prior to Serial No. S101893. Referring to Figure 1, proceed as follows:

1. Scrape sealer away from cable to firewall clip and remove clip.
2. Disconnect parking brake cable clip from steering gear retainer bolt.
3. Disconnect oil pressure line at gauge and pull line out of parking brake lever assembly bracket.
4. Remove two (2) bolts holding bracket to dash brace.
5. Pull complete lever and cable assembly to the rear, far enough to remove parking brake signal switch.
6. With handle all the way in, cable retainer pin will line up with hole in bottom of housing allowing pin to be driven out from bottom with a punch.
7. Remove cable to housing clip and separate cable from housing.
8. Install original seal on new lever assembly No. 3833251.
9. Reassemble by reversing the above steps using new cable retainer pin No. 3821200. NOTE: Chamfered side of pin must face forward to

actuate the parking brake signal switch properly.

10. Apply body sealer around cable at firewall to prevent water leaks.

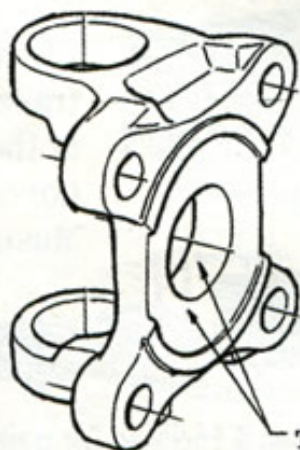
FIGURE 3 - DRIVESHAFT FLANGE

THESE SURFACES
MACHINED FOR
CLEARANCE

New machined Driveshaft Flanges No. 3832048, should be installed on all vehicles with Serial No. S101847 through S102667 (Ref. Figs. 2 and 3).

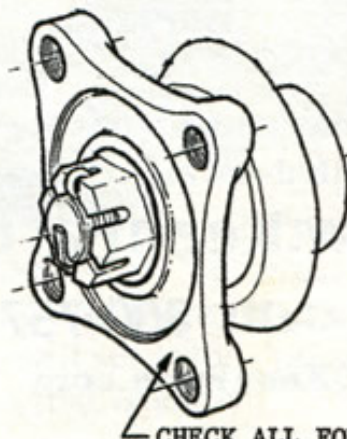
FIGURE 4 - SPINDLE FLANGE

CHECK ALL FOUR
BOSSES FOR CRACKS
IN THIS AREA

Replacement of the driveshaft flange is covered in the 1963 Corvette Shop Manual, Page 4-16. The rear wheel spindle flange attaching bolt bosses should be visually inspected while the axle driveshafts are out of the vehicle. Replace with new Spindle Flange Assembly No. 3830253 if any cracks are evident in the area indicated in Figure 4.

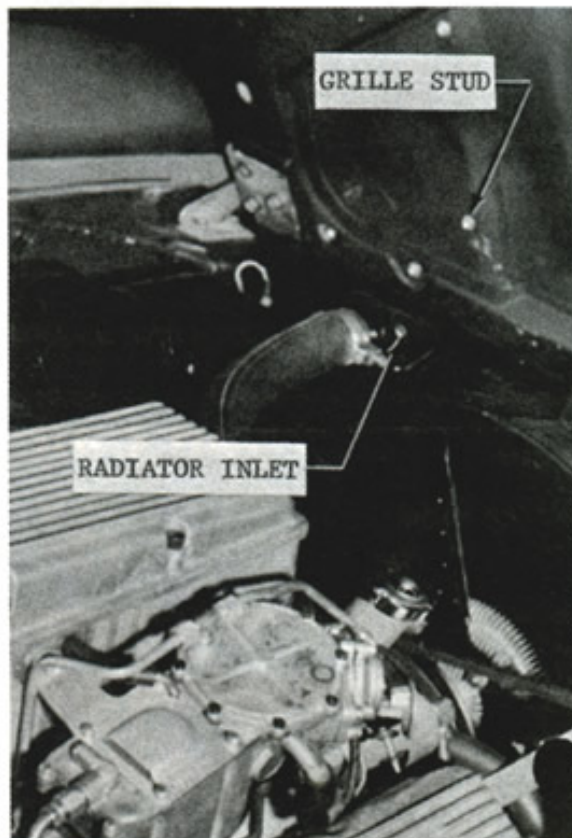
FIGURE 4

3. Vehicles prior to Serial No. S105362 may have interference between the radiator top tank inlet and one of the simulated hood grille attaching studs. Contact at this point might eventually rub through the radiator inlet causing loss of water and cooling system pressure.

All vehicles built prior to Serial Number S105362, may have interference between the hood simulated grille attaching stud indicated in Figure 4, and the radiator inlet. To eliminate possible radiator damage, the following steps should be followed:

1. File or grind stud off flush with lower face of nut.
2. Inspect radiator inlet for any signs of leakage in the area of stud contact.
3. Place a small thin piece of body sealer or clay on radiator inlet and close hood. Open hood and inspect sealer or clay to determine if metal to metal contact still exists. If necessary, carefully tap a small depression in radiator inlet using a ball peen hammer and recheck clearance with sealer or clay.
