1963 Corvette: Service Bulletin: Interim Production Changes

Source: Chevrolet Technical Service Bulletin

Bulletin No: DR #569

Date: December 31, 1962

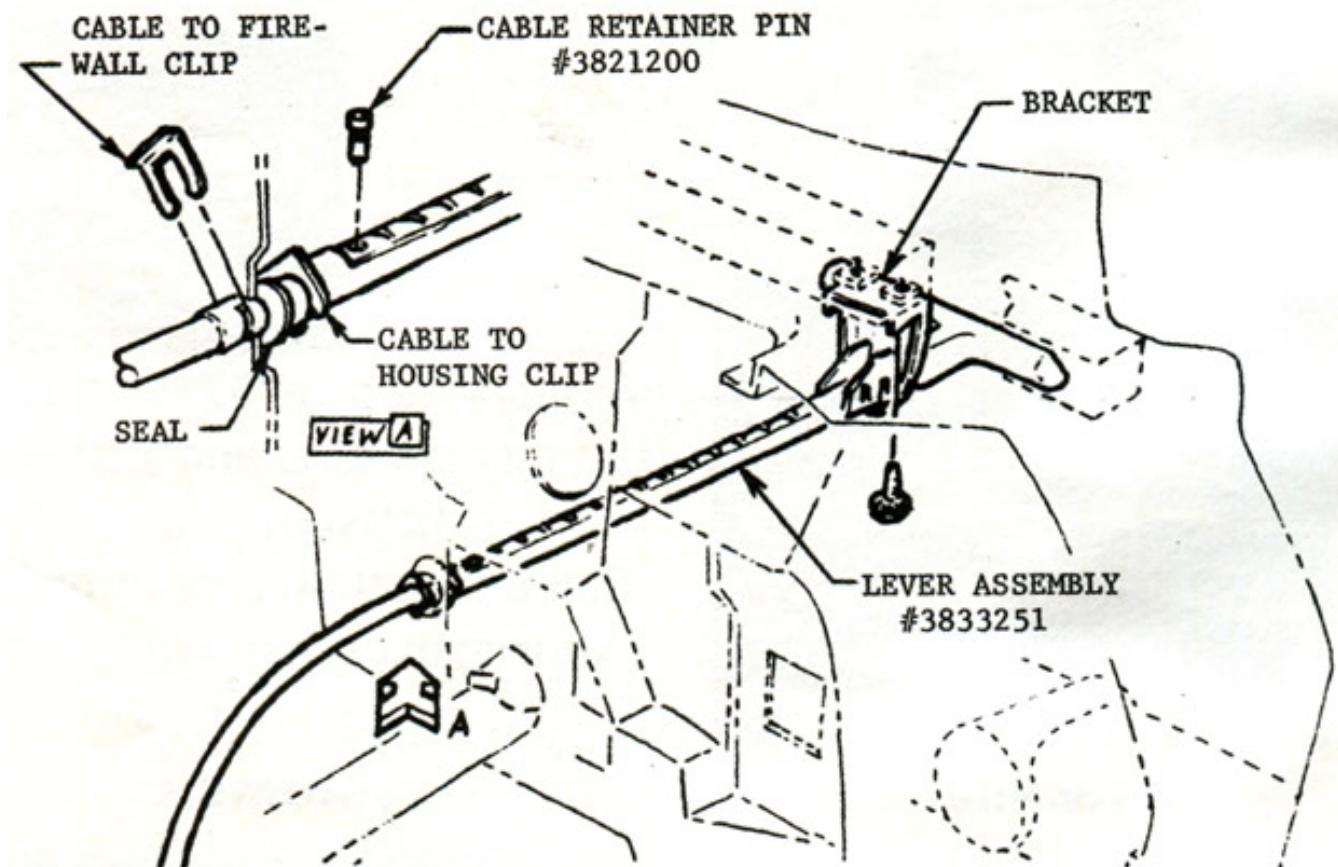
FIGURE 1

1. Effective with Serial No. S101893, a redesigned parking brake lever assembly entered Production. Early vehicles incorporate a lever assembly which may be difficult to release and in extreme cases, may actually jam making release impossible.
2. Vehicles with Serial No. S101847 through S102667, were built with a second design rear axle driveshaft flange that may not seat properly in the rear wheel drive spindle flange. An interference condition at this location could possibly lead to early failure of the rear wheel spindle flange attaching bolt bosses.

Lever Assembly should be replaced on all vehicles built prior to Serial No. S101893. Referring to Figure 1, proceed as follows:

1. Scrape sealer away from cable to firewall clip and remove clip.
2. Disconnect parking brake cable clip from steering gear retainer bolt.
3. Disconnect oil pressure line at gauge and pull line out of parking brake lever assembly bracket.
4. Remove two (2) bolts holding bracket to dash brace.
5. Pull complete lever and cable assembly to the rear, far enough to remove parking brake signal switch.
6. With handle all the way in, cable retainer pin will line up with hole in bottom of housing allowing pin to be driven out from bottom with a punch.
7. Remove cable to housing clip and separate cable from housing.
8. Install original seal on new lever assembly No. 3833251.
9. Reassemble by reversing the above steps using new cable retainer pin No. 3821200. NOTE: Chamfered side of pin must face forward to

actuate the parking brake signal switch properly.

10. Apply body sealer around cable at firewall to prevent water leaks.

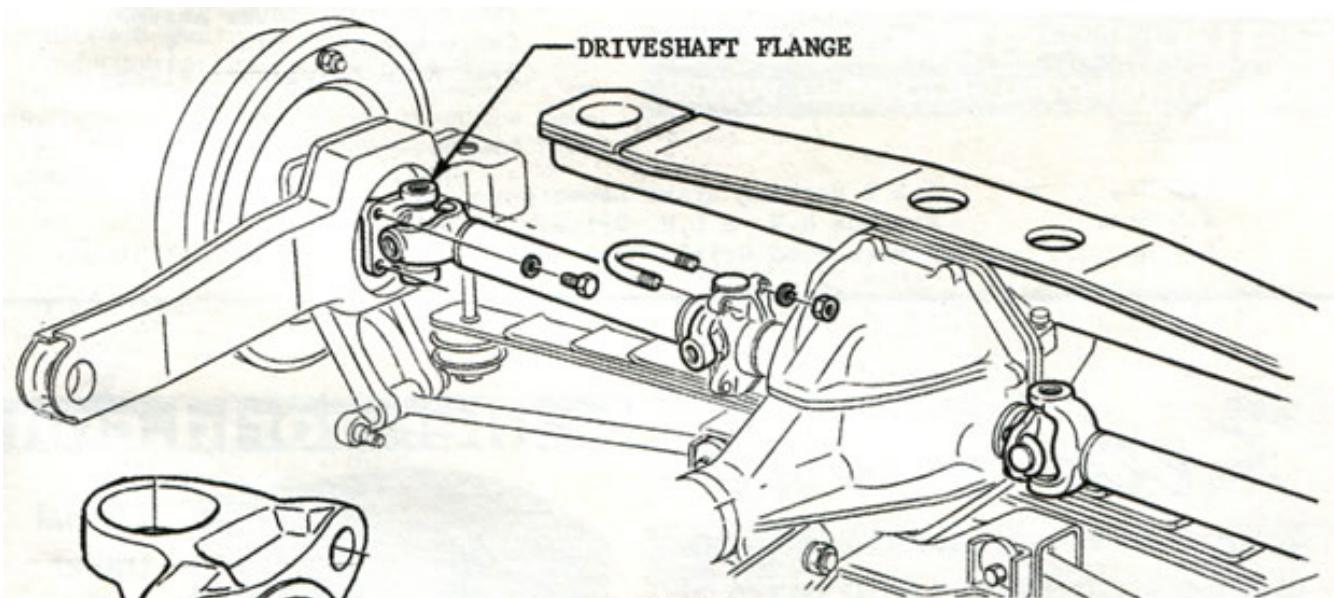
FIGURE 2

Vehicles built after S102667 incorporate selective fit pieces or additional machining to insure adequate clearance.

New machined Driveshaft Flanges No. 3832048, should be installed on all vehicles with Serial No. S101847 through S102667 (Ref. Figs. 2 and 3).

Replacement of the driveshaft flange is covered in the 1963 Corvette Shop Manual, Page 4-16. The rear wheel spindle flange attaching bolt bosses should be visually inspected while the axle driveshafts are out of the vehicle. Replace with new Spindle Flange Assembly No. 3830253 if any cracks are evident in the area indicated in Figure 4.

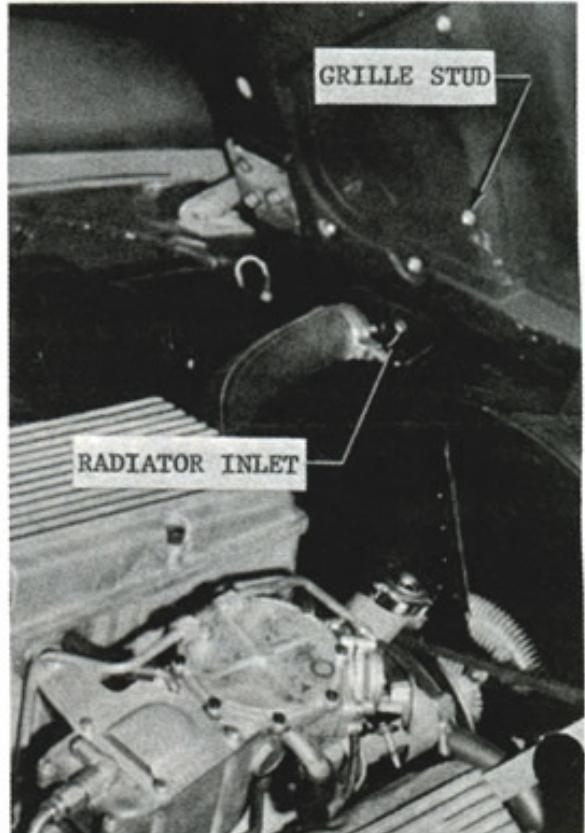
FIGURE 4

3. Vehicles prior to Serial No. S105362 may have interference between the radiator top tank inlet and one of the simulated hood grille attaching studs. Contact at this point might eventually rub through the radiator inlet causing loss of water and cooling system pressure.

All vehicles built prior to Serial Number S105362, may have interference between the hood simulated grille attaching stud indicated in Figure 4, and the radiator inlet. To eliminate possible radiator damage, the following steps should be followed:

1. File or grind stud off flush with lower face of nut.
2. Inspect radiator inlet for any signs of leakage in the area of stud contact.
3. Place a small thin piece of body sealer or clay on radiator inlet and close hood. Open hood and inspect sealer or clay to determine if metal to metal contact still exists. If necessary, carefully tap a small depression in radiator inlet using a ball peen hammer and recheck clearance with sealer or clay.
