1968 Corvette: Service Bulletin: Heat Damage to Engine Wiring Harness at Starter Solenoid

Model and Year: 1968 Corvette with 396 or 427 Cubic Inch Engine

Source: Chevrolet Dealer Service Technical Bulletin

Bulletin No: 68-T-66

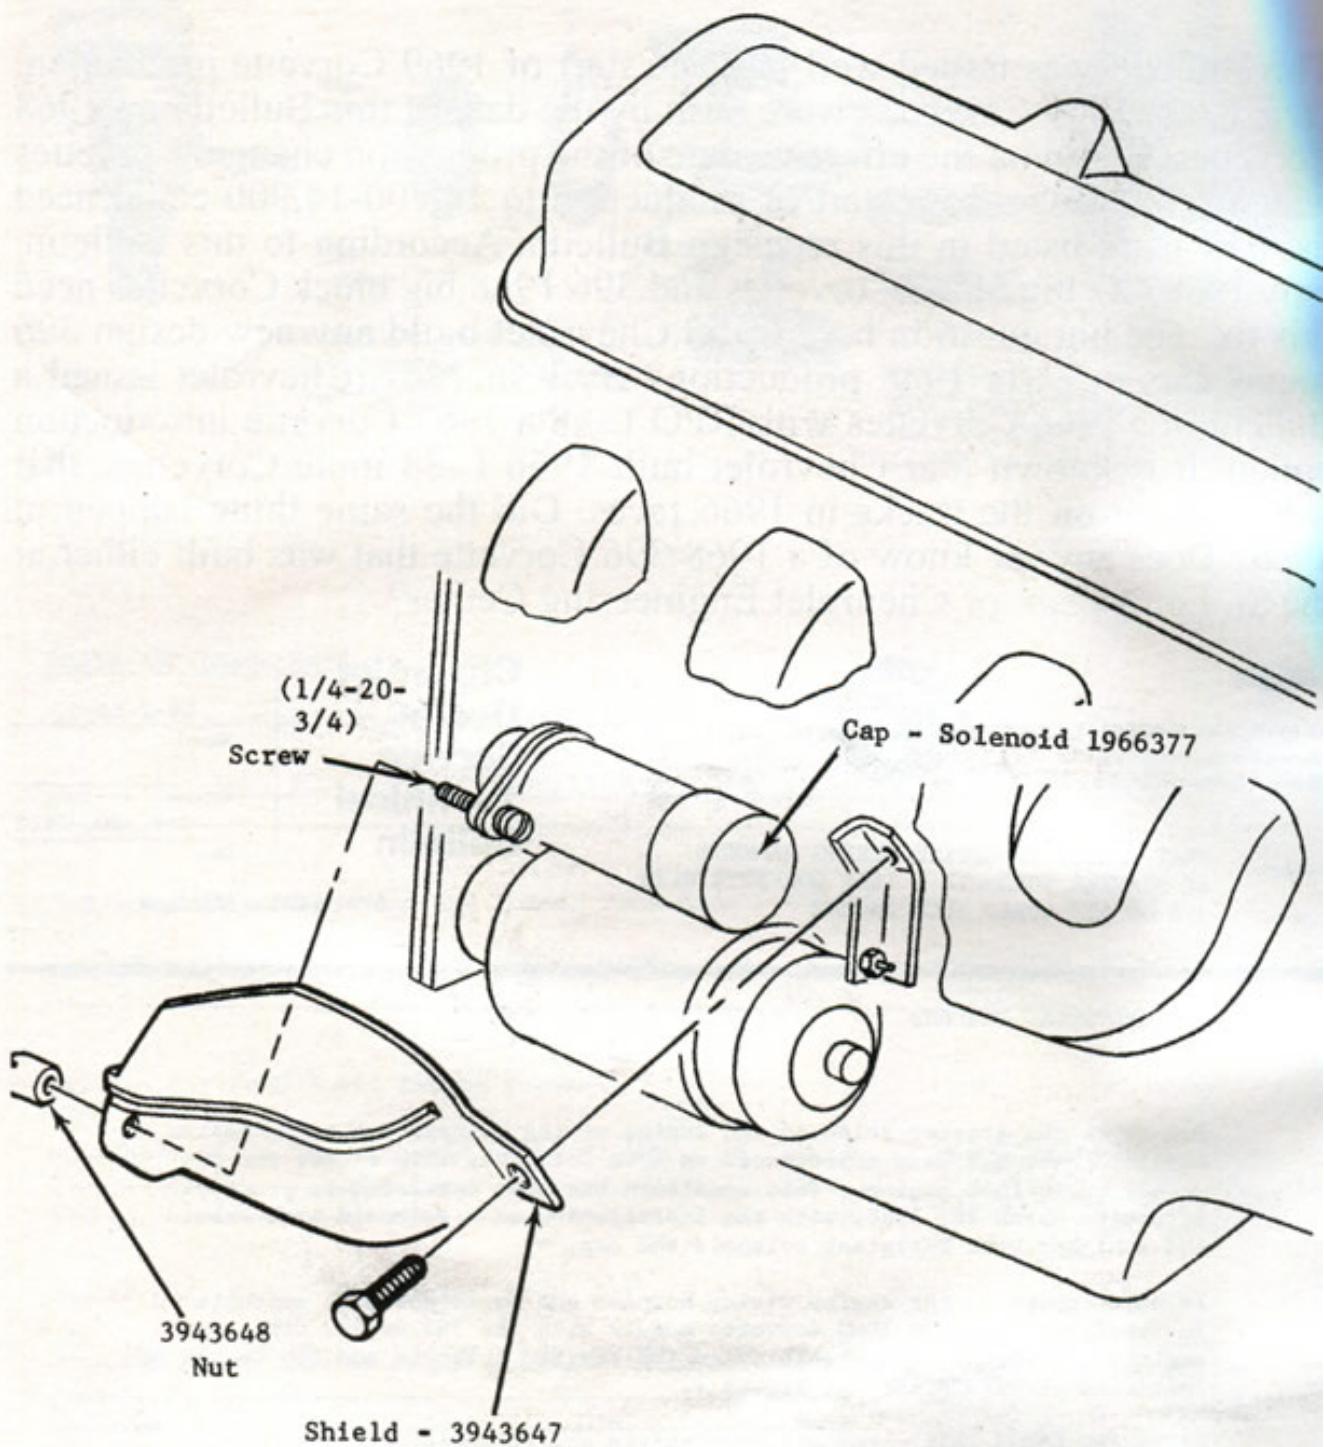
Figure 1

Damage to the starter solenoid and engine wiring harness due to excessive manifold heat has been experienced on 1968 Corvettes with either the 396 or 427 cubic inch engine. This condition has been corrected in production effective March 28, 1968, with the installation of a solenoid heat shield and a higher heat resistant solenoid end cap.

Installation of Heat Shield
and Solenoid Cap

If heat damage to the engine wiring harness and/or solenoid is encountered in the field on early 1968 Corvette models with the 396 or 427 cubic inch engine, the solenoid heat shield and the revised solenoid end cap should be installed as illustrated in figure 1.

QUA.	PART NO.	PART DESCRIPTION
1.	1	3943647	Shield
2.	1	1966377	Solenoid Cap
3.	1	3943648	Special Nut
