1968 Corvette: Service Bulletin: Heat Damage to Engine Wiring Harness at Starter Solenoid

Subject: Heat Damage to Engine Wiring Harness at Starter Solenoid
Model and Year: 1968 Corvette with 396 or 427 Cubic Inch Engine
Source: Chevrolet Dealer Service Technical Bulletin
Bulletin No: 68-T-66
Section: VIy
Date: October 30, 1968

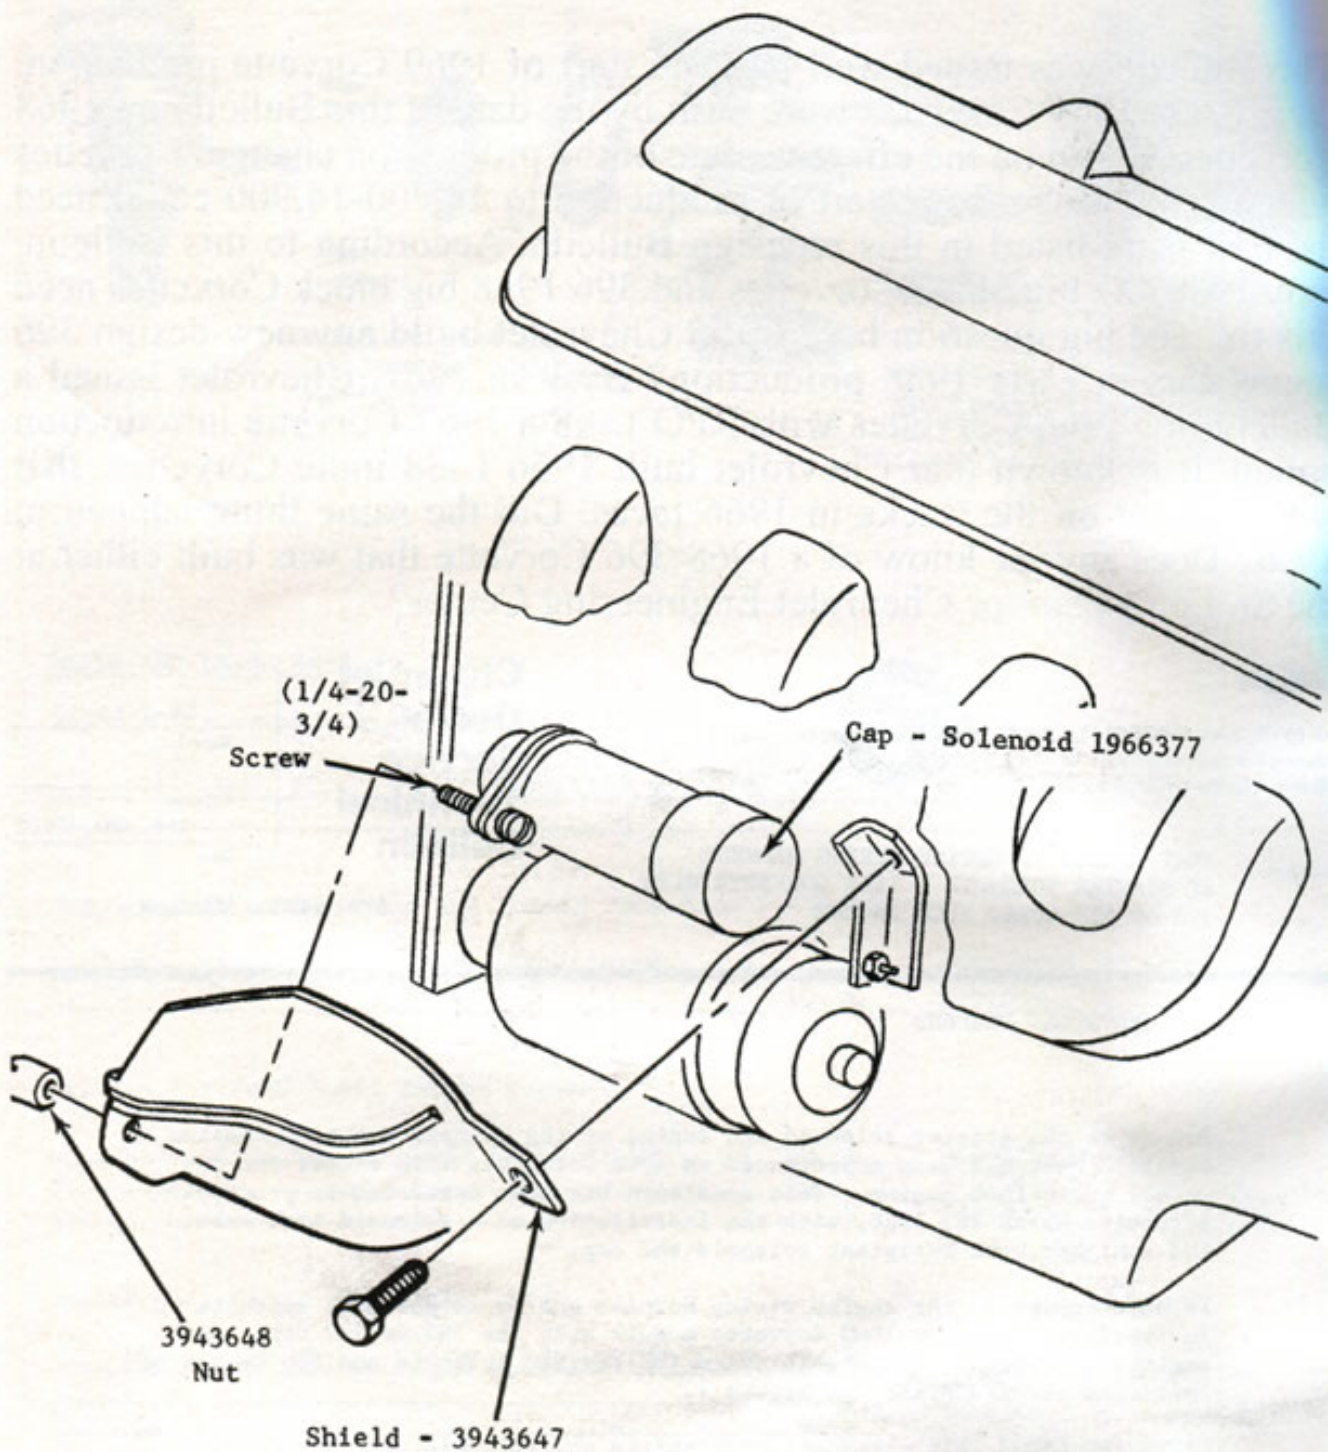
Figure 1

Damage to the starter solenoid and engine wiring harness due to excessive manifold heat has been experienced on 1968 Corvettes with either the 396 or 427 cubic inch engine. This condition has been corrected in production effective March 28, 1968, with the installation of a solenoid heat shield and a higher heat resistant solenoid end cap.

Installation of Heat Shield
and Solenoid Cap

If heat damage to the engine wiring harness and/or solenoid is encountered in the field on early 1968 Corvette models with the 396 or 427 cubic inch engine, the solenoid heat shield and the revised solenoid end cap should be installed as illustrated in figure 1.
