# 1968 Corvette: Service Bulletin: Heat Damage to Engine Wiring Harness at Starter Solenoid

**Model and Year:** 1968 Corvette with 396 or 427 Cubic Inch Engine

**Source:** Chevrolet Dealer Service Technical Bulletin

**Bulletin No:** 68-T-66

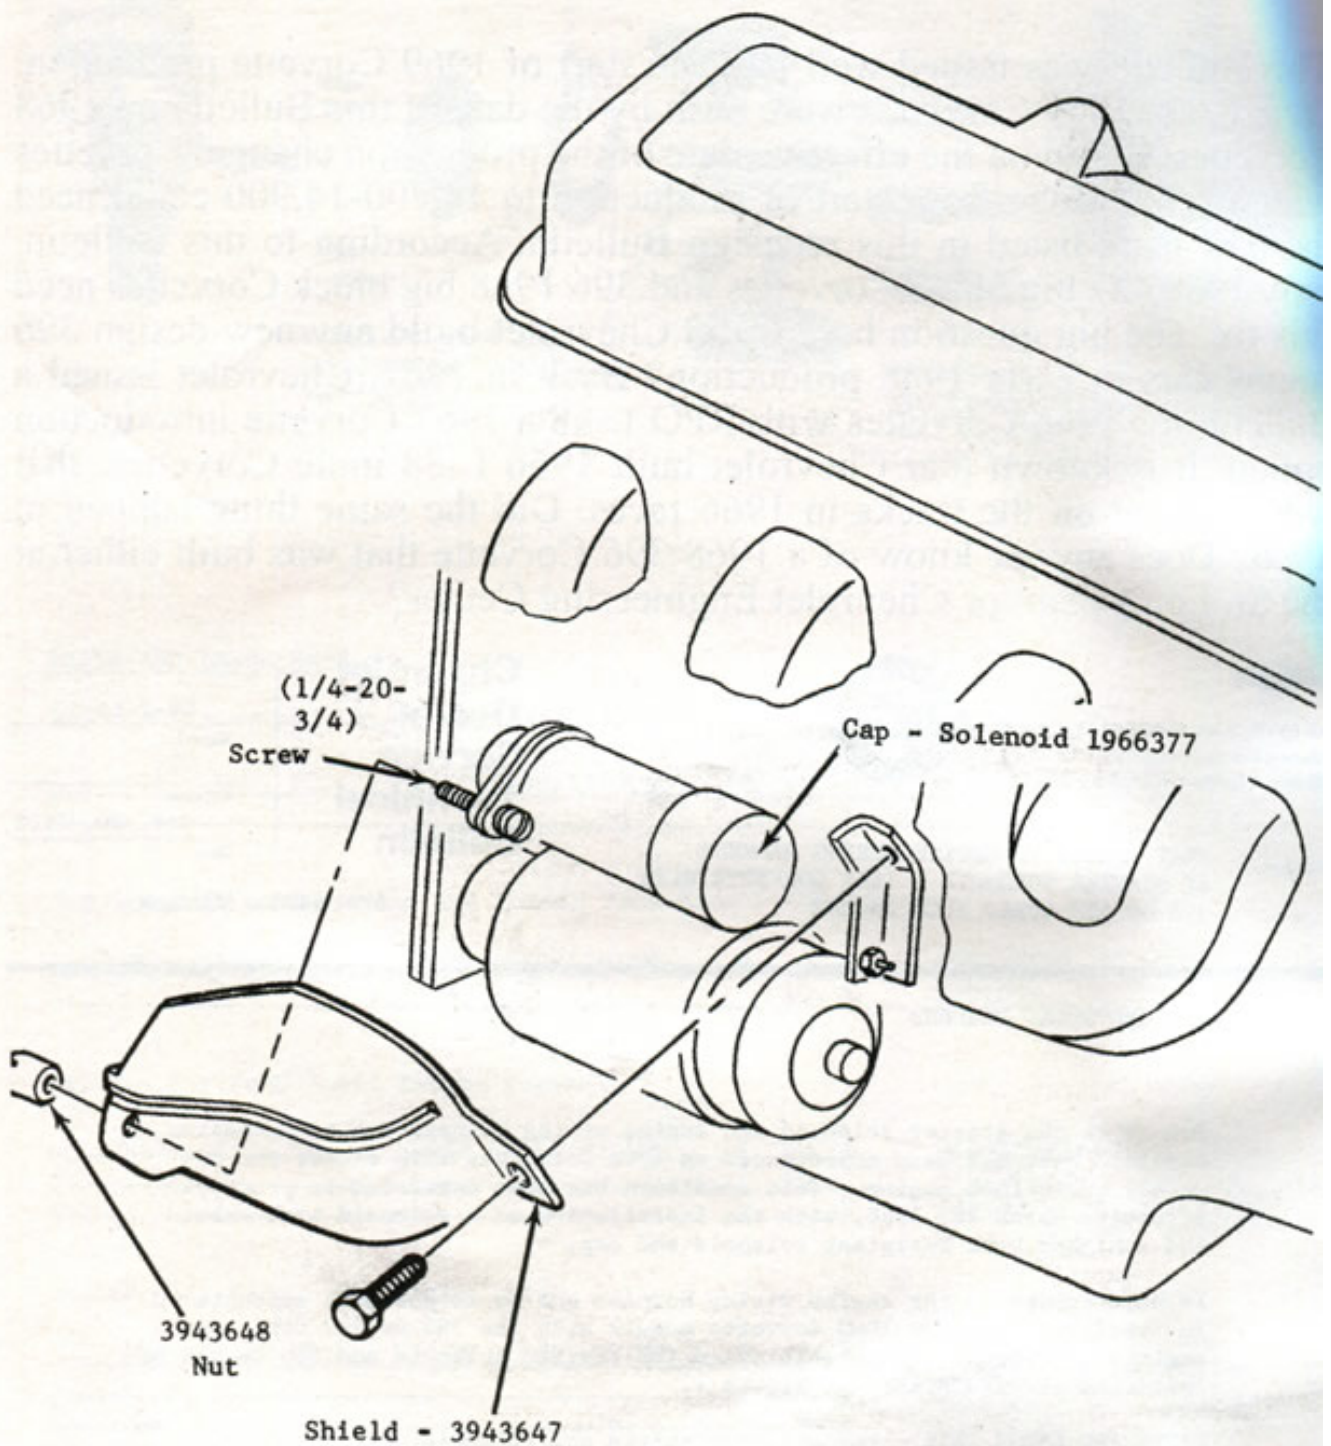
Figure 1

Damage to the starter solenoid and engine wiring harness due to excessive manifold heat has been experienced on 1968 Corvettes with either the 396 or 427 cubic inch engine. This condition has been corrected in production effective March 28, 1968, with the installation of a solenoid heat shield and a higher heat resistant solenoid end cap.

Installation of Heat Shield  
and Solenoid Cap

If heat damage to the engine wiring harness and/or solenoid is encountered in the field on early 1968 Corvette models with the 396 or 427 cubic inch engine, the solenoid heat shield and the revised solenoid end cap should be installed as illustrated in figure 1.
