2014 Corvette: GM TechLink: Steering Pull at Highway Speeds

Subject: Steering Pull at Highway Speeds

Model and Year: 2014 Corvette

Source: GM TechLink

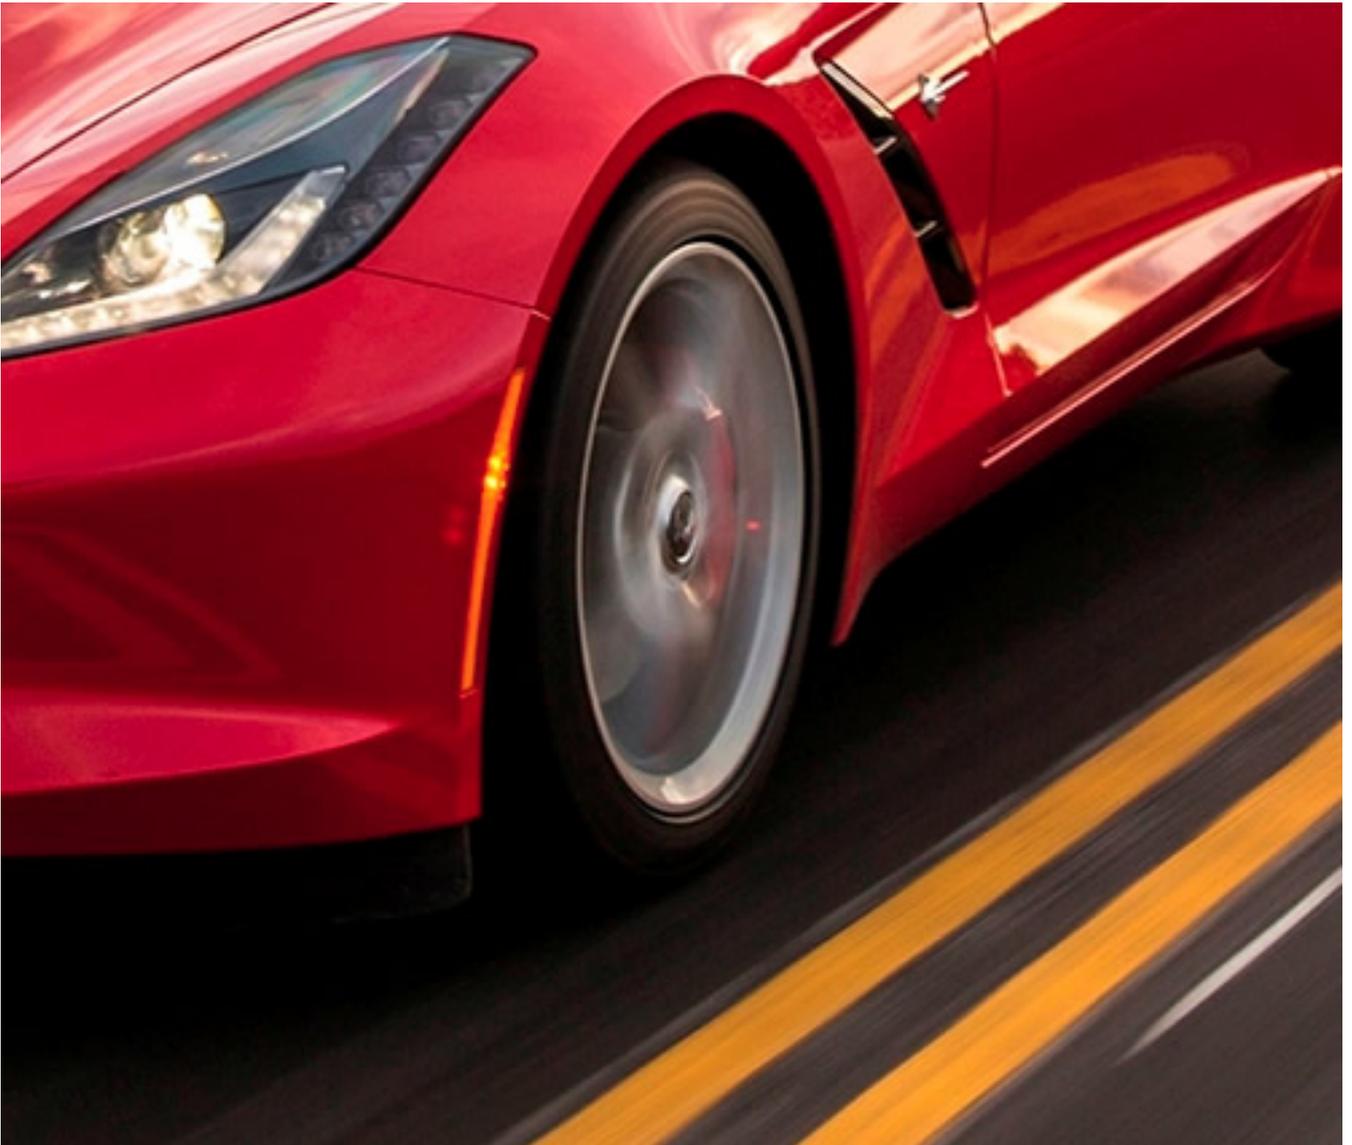
Fig. 6

On some 2014 Corvettes, the steering may pull to the right while driving at highway speeds. (Fig. 6)

2) Do a left to right front wheel/tire assembly swap and evaluate the vehicle again. Document the results. If the pull direction is opposite, refer to the Radial Tire Lead/Pull Correction procedure in the appropriate Service Information to isolate the tire causing the condition. Otherwise, continue to the next step if the pull in the same direction is still present.

3) Put the vehicle on an alignment rack. Record the “Before” measurements and modify the wheel alignment to counteract the pull condition. A vehicle will typically pull to the side with more positive camber. If the vehicle is pulling to the right, increase camber on the left, or decrease camber on the right. Stay within the current wheel alignment specifications in the Service Information. If, after exhausting standard Vehicle Leads/Pulls diagnostics and the above steps, a pull to the right condition still exists, adjust the front cross-camber by up to 1.0 degree. (This is currently outside the specifications noted in the Service Information.) Evaluate the vehicle for pull on both left and right sloping road crown/camber road surfaces.

4) If cross-camber is not causing the right pull condition by being near the negative limit noted in the Service Information and the condition still exists, increase caster on the right and/or decrease caster on the left. Stay within the current wheel alignment specifications in the Service Information. If necessary, use cross-caster down to, or as far negative as, -1.0 degree (which is currently outside the specifications noted in the Service Information). Split the left and right caster about the current nominal caster values in the Service Information by increasing one side of the vehicle by the same amount decreased on the other side. Again, try to remain within the wheel alignment specifications noted in the Service Information. Evaluate the vehicle for pull
