2014 Corvette: GM TechLink: Steering Pull at Highway Speeds

Subject: Steering Pull at Highway Speeds

Model and Year: 2014 Corvette

Source: GM TechLink

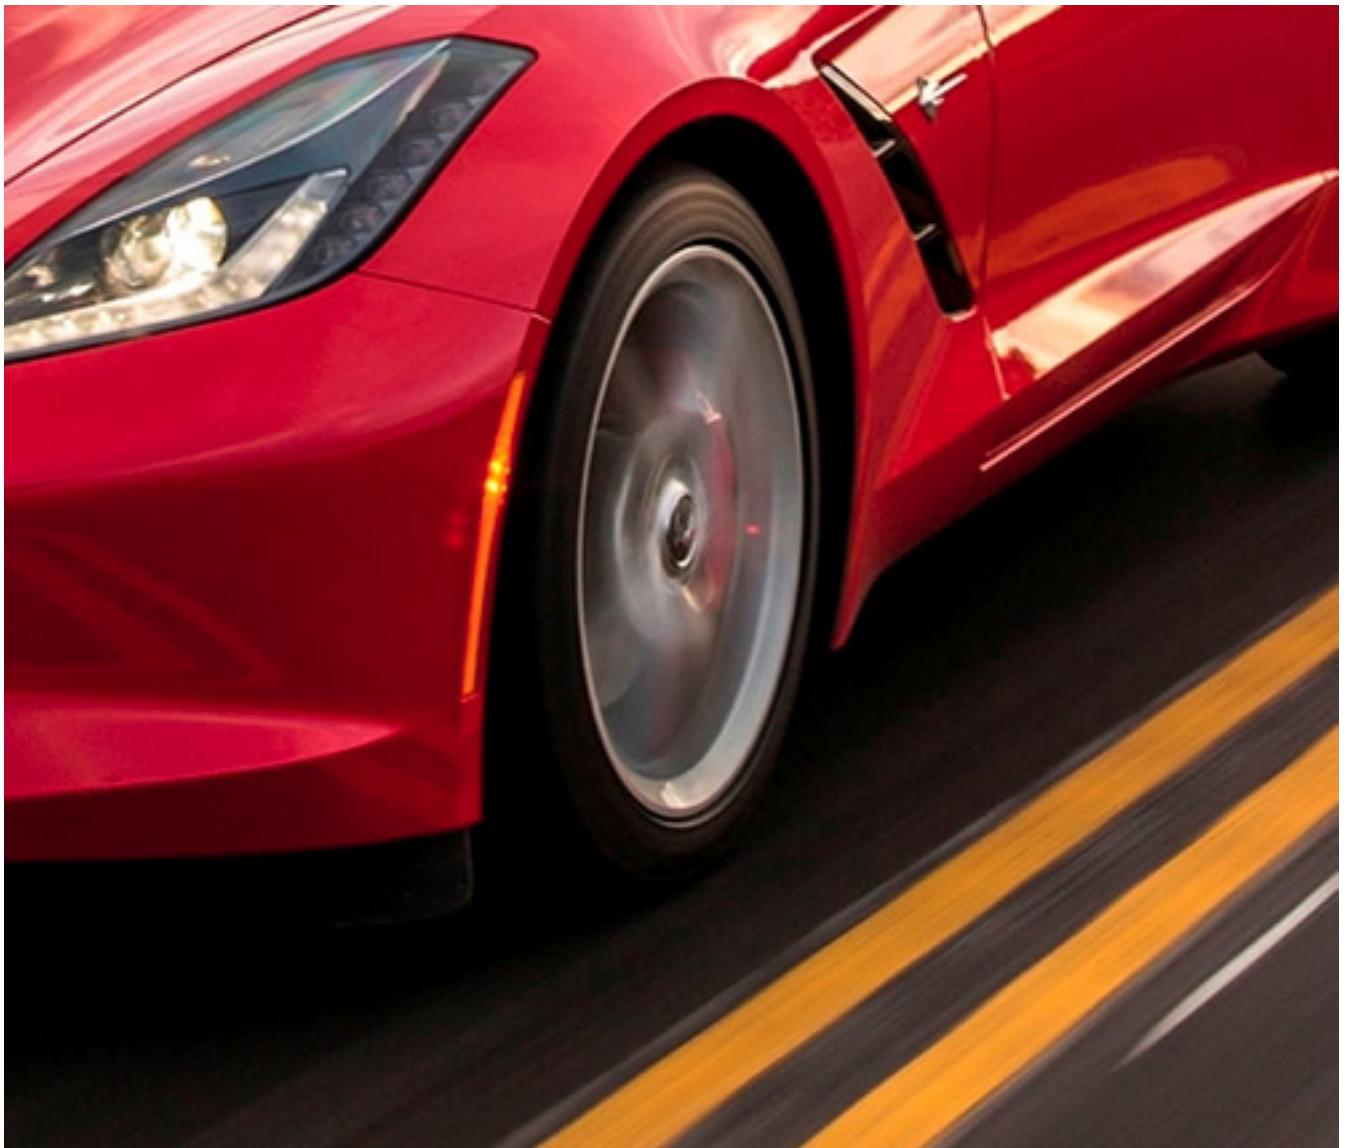
Fig. 6

On some 2014 Corvettes, the steering may pull to the right while driving at highway speeds. (Fig. 6)

Diagnosis should follow these steps:

- 1) If the pull is minor, but still correctable, verify the condition by lightly

holding the steering wheel while driving the vehicle in a straight line at 60-65 mph (97-105 km/h). Document the direction of the pull and rate the condition by describing the amount of pull on a scale of 1-10. Do this evaluation in both left and right sloping lanes as the vehicle will follow the road crown/camber. If the vehicle follows the road crown/camber, this is normal operation and the vehicle is performing to design intent. No repairs are necessary.

- 2) Do a left to right front wheel/tire assembly swap and evaluate the vehicle again. Document the results. If the pull direction is opposite, refer to the Radial Tire Lead/Pull Correction procedure in the appropriate Service Information to isolate the tire causing the condition. Otherwise, continue to the next step if the pull in the same direction is still present.

- 3) Put the vehicle on an alignment rack. Record the “Before” measurements and modify the wheel alignment to counteract the pull condition. A vehicle will typically pull to the side with more positive camber. If the vehicle is pulling to the right, increase camber on the left, or decrease camber on the right. Stay within the current wheel alignment specifications in the Service Information. If, after exhausting standard Vehicle Leads/Pulls diagnostics and the above steps, a pull to the right condition still exists, adjust the front cross-camber by up to 1.0 degree. (This is currently outside the specifications noted in the Service Information.) Evaluate the vehicle for pull on both left and right sloping road crown/camber road surfaces.

- 4) If cross-camber is not causing the right pull condition by being near the negative limit noted in the Service Information and the condition still exists, increase caster on the right and/or decrease caster on the left. Stay within the current wheel alignment specifications in the Service Information. If necessary, use cross-caster down to, or as far negative as, -1.0 degree (which is currently outside the specifications noted in the Service Information). Split the left and right caster about the current nominal caster values in the Service Information by increasing one side of the vehicle by the same amount decreased on the other side. Again, try to remain within the wheel alignment specifications noted in the Service Information. Evaluate the vehicle for pull

in both left and right sloping road crown/camber road conditions and verify normal operation. Record the “After” wheel alignment measurements to include with the “Before” measurements in the warranty claim.
