# 1984 - 1985 Corvette: Service Bulletin: Noise in Direct Drive 4-Speed Manual Transmission

**Model and Year:** 1984 - 1985 Corvette

**Source:** Chevrolet Dealer Service Bulletin

**Bulletin No:** 85-111

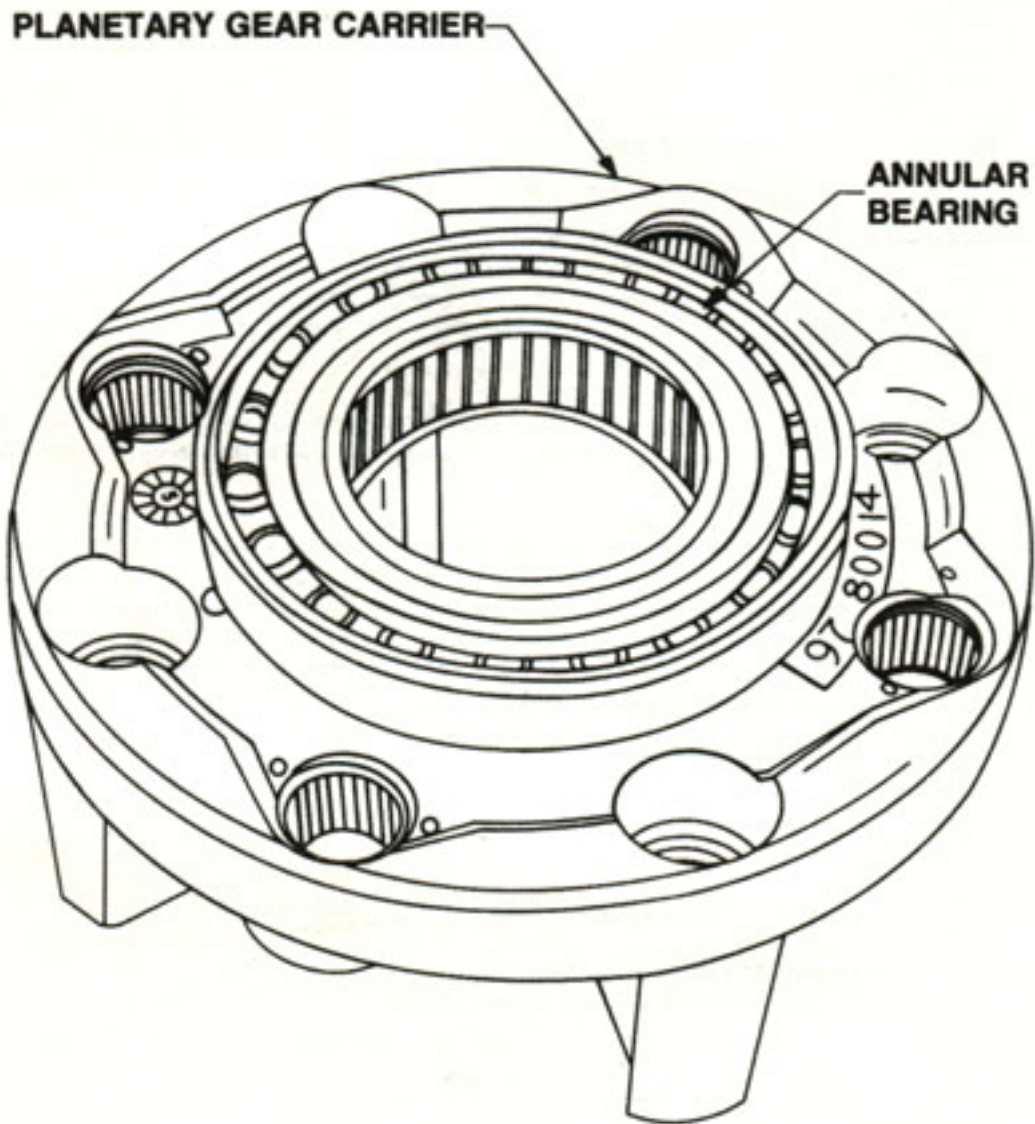
**Figure 1**

This condition may be caused by a worn annular bearing on the planetary gear carrier (see illustration). Continued operation of a noisy transmission in the direct drive model will cause damage to the planetary carrier, adapter plate, input sun gear, and input sun gear oil seal. If the input sun gear oil seal is damaged, it is possible for overdrive unit oil (Dexron II) to leak into the manual portion of the transmission.

On transmissions beginning with serial number D5C 14413 CF, a new planetary gear carrier has been released. This carrier (P/N 14094571) incorporates an annular bearing with increased thrust capacity.

1. Inspect the adapter plate surface, input sun gear, and input sun gear oil seal for damage. If there is indication of damage, the adapter plate, input sun gear, and input sun gear oil seal should be replaced. If there is no sign of damage, these parts may be reused.
2. If debris is present in the overdrive unit, completely disassemble and clean the unit, including the valve body. Thoroughly flush the cooler lines to remove any debris following the procedure outlined in the Vehicle Service Manual. Replace the oil filter.
3. If there is evidence of oil intrusion from the automatic overdrive unit into the 4-speed manual unit, the manual unit should be drained and flushed also.
4. Replace the planetary gear carrier with the new, P/N 14094571, carrier.
