1984 - 1985 Corvette: Service Bulletin: Noise in Direct Drive 4-Speed Manual Transmission

Source: Chevrolet Dealer Service Bulletin

Bulletin No: 85-111

Date: Aug., 1985

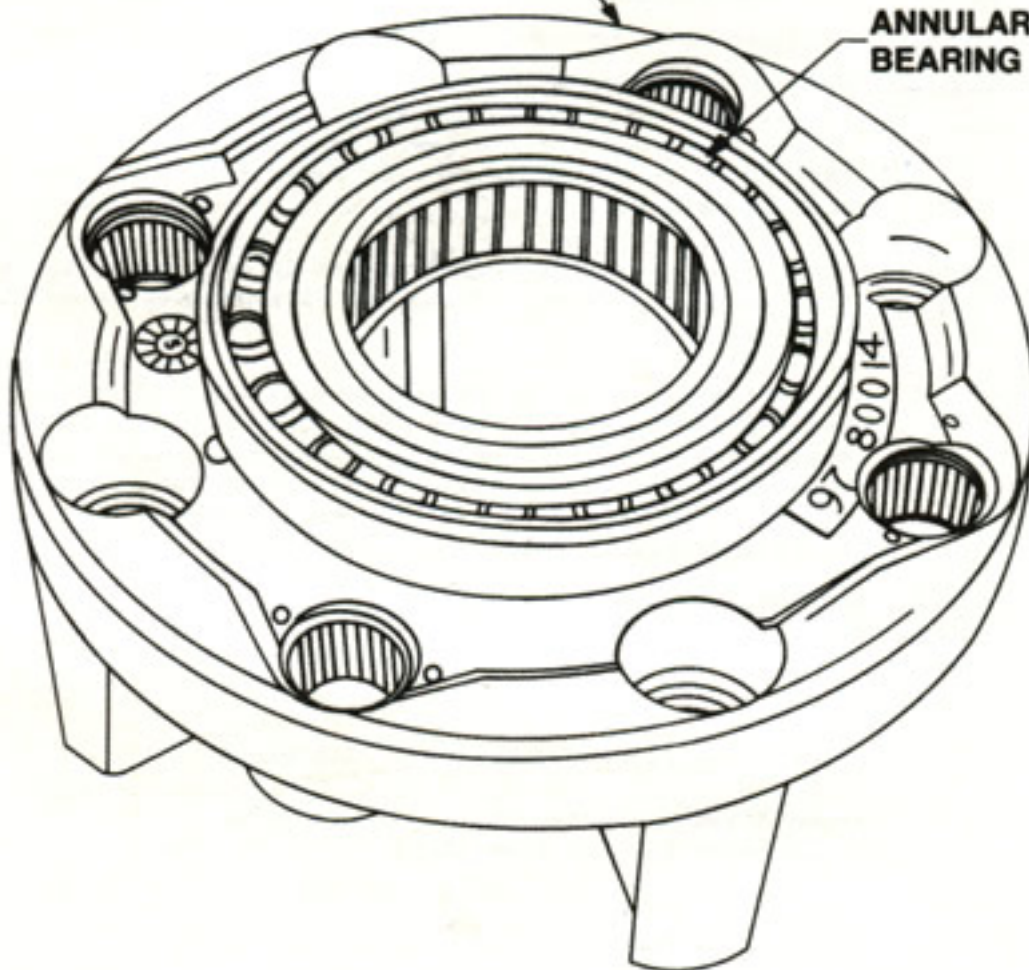
Figure 1

This condition may be caused by a worn annular bearing on the planetary gear carrier (see illustration). Continued operation of a noisy transmission in the direct drive model will cause damage to the planetary carrier, adapter plate, input sun gear, and input sun gear oil seal. If the input sun gear oil seal is damaged, it is possible for overdrive unit oil (Dexron II) to leak into the manual portion of the transmission.

On transmissions beginning with serial number D5C 14413 CF, a new planetary gear carrier has been released. This carrier (P/N 14094571) incorporates an annular bearing with increased thrust capacity.

1. Inspect the adapter plate surface, input sun gear, and input sun gear oil seal for damage. If there is indication of damage, the adapter plate, input sun gear, and input sun gear oil seal should be replaced. If there is no sign of damage, these parts may be reused.
2. If debris is present in the overdrive unit, completely disassemble and clean the unit, including the valve body. Thoroughly flush the cooler lines to remove any debris following the procedure outlined in the Vehicle Service Manual. Replace the oil filter.
3. If there is evidence of oil intrusion from the automatic overdrive unit into the 4-speed manual unit, the manual unit should be drained and flushed also.
4. Replace the planetary gear carrier with the new, P/N 14094571, carrier.
