1984 - 1985 Corvette: Service Bulletin: Noise in Direct Drive 4-Speed Manual Transmission

Subject: Noise in Direct Drive 4-Speed Manual Transmission

Model and Year: 1984 - 1985 Corvette

Bulletin No: 85-111

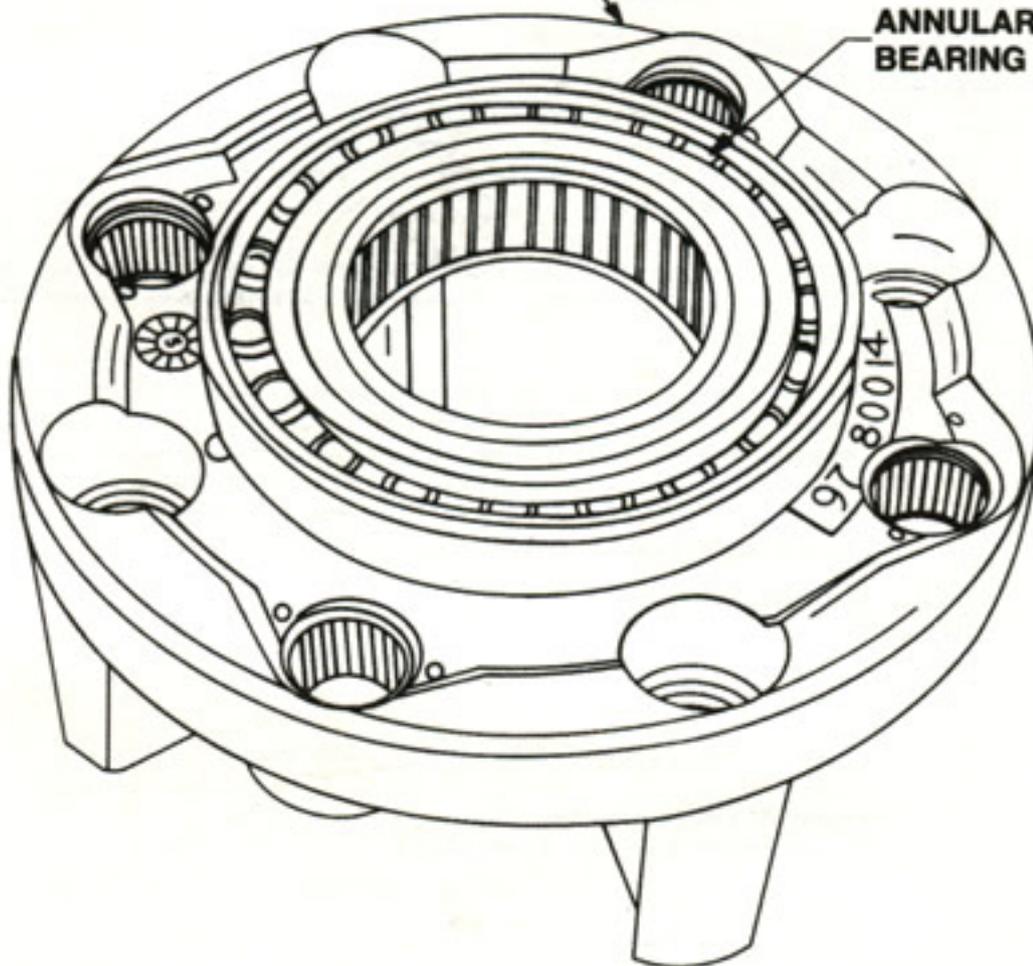
Figure 1

This condition may be caused by a worn annular bearing on the planetary gear carrier (see illustration). Continued operation of a noisy transmission in the direct drive model will cause damage to the planetary carrier, adapter plate, input sun gear, and input sun gear oil seal. If the input sun gear oil seal is damaged, it is possible for overdrive unit oil (Dexron II) to leak into the manual portion of the transmission.

PLANETARY GEAR CARRIER

ANNULAR BEARING

On transmissions beginning with serial number D5C 14413 CF, a new planetary gear carrier has been released. This carrier (P/N 14094571) incorporates an annular bearing with increased thrust capacity.

1. Inspect the adapter plate surface, input sun gear, and input sun gear oil seal for damage. If there is indication of damage, the adapter plate, input sun gear, and input sun gear oil seal should be replaced. If there is no sign of damage, these parts may be reused.
2. If debris is present in the overdrive unit, completely disassemble and clean the unit, including the valve body. Thoroughly flush the cooler lines to remove any debris following the procedure outlined in the Vehicle Service Manual. Replace the oil filter.
3. If there is evidence of oil intrusion from the automatic overdrive unit into the 4-speed manual unit, the manual unit should be drained and flushed also.
4. Replace the planetary gear carrier with the new, P/N 14094571, carrier.
