1984 - 1985 Corvette: Service Bulletin: Noise in Direct Drive 4-Speed Manual Transmission

Source: Chevrolet Dealer Service Bulletin

Bulletin No: 85-111

Date: Aug., 1985

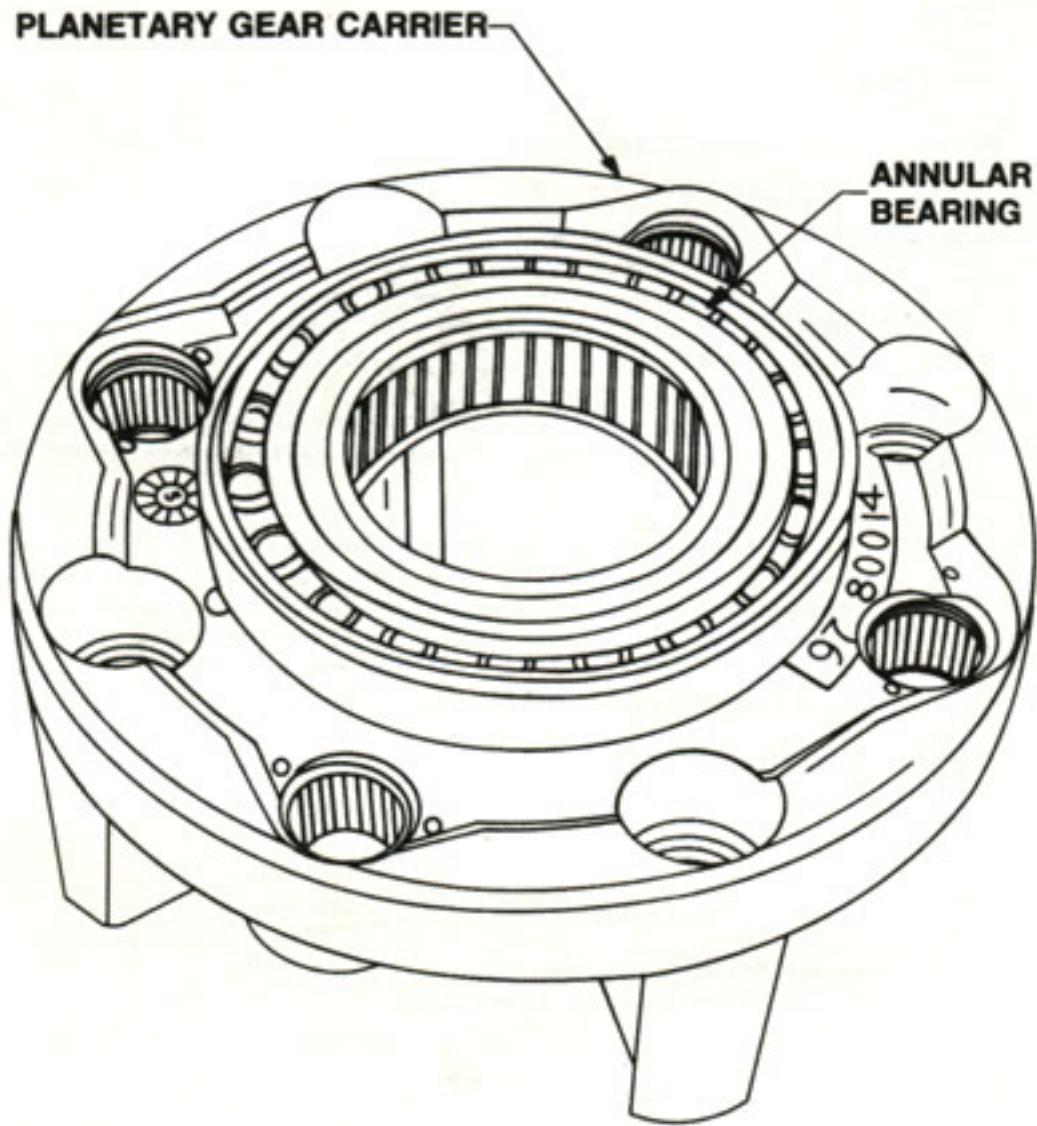
Figure 1

This condition may be caused by a worn annular bearing on the planetary gear carrier (see illustration). Continued operation of a noisy transmission in the direct drive model will cause damage to the planetary carrier, adapter plate, input sun gear, and input sun gear oil seal. If the input sun gear oil seal is damaged, it is possible for overdrive unit oil (Dexron II) to leak into the manual portion of the transmission.

On transmissions beginning with serial number D5C 14413 CF, a new planetary gear carrier has been released. This carrier (P/N 14094571) incorporates an annual bearing with increased thrust capacity.

1. Inspect the adapter plate surface, input sun gear, and input sun gear oil seal for damage. If there is indication of damage, the adapter plate, input sun gear, and input sun gear oil seal should be replaced. If there is no sign of damage, these parts may be reused.
2. If debris is present in the overdrive unit, completely disassemble and clean the unit, including the valve body. Thoroughly flush the cooler lines to remove any debris following the procedure outlined in the Vehicle Service Manual. Replace the oil filter.
3. If there is evidence of oil intrusion from the automatic overdrive unit into the 4-speed manual unit, the manual unit should be drained and flushed also.
4. Replace the planetary gear carrier with the new, P/N 14094571, carrier.
