1962 Corvette: Service Bulletin: Aluminum Powerglide Shift Problems

Source: Chevrolet Technical Service Bulletin

Bulletin No: DR #514

Date: January 16, 1962

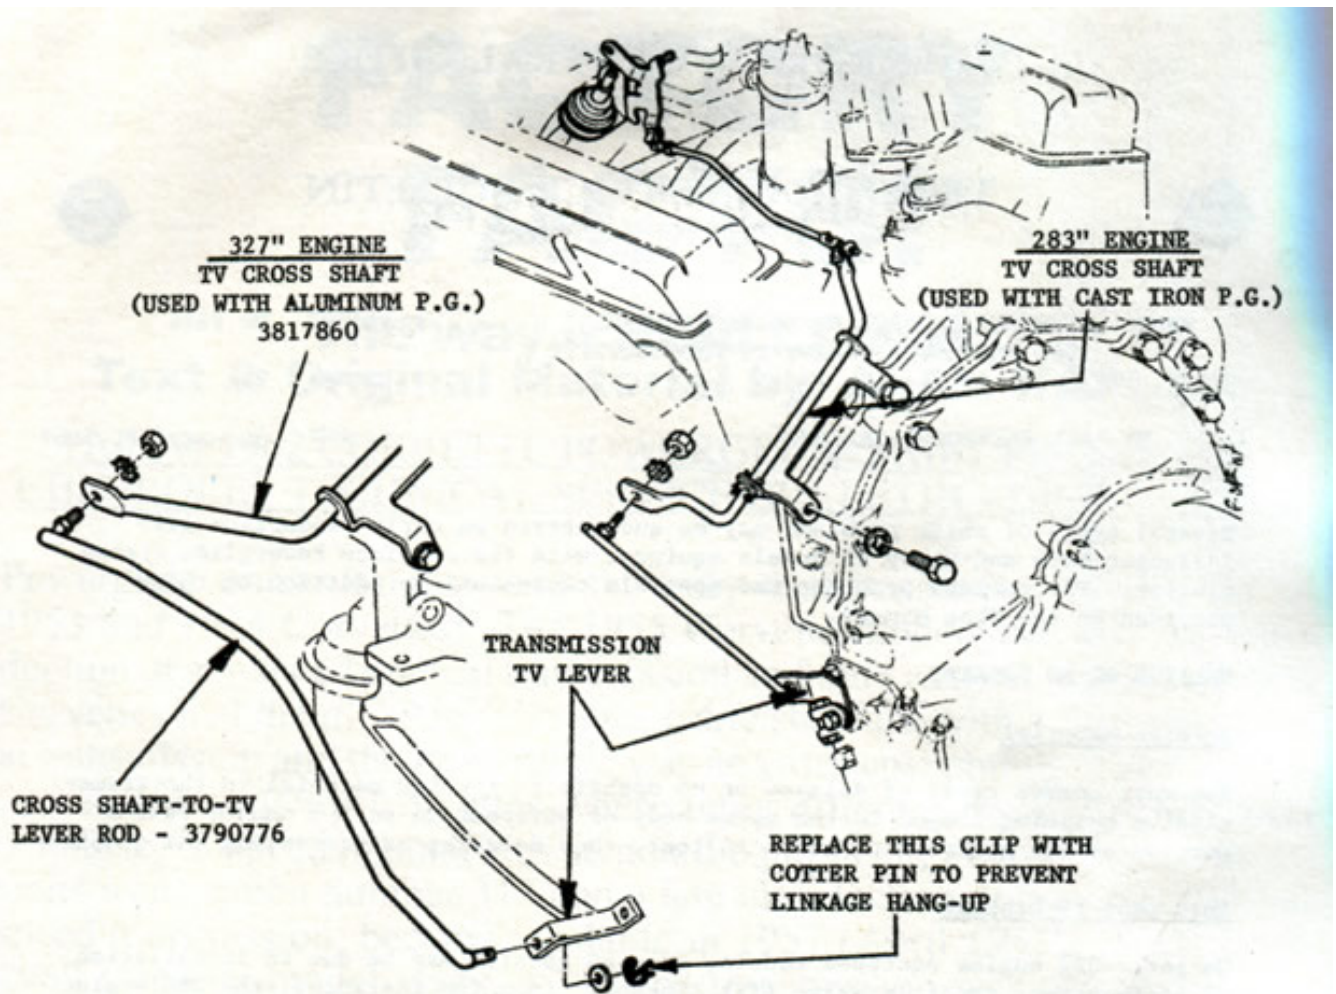
FIGURE 1- 327 AND 283 POWERGLIDE TV LINKAGE COMPARISON

Incorrect TV Linkage

On early 327 engine equipped models, delayed upshift may be due to installation of an incorrect throttle valve (TV) linkage. In a few instances, the 283 engine cross shaft was installed instead of the correct TV cross shaft, 3817860. The TV cross shaft are easily identified as the 283 version has a bend in its outboard lever whereas the 327 cross-shaft lever is straight in this same area. (Figure 1). If the TV cross shaft was incorrect, also check the cross shaft-to-TV lever rod. As shown in Figure 1, this rod, 3790776, is formed on 327 engine applications as compared to the straight rod used on 283 engine versions.

Cross Shaft, TV (327 engine) ---- 3817860

Rod, Cross Shaft-to TV (327 engine) ----- 3790776

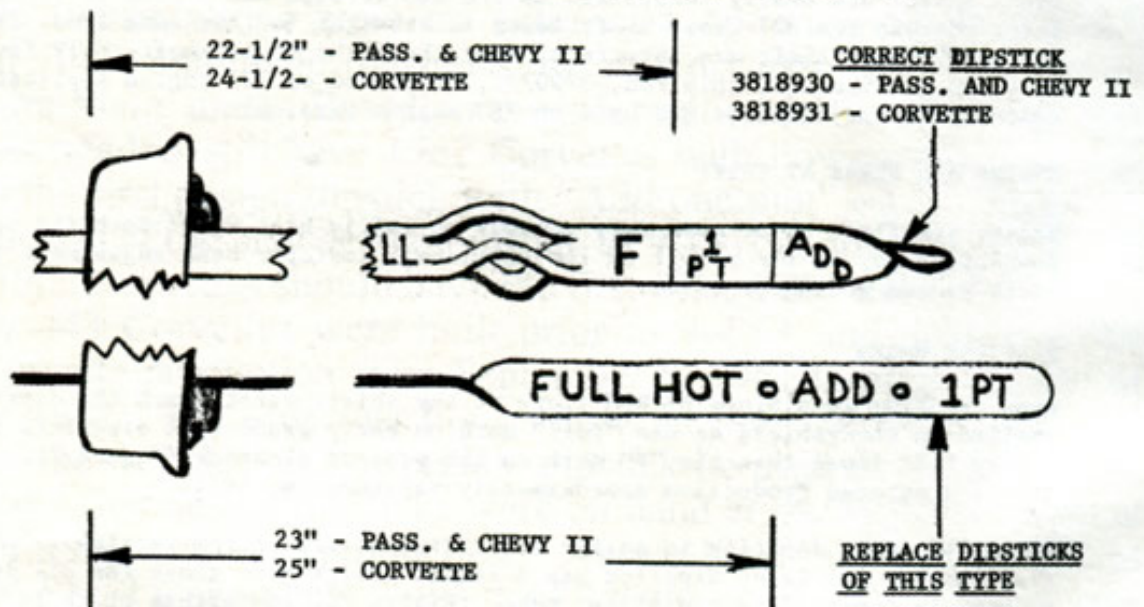
FIGURE 2 - ALUMINUM POWERGLIDE DIPSTICKS

When checking complaints of RPM flare at the shift, first check the dipstick installed in the vehicle as the "Full" mark on early production dipsticks is approximately 1/2" lower than the "F" mark on the present dipstick (Figure 2). The later dipstick entered Production approximately September 4, 1961.

The early style dipstick is easily identified as its bottom section is absolutely flat whereas the later dipstick has a formed bridge just above the oil level markings to keep it centered in the filler tube. (Figure 2). A further check is to measure the distance from the top of the cap to the "Full" mark; on

Passenger and Chevy II dipsticks, this distance is now 22-1/2", as compared to 23" on the earlier dipsticks. This distance on the Corvette dipstick is now 24-1/2" as compared to 25" on earlier units.

Replace all early dipsticks with the later part when found and add oil as

required to raise the transmission oil level to the "F" mark. The later dipstick for 327 engine passenger cars and all Chevy II Models is 3818930; for Corvette, 3818931.
