# 1962 Corvette: Service Bulletin: Aluminum Powerglide Shift Problems

**Source:** Chevrolet Technical Service Bulletin

**Bulletin No:** DR #514

**Date:** January 16, 1962

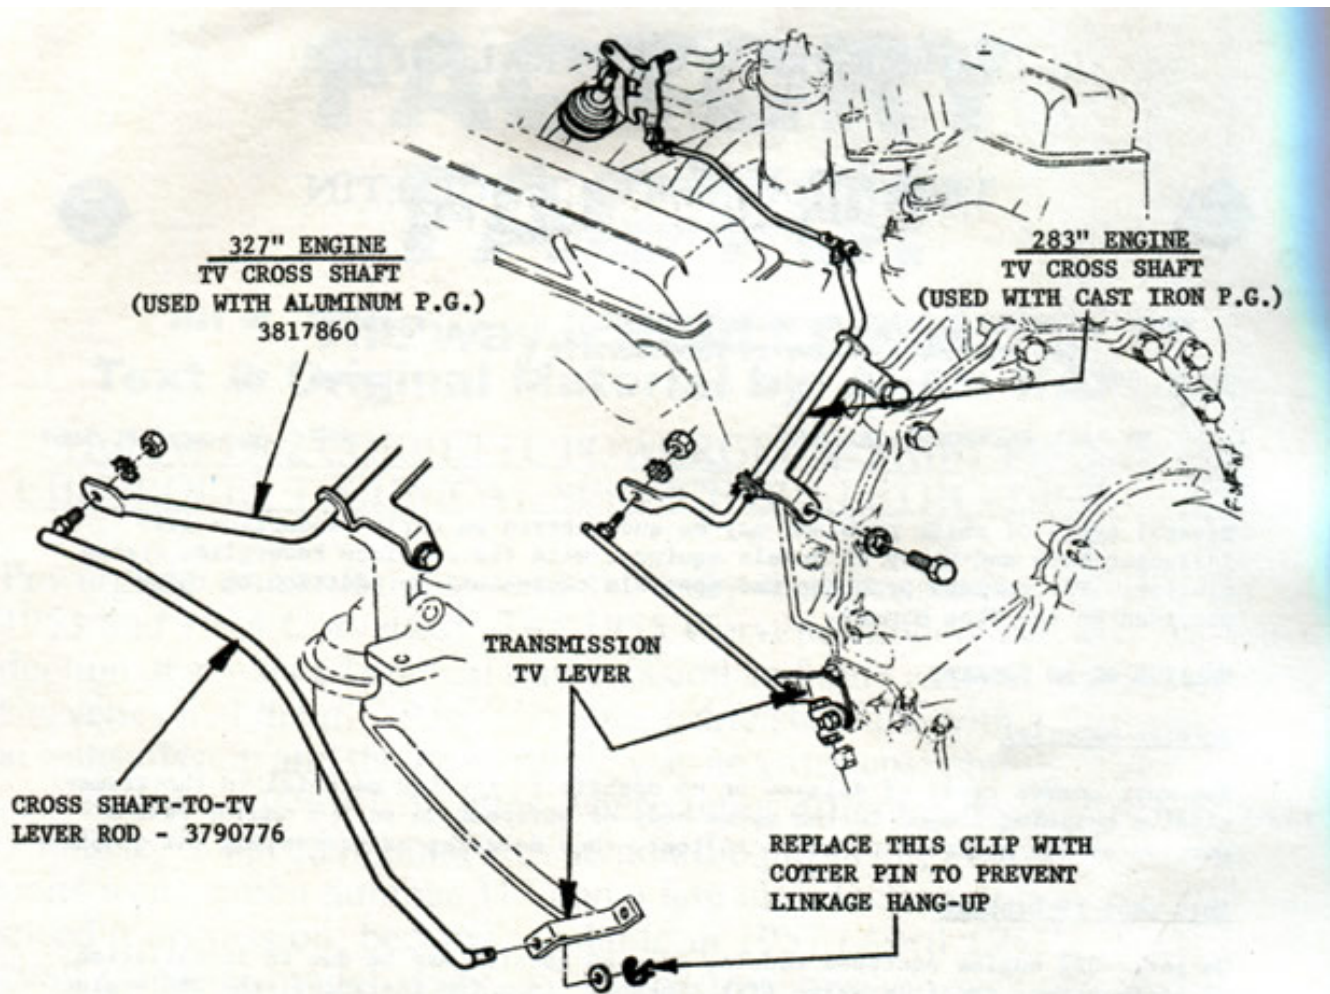
FIGURE 1- 327 AND 283 POWERGLIDE TV LINKAGE COMPARISON

On early 327 engine equipped models, delayed upshift may be due to installation of an incorrect throttle valve (TV) linkage. In a few instances, the 283 engine cross shaft was installed instead of the correct TV cross shaft, 3817860. The TV cross shaft are easily identified as the 283 version has a bend in its outboard lever whereas the 327 cross-shaft lever is straight in this same area. (Figure 1). If the TV cross shaft was incorrect, also check the cross shaft-to-TV lever rod. As shown in Figure 1, this rod, 3790776, is formed on 327 engine applications as compared to the straight rod used on 283 engine versions.

Cross Shaft, TV (327 engine) ---- 3817860

Rod, Cross Shaft-to TV (327 engine) ----- 3790776

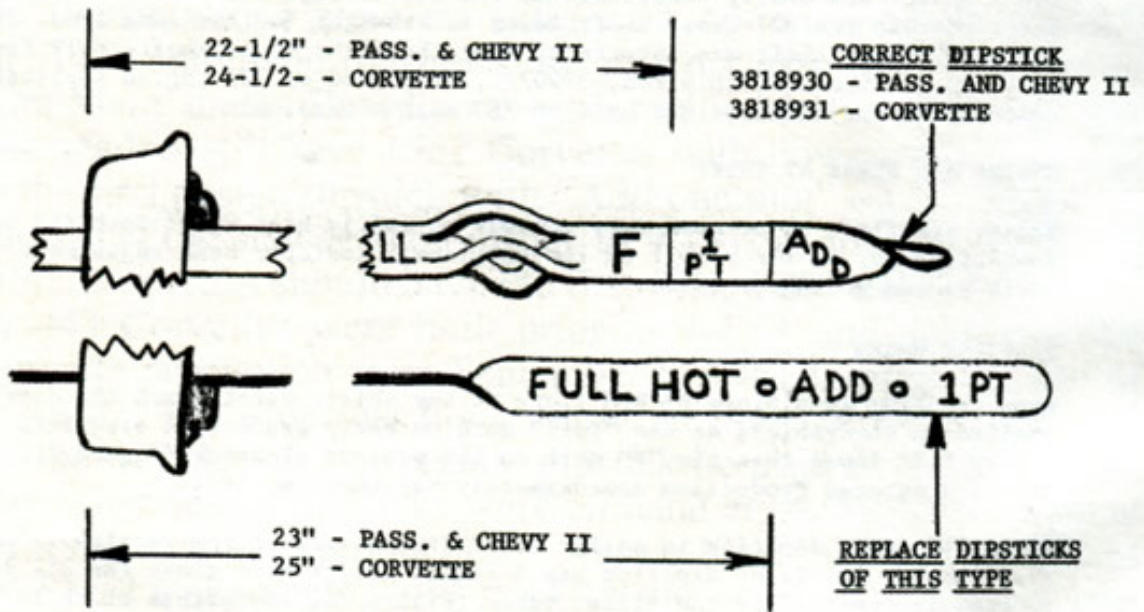
FIGURE 2 - ALUMINUM POWERGLIDE DIPSTICKS

When checking complaints of RPM flare at the shift, first check the dipstick installed in the vehicle as the "Full" mark on early production dipsticks is approximately 1/2" lower than the "F" mark on the present dipstick (Figure 2). The later dipstick entered Production approximately September 4, 1961.

The early style dipstick is easily identified as its bottom section is absolutely flat whereas the later dipstick has a formed bridge just above the oil level markings to keep it centered in the filler tube. (Figure 2). A further check is to measure the distance from the top of the cap to the "Full" mark; on

Passenger and Chevy II dipsticks, this distance is now 22-1/2", as compared to 23" on the earlier dipsticks. This distance on the Corvette dipstick is now 24-1/2" as compared to 25" on earlier units.

Replace all early dipsticks with the later part when found and add oil as

required to raise the transmission oil level to the "F" mark. The later dipstick for 327 engine passenger cars and all Chevy II Models is 3818930; for Corvette, 3818931.
