1962 Corvette: Service Bulletin: Aluminum Powerglide Shift Problems

Source: Chevrolet Technical Service Bulletin

Bulletin No: DR #514

Date: January 16, 1962

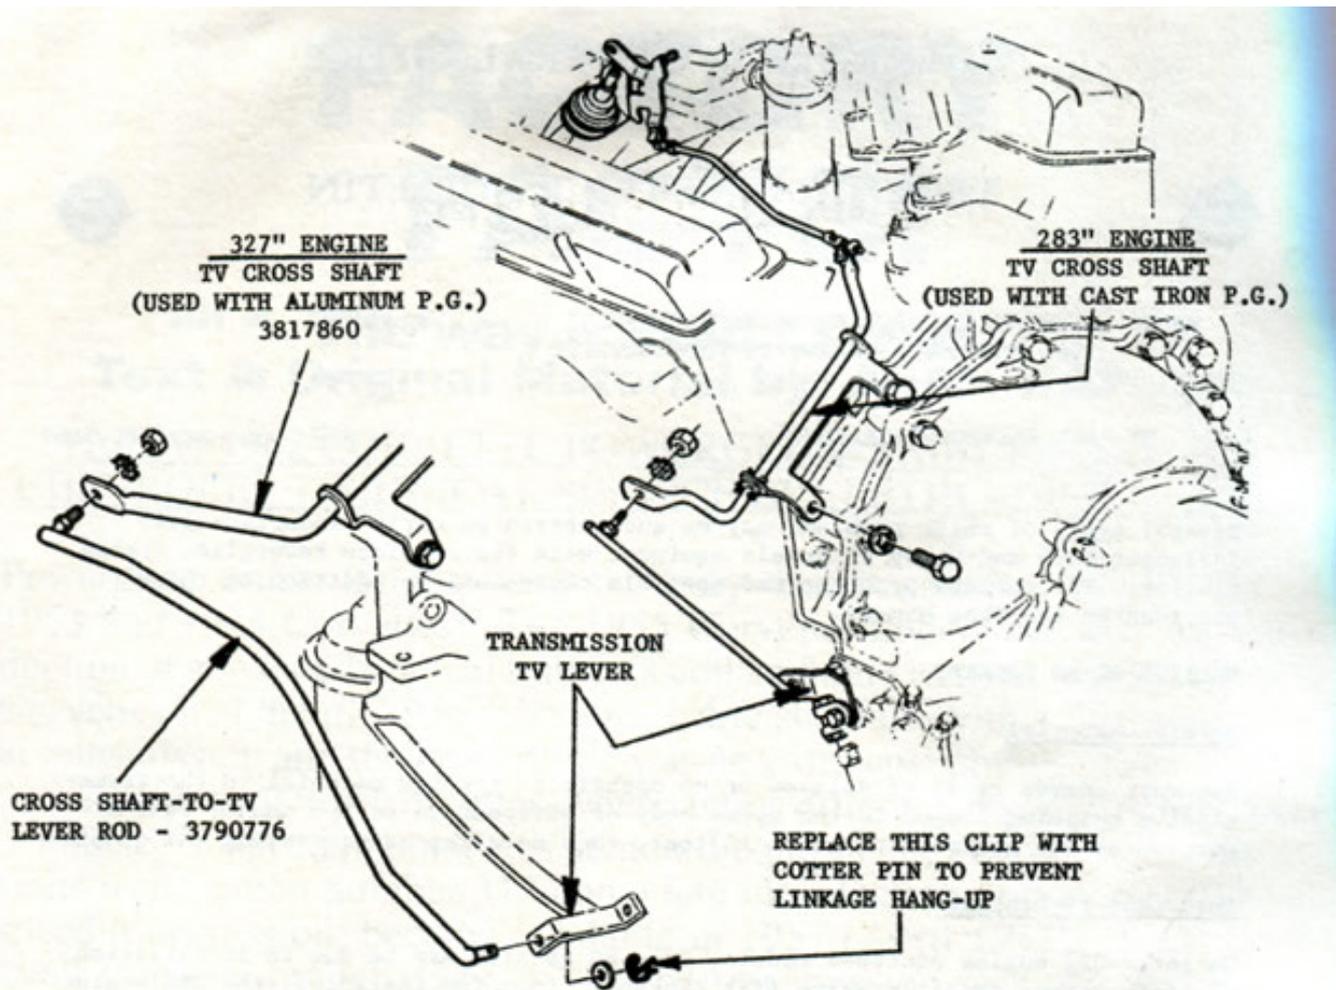
FIGURE 1- 327 AND 283 POWERGLIDE TV LINKAGE COMPARISON

Incorrect TV Linkage

On early 327 engine equipped models, delayed upshift may be due to installation of an incorrect throttle valve (TV) linkage. In a few instances, the 283 engine cross shaft was installed instead of the correct TV cross shaft, 3817860. The TV cross shaft are easily identified as the 283 version has a bend in its outboard lever whereas the 327 cross-shaft lever is straight in this same area. (Figure 1). If the TV cross shaft was incorrect, also check the cross shaft-to-TV lever rod. As shown in Figure 1, this rod, 3790776, is formed on 327 engine applications as compared to the straight rod used on 283 engine versions.

Cross Shaft, TV (327 engine) ---- 3817860

Rod, Cross Shaft-to TV (327 engine) ----- 3790776

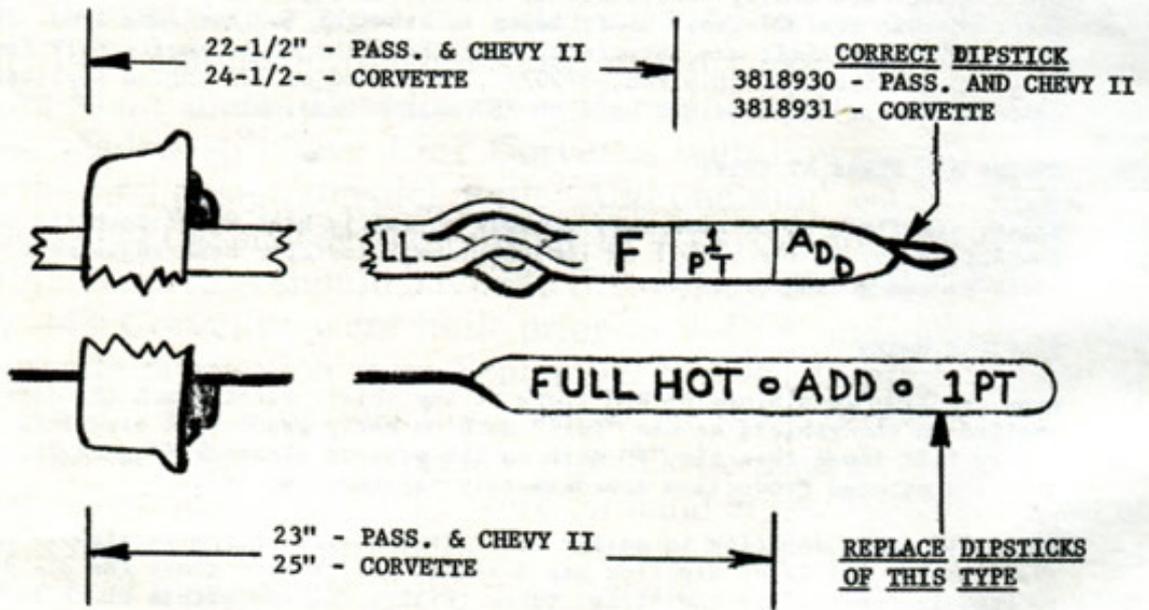
FIGURE 2 - ALUMINUM POWERGLIDE DIPSTICKS

Dipstick Usage

When checking complaints of RPM flare at the shift, first check the dipstick installed in the vehicle as the "Full" mark on early production dipsticks is approximately 1/2" lower than the "F" mark on the present dipstick (Figure 2). The later dipstick entered Production approximately September 4, 1961.

The early style dipstick is easily identified as its bottom section is absolutely flat whereas the later dipstick has a formed bridge just above the oil level markings to keep it centered in the filler tube. (Figure 2). A further check is to measure the distance from the top of the cap to the "Full" mark; on

Passenger and Chevy II dipsticks, this distance is now 22-1/2", as compared to 23" on the earlier dipsticks. This distance on the Corvette dipstick is now 24-1/2" as compared to 25" on earlier units.

Replace all early dipsticks with the later part when found and add oil as

required to raise the transmission oil level to the "F" mark. The later dipstick for 327 engine passenger cars and all Chevy II Models is 3818930; for Corvette, 3818931.
