1962 Corvette: Service Bulletin: Aluminum Powerglide Shift Problems

Source: Chevrolet Technical Service Bulletin

Bulletin No: DR #514

Date: January 16, 1962

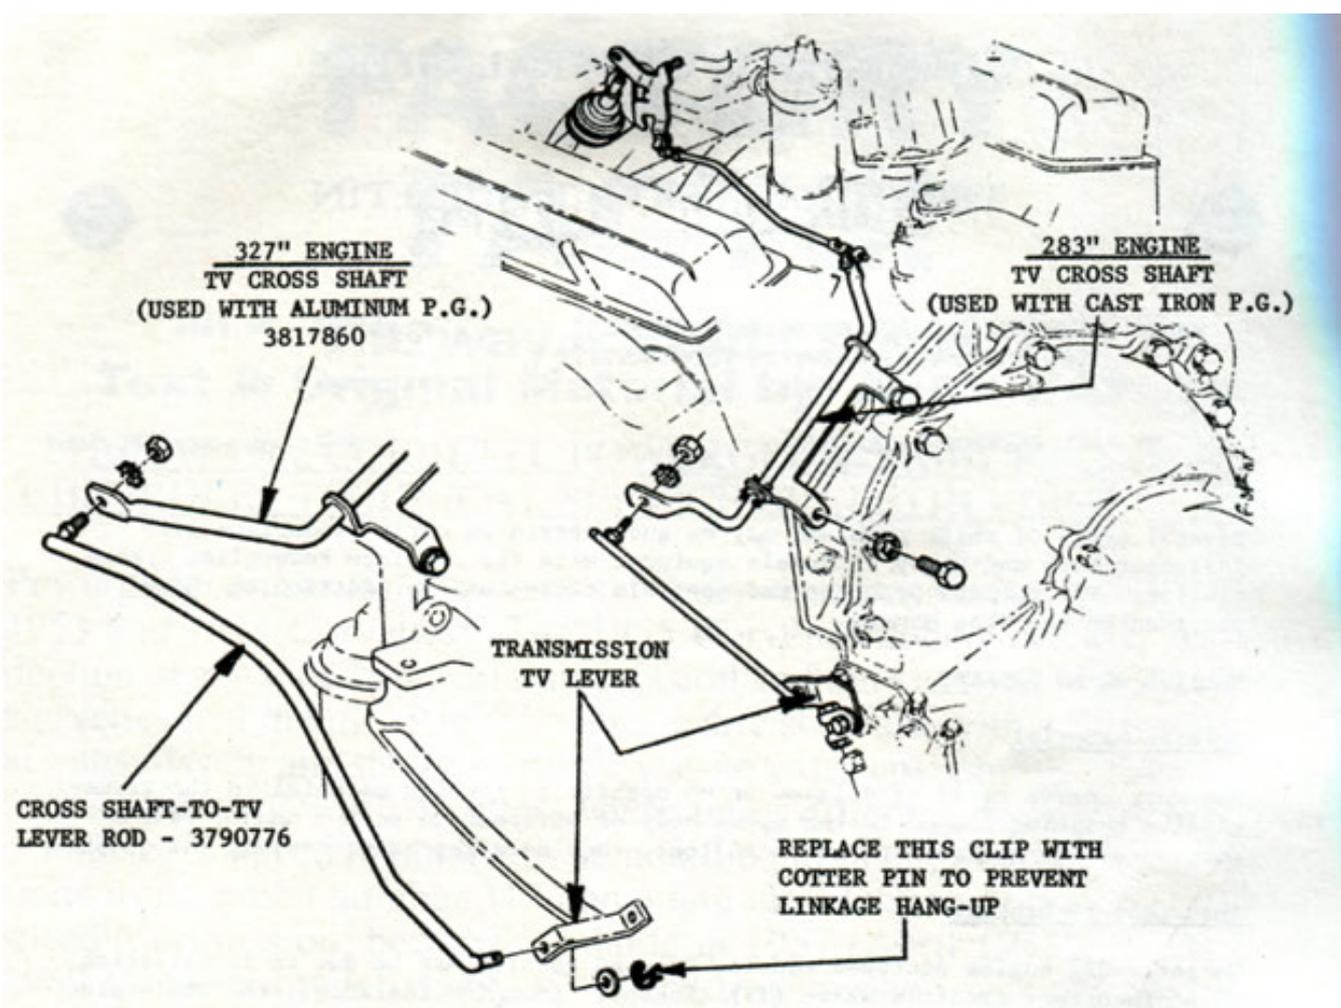
FIGURE 1- 327 AND 283 POWERGLIDE TV LINKAGE COMPARISON

Incorrect TV Linkage

On early 327 engine equipped models, delayed upshift may be due to installation of an incorrect throttle valve (TV) linkage. In a few instances, the 283 engine cross shaft was installed instead of the correct TV cross shaft, 3817860. The TV cross shaft are easily identified as the 283 version has a bend in its outboard lever whereas the 327 cross-shaft lever is straight in this same area. (Figure 1). If the TV cross shaft was incorrect, also check the cross shaft-to-TV lever rod. As shown in Figure 1, this rod, 3790776, is formed on 327 engine applications as compared to the straight rod used on 283 engine versions.

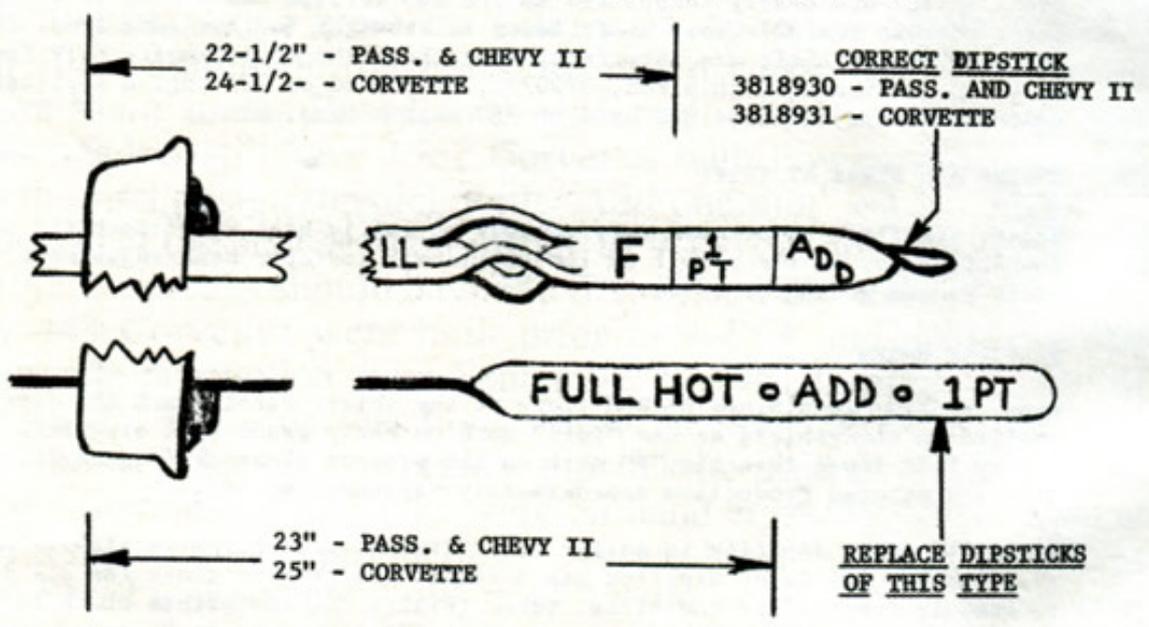
FIGURE 2 - ALUMINUM POWERGLIDE DIPSTICKS

When checking complaints of RPM flare at the shift, first check the dipstick installed in the vehicle as the "Full" mark on early production dipsticks is approximately 1/2" lower than the "F" mark on the present dipstick (Figure 2). The later dipstick entered Production approximately September 4, 1961.

The early style dipstick is easily identified as its bottom section is absolutely flat whereas the later dipstick has a formed bridge just above the oil level markings to keep it centered in the filler tube. (Figure 2). A further check is to measure the distance from the top of the cap to the "Full" mark; on

Passenger and Chevy II dipsticks, this distance is now 22-1/2", as compared to 23" on the earlier dipsticks. This distance on the Corvette dipstick is now 24-1/2" as compared to 25" on earlier units.

Replace all early dipsticks with the later part when found and add oil as

required to raise the transmission oil level to the "F" mark. The later dipstick for 327 engine passenger cars and all Chevy II Models is 3818930; for Corvette, 3818931.
