# 1964 Corvette: Service Bulletin: Neutral Safety Switch Malfunction

**Subject:** Neutral Safety Switch Malfunction  
**Model and Year:** 1964 Corvettes with Powerglide Transmissions  
**Source:** Chevrolet Technical Service Bulletin  
**Bulletin No:** DR #658  
**Section:** VII  
**Date:** March 10, 1964

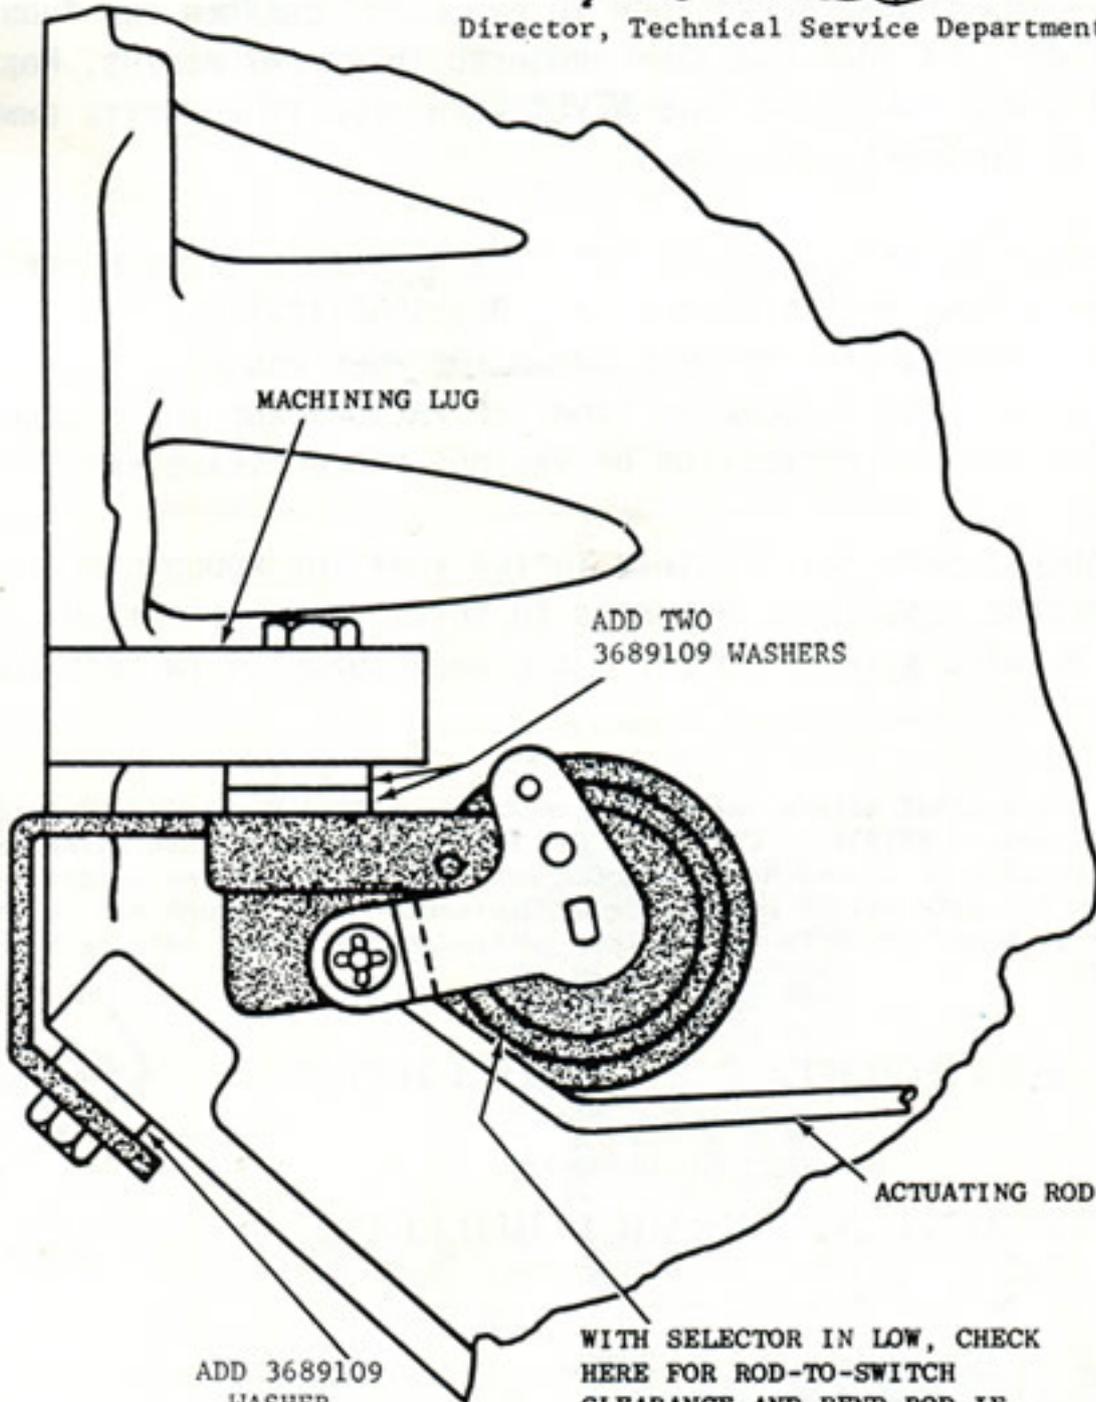
Interference between the neutral safety switch and the underbody may exist on some early production Corvette Models with Powerglide transmissions.

This could result in the engine being started while the transmission selector is in a drive position. In addition, the added load imposed on the shift linkage by the misalignment causes a reduction or loss of detent feel when the transmission is shifted manually. The transmission might then be accidentally operated between ranges and internal damage could result.

Correction of switch malfunction may be made by shimming the switch assembly downward as shown in the attached sketch. Note that operating clearance must exist between the switch body and the switch actuating rod after the shimming operation is completed.

WITH SELECTOR IN LOW, CHECK HERE FOR ROD-TO-SWITCH CLEARANCE AND BEND ROD IF NECESSARY. TEST ACTION OF SWITCH AFTER BENDING ROD & ADJUST LENGTH OF ROD AS REQUIRED BY TURNING THREADED PIVOT.
