# 1964 Corvette: Service Bulletin: Neutral Safety Switch Malfunction

**Subject:** Neutral Safety Switch Malfunction

**Model and Year:** 1964 Corvettes with Powerglide Transmissions

**Bulletin No:** DR #658

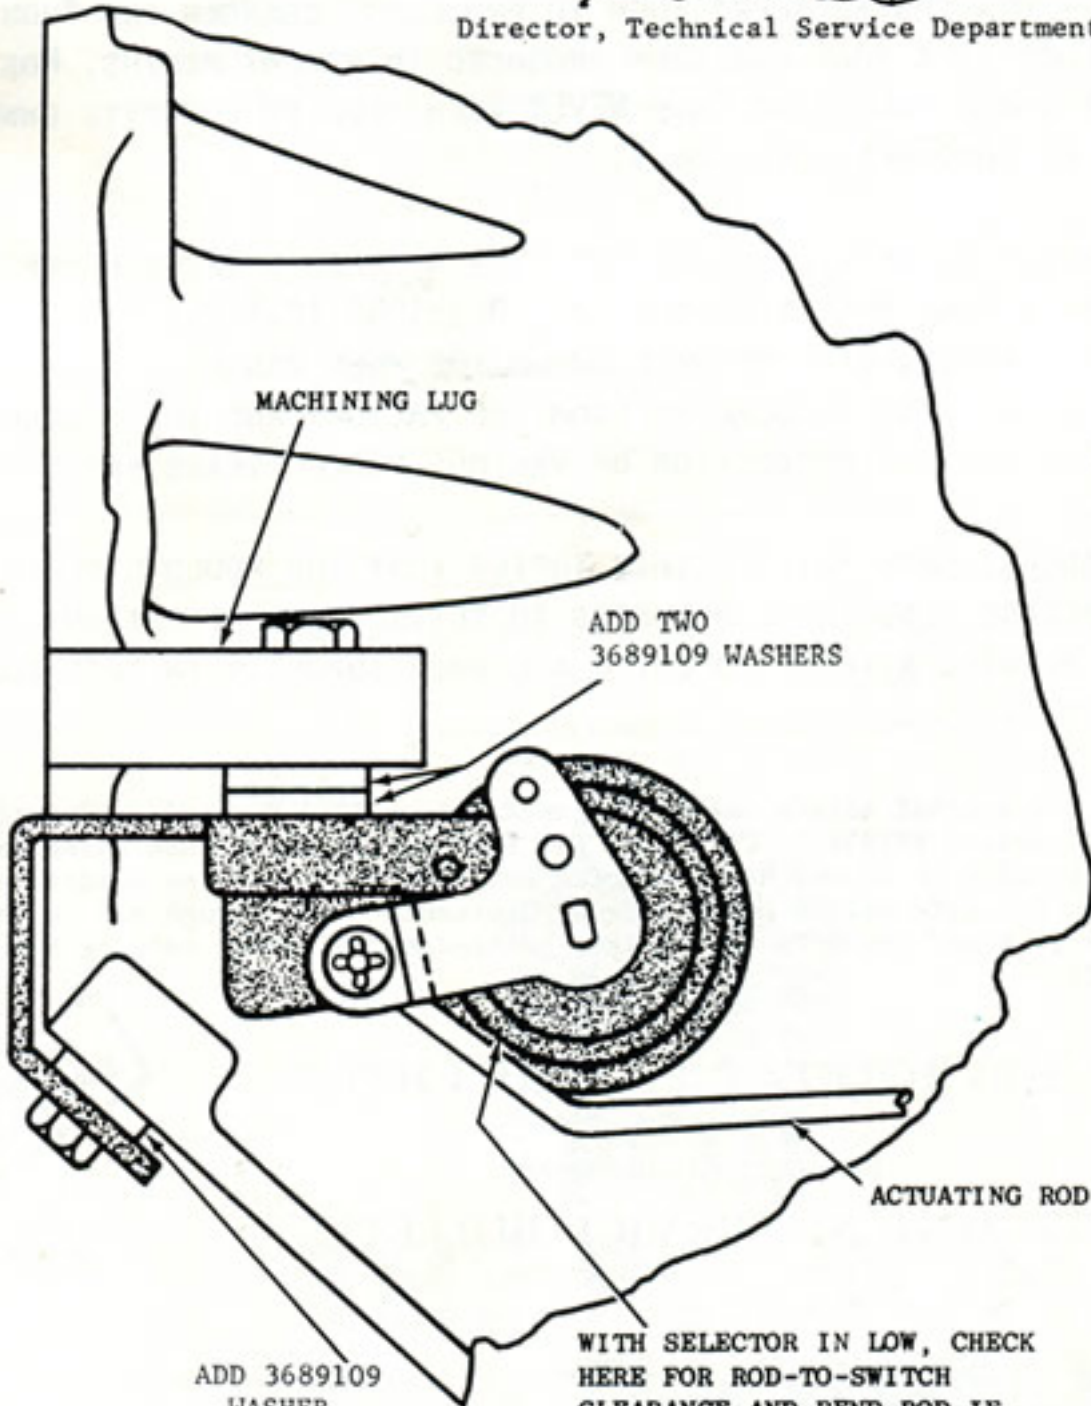
Interference between the neutral safety switch and the underbody may exist on some early production Corvette Models with Powerglide transmissions.

This could result in the engine being started while the transmission selector is in a drive position. In addition, the added load imposed on the shift linkage by the misalignment causes a reduction or loss of detent feel when the transmission is shifted manually. The transmission might then be accidentally operated between ranges and internal damage could result.

Correction of switch malfunction may be made by shimming the switch assembly downward as shown in the attached sketch. Note that operating clearance must exist between the switch body and the switch actuating rod after the shimming operation is completed.

WITH SELECTOR IN LOW, CHECK  
HERE FOR ROD-TO-SWITCH  
CLEARANCE AND BEND ROD IF  
NECESSARY. TEST ACTION OF SWITCH  
AFTER BENDING ROD & ADJUST LENGTH  
OF ROD AS REQUIRED BY TURNING  
THREADED PIVOT.
