1964 Corvette: Service Bulletin: Neutral Safety Switch Malfunction

Model and Year: 1964 Corvettes with Powerglide Transmissions

Source: Chevrolet Technical Service Bulletin

Bulletin No: DR #658

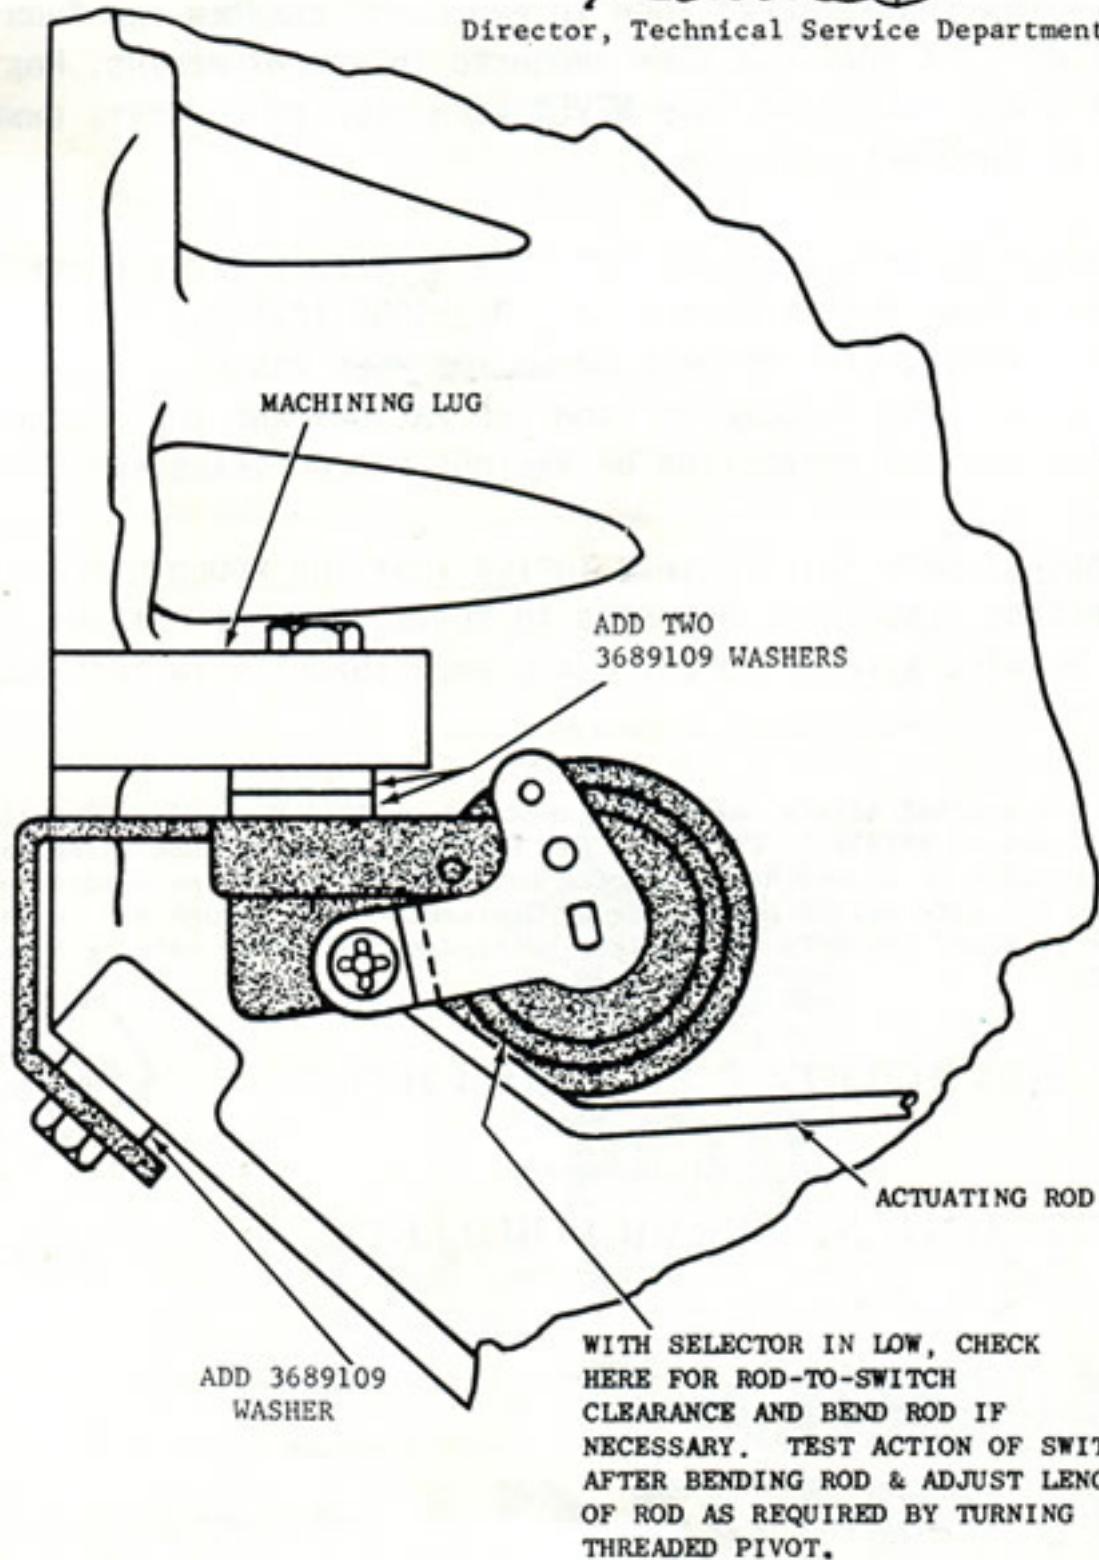
Interference between the neutral safety switch and the underbody may exist on some early production Corvette Models with Powerglide transmissions.

This could result in the engine being started while the transmission selector is in a drive position. In addition, the added load imposed on the shift linkage by the misalignment causes a reduction or loss of detent feel when the transmission is shifted manually. The transmission might then be accidentally operated between ranges and internal damage could result.

Correction of switch malfunction may be made by shimming the switch assembly downward as shown in the attached sketch. Note that operating clearance must exist between the switch body and the switch actuating rod after the shimming operation is completed.
