1964 Corvette: Service Bulletin: Neutral Safety Switch Malfunction

Model and Year: 1964 Corvettes with Powerglide Transmissions

Source: Chevrolet Technical Service Bulletin

Bulletin No: DR #658

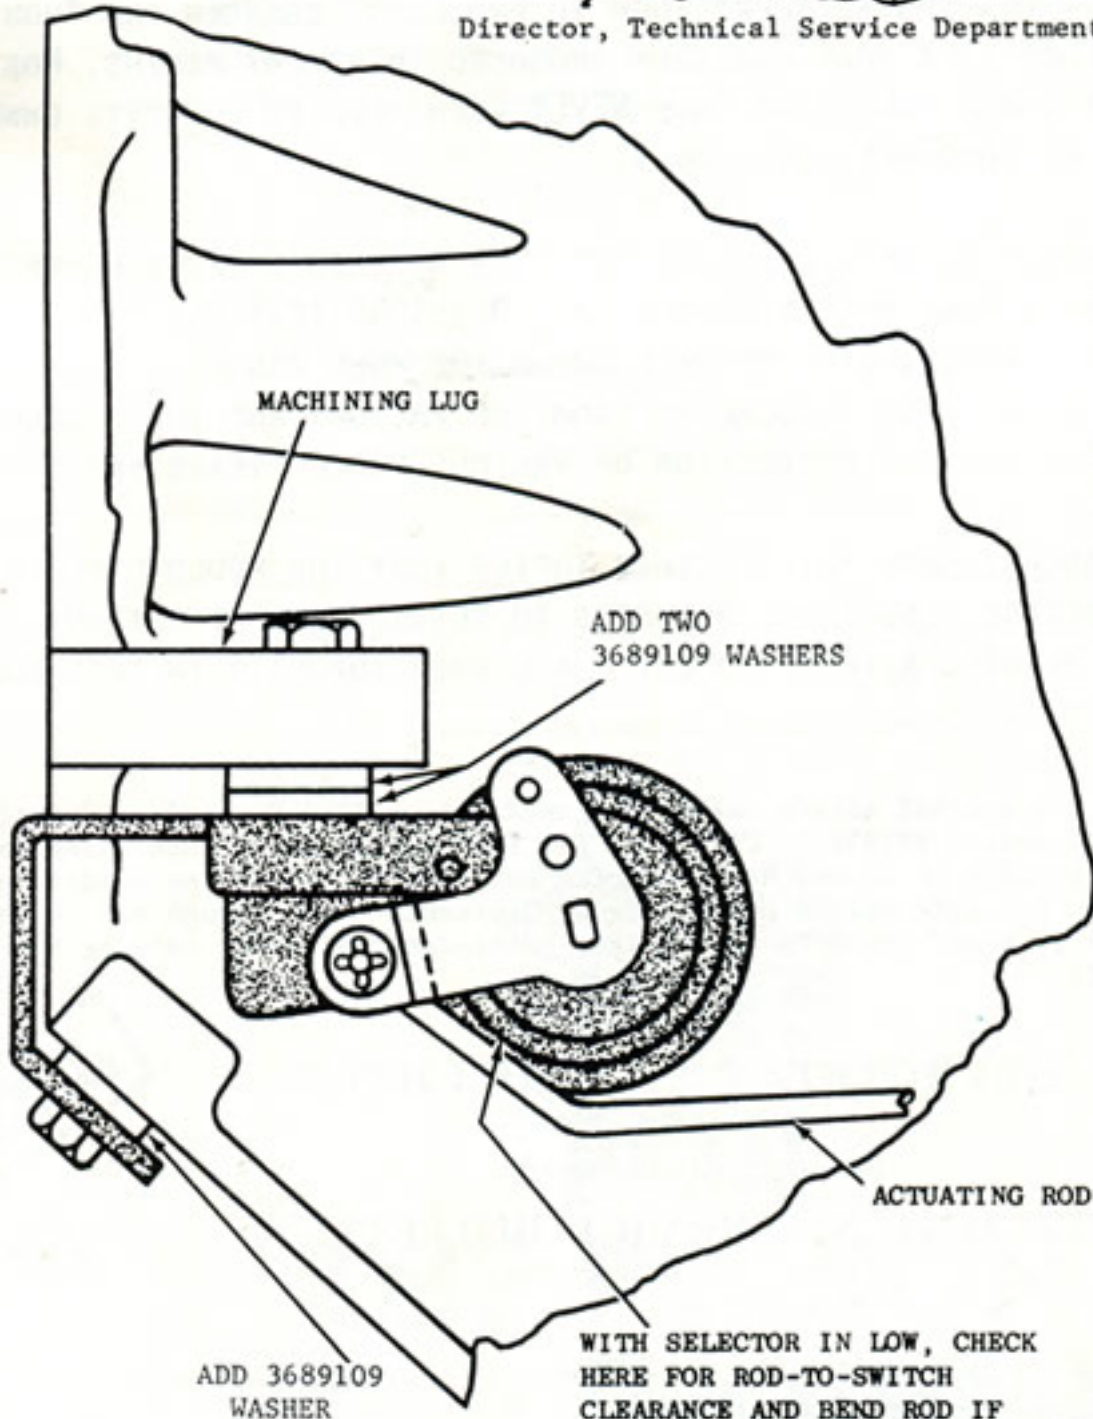
Interference between the neutral safety switch and the underbody may exist on some early production Corvette Models with Powerglide transmissions.

This could result in the engine being started while the transmission selector is in a drive position. In addition, the added load imposed on the shift linkage by the misalignment causes a reduction or loss of detent feel when the transmission is shifted manually. The transmission might then be accidentally operated between ranges and internal damage could result.

Correction of switch malfunction may be made by shimming the switch assembly downward as shown in the attached sketch. Note that operating clearance must exist between the switch body and the switch actuating rod after the shimming operation is completed.

WITH SELECTOR IN LOW, CHECK
HERE FOR ROD-TO-SWITCH
CLEARANCE AND BEND ROD IF
NECESSARY. TEST ACTION OF SWITCH
AFTER BENDING ROD & ADJUST LENGTH
OF ROD AS REQUIRED BY TURNING
THREADED PIVOT.
