1997 - 1998 Corvette: Service News: Corvette Engine Low Coolant MIL

Subject: Corvette Engine Low Coolant MIL

Model and Year: 1997 - 1998 Corvette

Date: May 1998 - Volume 7 - Number 5

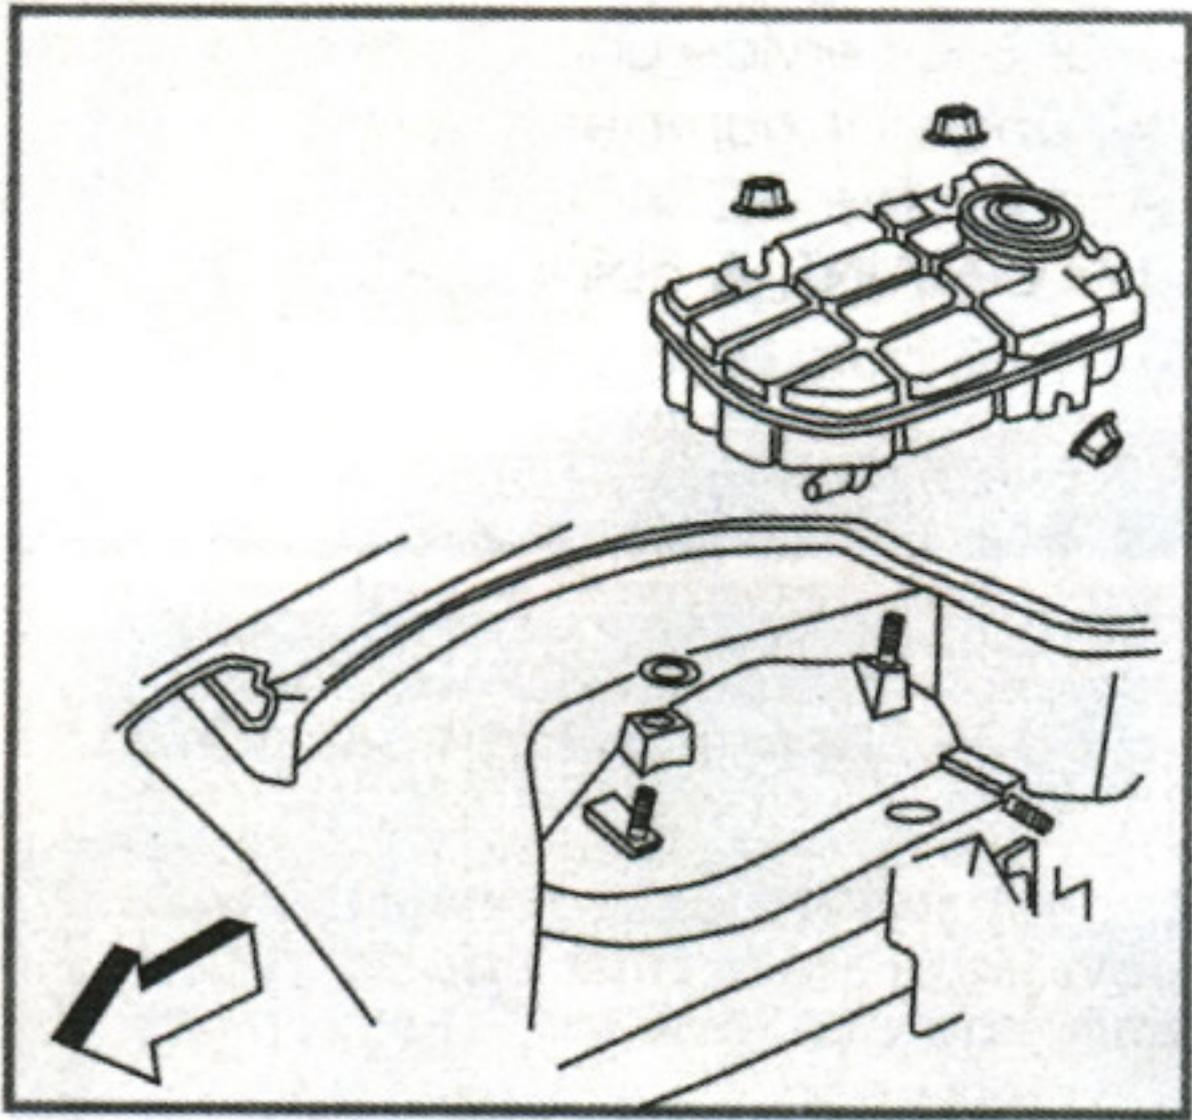
The engine low coolant MIL may come on intermittently on some 1997 - 1998 Corvettes. This condition may be due to the position of the radiator surge tank, and is more likely to occur when the engine is cold and when parked or driven going forward down a hill.

There are three mounting studs for the surge tank. The lower horizontal stud engages a slot in the tank. If the stud is not bottomed out in the slot, the tank will be tipped and affect the proper coolant level reading. To correct this condition, loosen all three attaching nuts and insure that the lower horizontal stud is fully seated in the slot. Tighten the bottom nut, followed by the two top nuts, to the proper torque.
