# 1997 - 1998 Corvette: Service News: Corvette Engine Low Coolant MIL

**Subject:** Corvette Engine Low Coolant MIL

**Model and Year:** 1997 - 1998 Corvette

**Date:** May 1998 - Volume 7 - Number 5

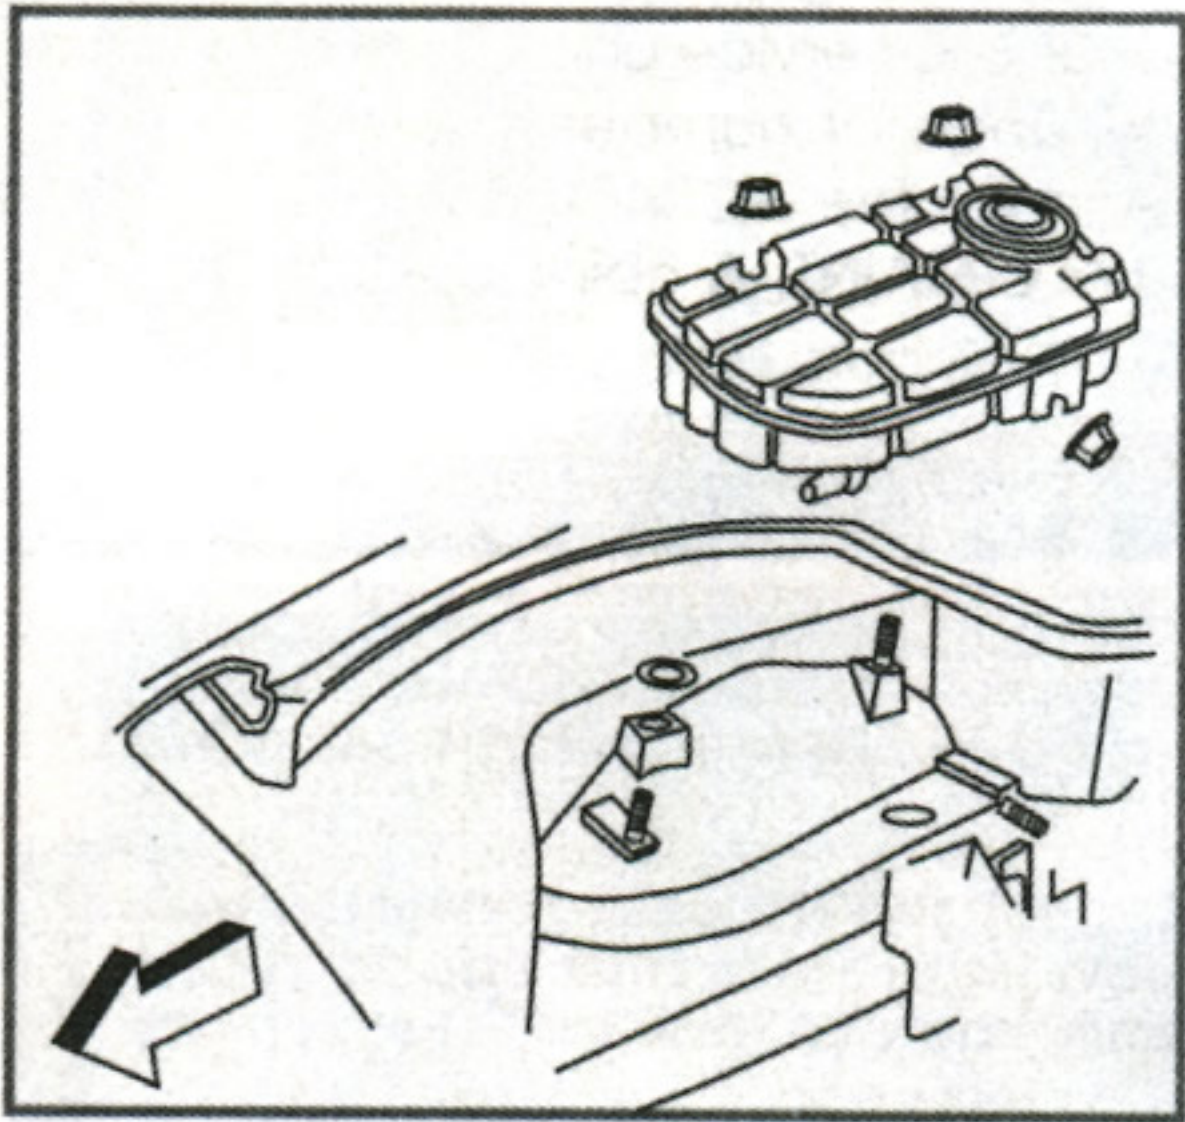
The engine low coolant MIL may come on intermittently on some 1997 - 1998 Corvettes. This condition may be due to the position of the radiator surge tank, and is more likely to occur when the engine is cold and when parked or driven going forward down a hill.

There are three mounting studs for the surge tank. The lower horizontal stud engages a slot in the tank. If the stud is not bottomed out in the slot, the tank will be tipped and affect the proper coolant level reading. To correct this condition, loosen all three attaching nuts and insure that the lower horizontal stud is fully seated in the slot. Tighten the bottom nut, followed by the two top nuts, to the proper torque.
