# 1968 Corvette: Service Bulletin: Cold Start Failure

**Subject:** Cold Start Failure

**Model and Year:** All 1968 Vehicles Incorporating V-8 Engines

**Bulletin No:** 68-T-31

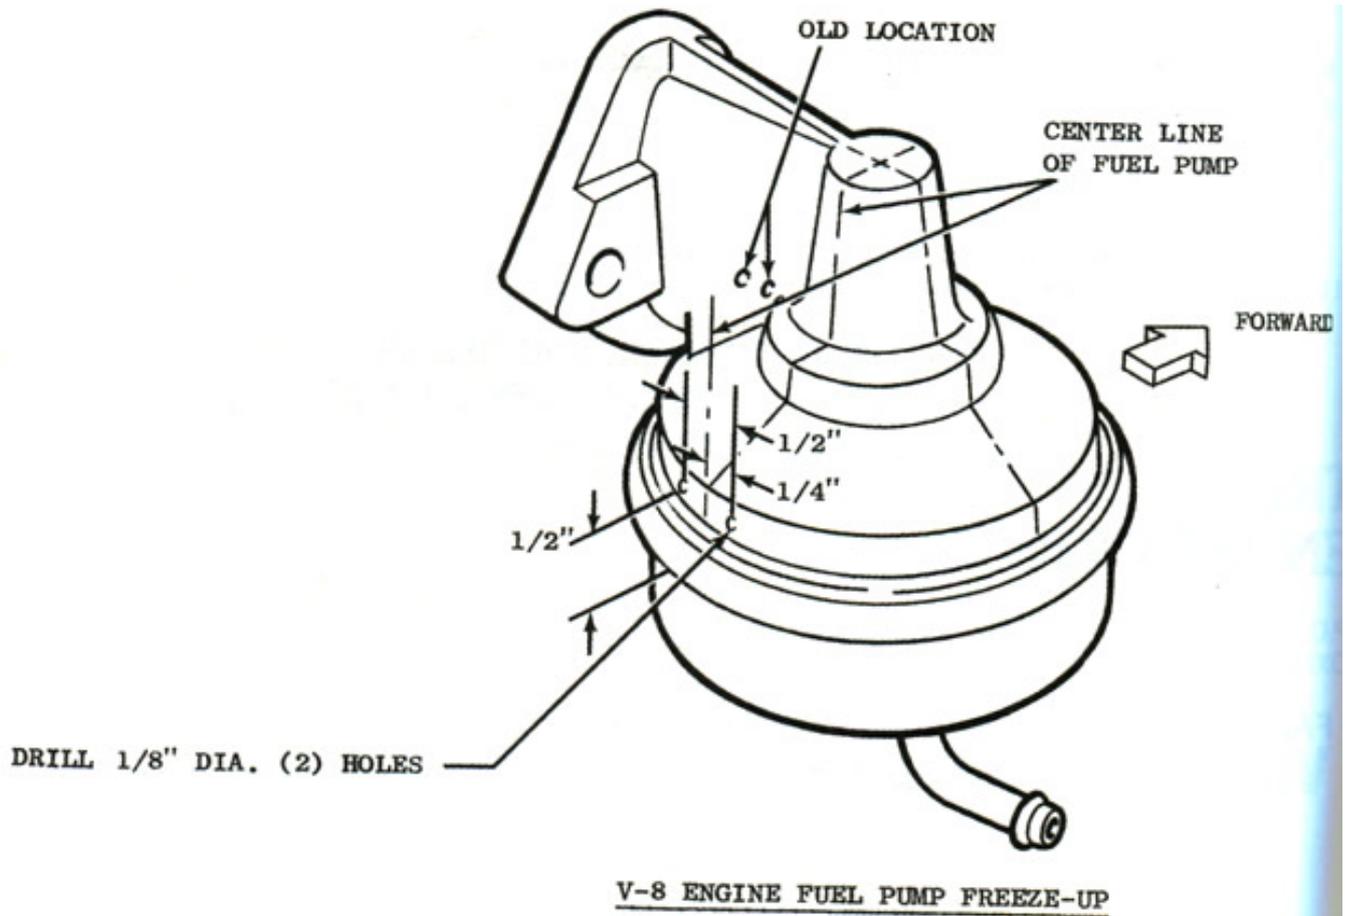
Incidents of fuel pump freeze-up and failing to supply fuel have been encountered on some 1968 vehicles equipped with V-8 engines. These failures usually occur in areas which encounter rain and overnight sub-freezing temperatures. The fuel pump becomes inoperative when water enters through the atmospheric vent holes and freezes.

A good indication of this condition could be a fuel pump that operates satisfactorily in above-freezing temperatures, such as being stored inside, but does not operate after setting for a period of time in sub-freezing temperatures. A simple check can be made on vehicles not subjected to above-freezing temperatures by removing the air cleaner, stroking the throttle rod, and observing for fuel discharge into the carburetor venturi. If there is no fuel discharge, remove the fuel pump and allow it to thaw and drain. To prevent

To prevent the above condition and to provide a drain, all V-8 engine fuel pumps are being revised by relocating the atmospheric vent holes from near the mounting flange to near the crimp flange. Refer to Sketch on Page.

recurrence, drill two 1/8" holes as shown in sketch.
