1968 Corvette: Service Bulletin: Cold Start Failure

Subject: Cold Start Failure

Model and Year: All 1968 Vehicles Incorporating V-8 Engines

Bulletin No: 68-T-31

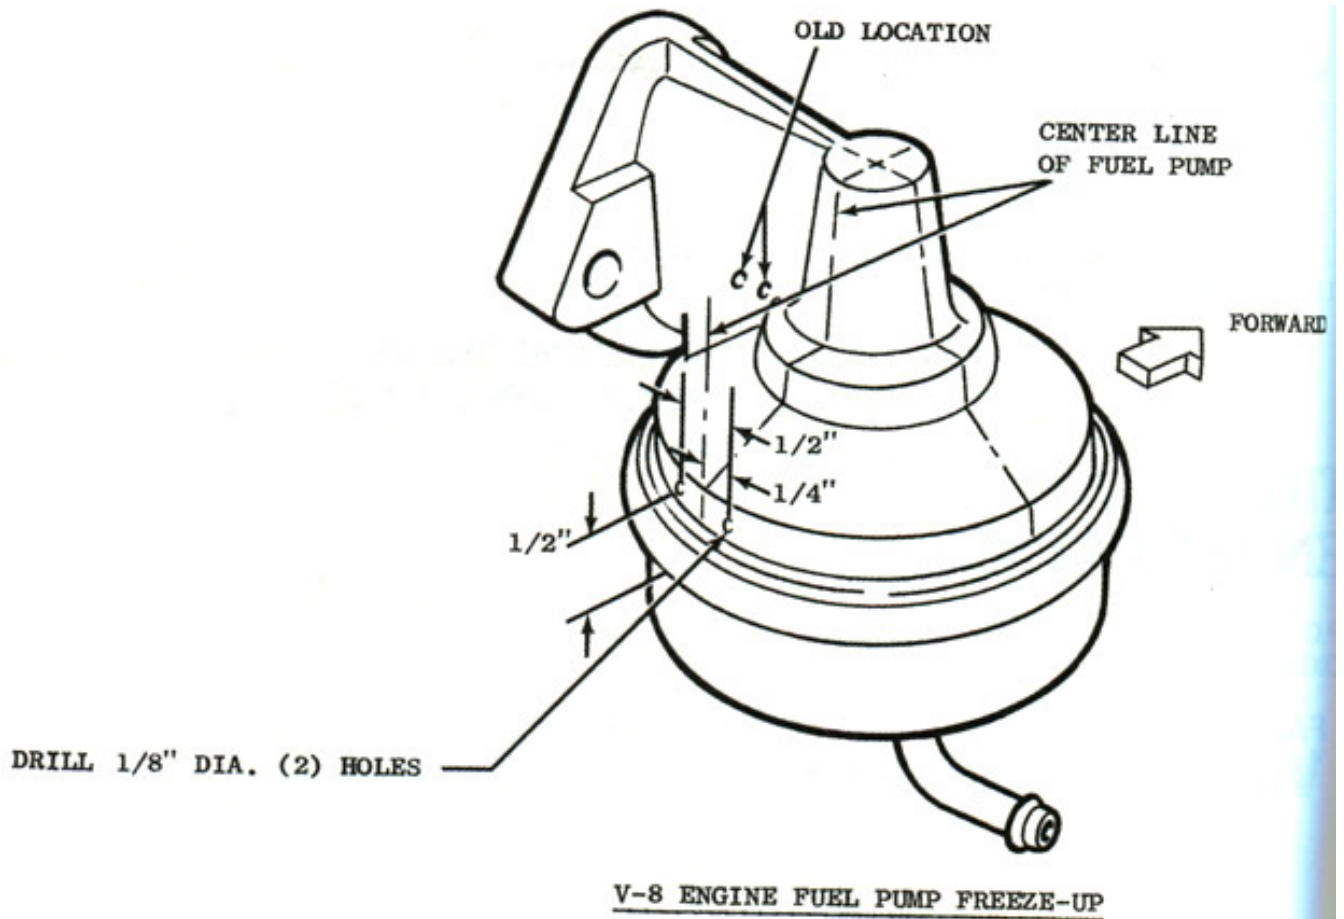
Incidents of fuel pump freeze-up and failing to supply fuel have been encountered on some 1968 vehicles equipped with V-8 engines. These failures usually occur in areas which encounter rain and overnight sub-freezing temperatures. The fuel pump becomes inoperative when water enters through the atmospheric vent holes and freezes.

A good indication of this condition could be a fuel pump that operates satisfactorily in above-freezing temperatures, such as being stored inside, but does not operate after setting for a period of time in sub-freezing temperatures. A simple check can be made on vehicles not subjected to above-freezing temperatures by removing the air cleaner, stroking the throttle rod, and observing for fuel discharge into the carburetor venturi. If there is no fuel discharge, remove the fuel pump and allow it to thaw and drain. To prevent

To prevent the above condition and to provide a drain, all V-8 engine fuel pumps are being revised by relocating the atmospheric vent holes from near the mounting flange to near the crimp flange. Refer to Sketch on Page.

recurrence, drill two 1/8" holes as shown in sketch.
