2014 Corvette: GM TechLink: Oil Leak after the Harmonic Balancer is Removed

Model and Year: 2014 Corvette

Source: GM TechLink

Date: December 17, 2014

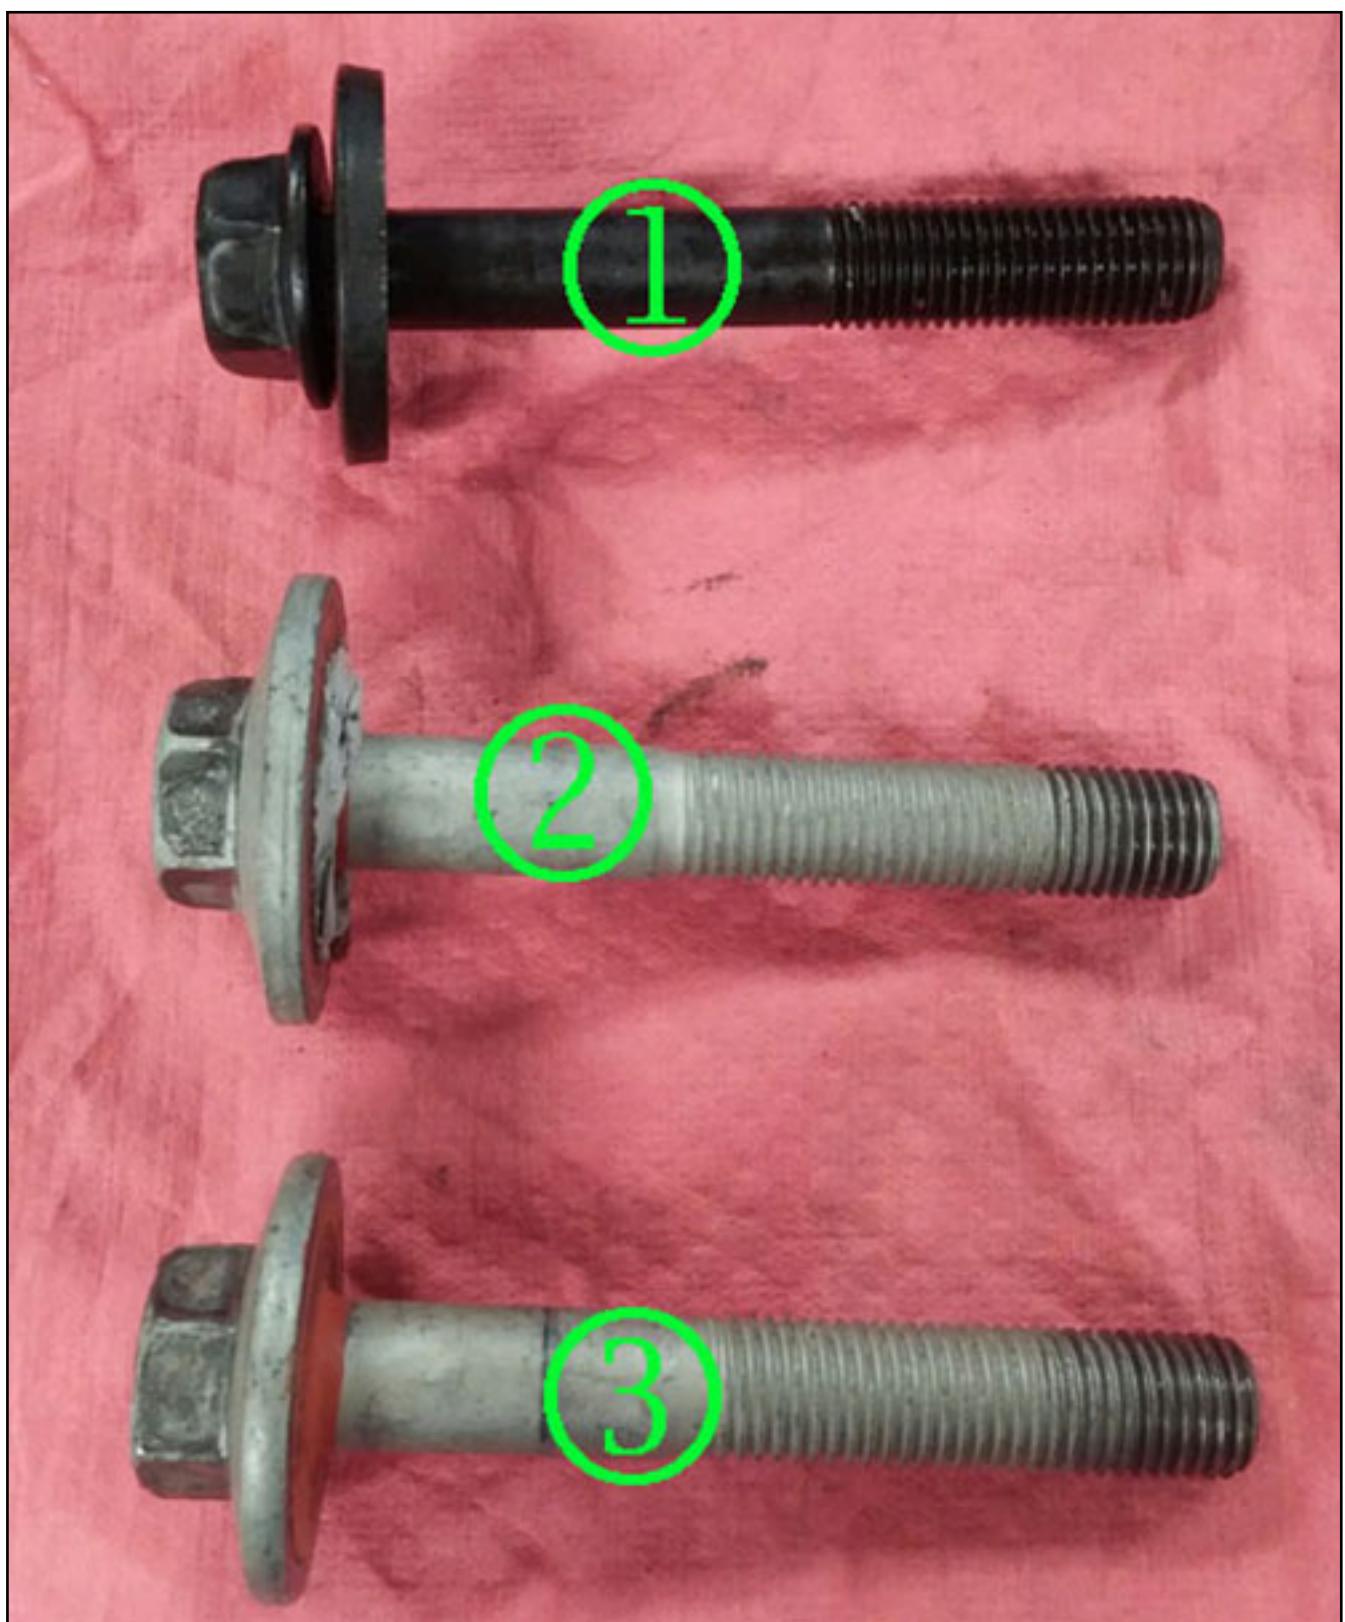
Fig. 24

If a Gen 4 bolt is used in a Gen5 engine, it will result in an oil leak.

The bolts (Fig. 24) shown below are:

Bolt 1– Gen 5 engine

Bolt 2 – Gen 5 engine

Bolt 3 – Gen 4 engine

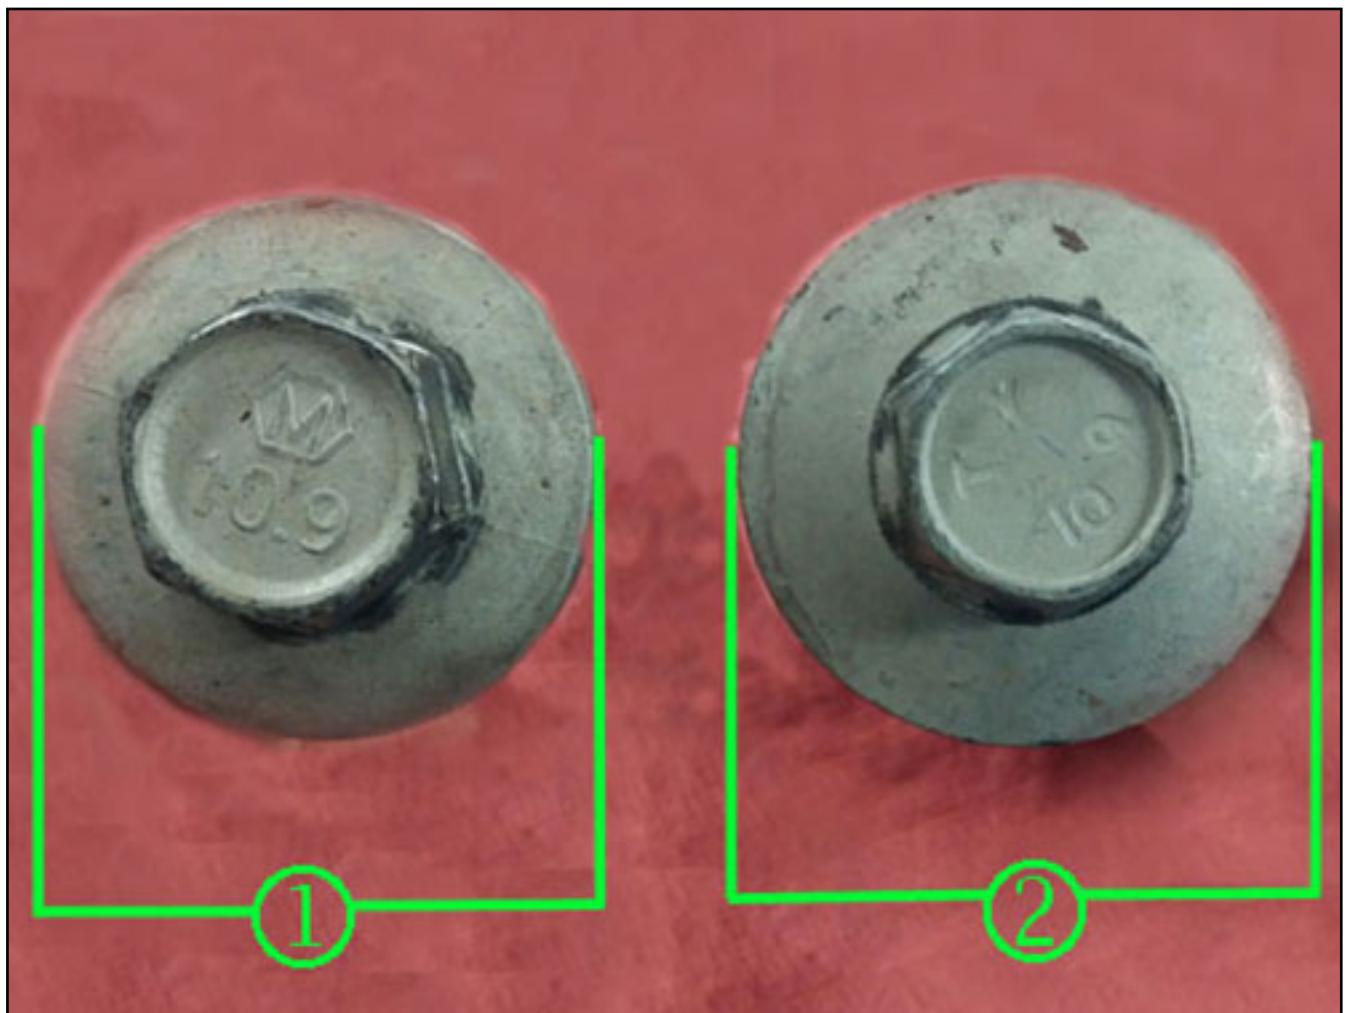
Fig. 25

Bolt measurements (Fig. 25) are:

Bolt 1 – 1 piece Gen 4 bolt: 1.869 in. (47.5 mm) at the flange

Bolt 2 – 1 piece Gen 5 Bolt: 2.055 in. (52.2 mm) at the flange

TIP: The LT1 engine dry sump uses a longer bolt due to the oil pump that is used on this system.
