2014 Corvette: GM TechLink: Oil Leak after the Harmonic Balancer is Removed

Subject: Oil Leak after the Harmonic Balancer is Removed

Model and Year: 2014 Corvette

Source: GM TechLink

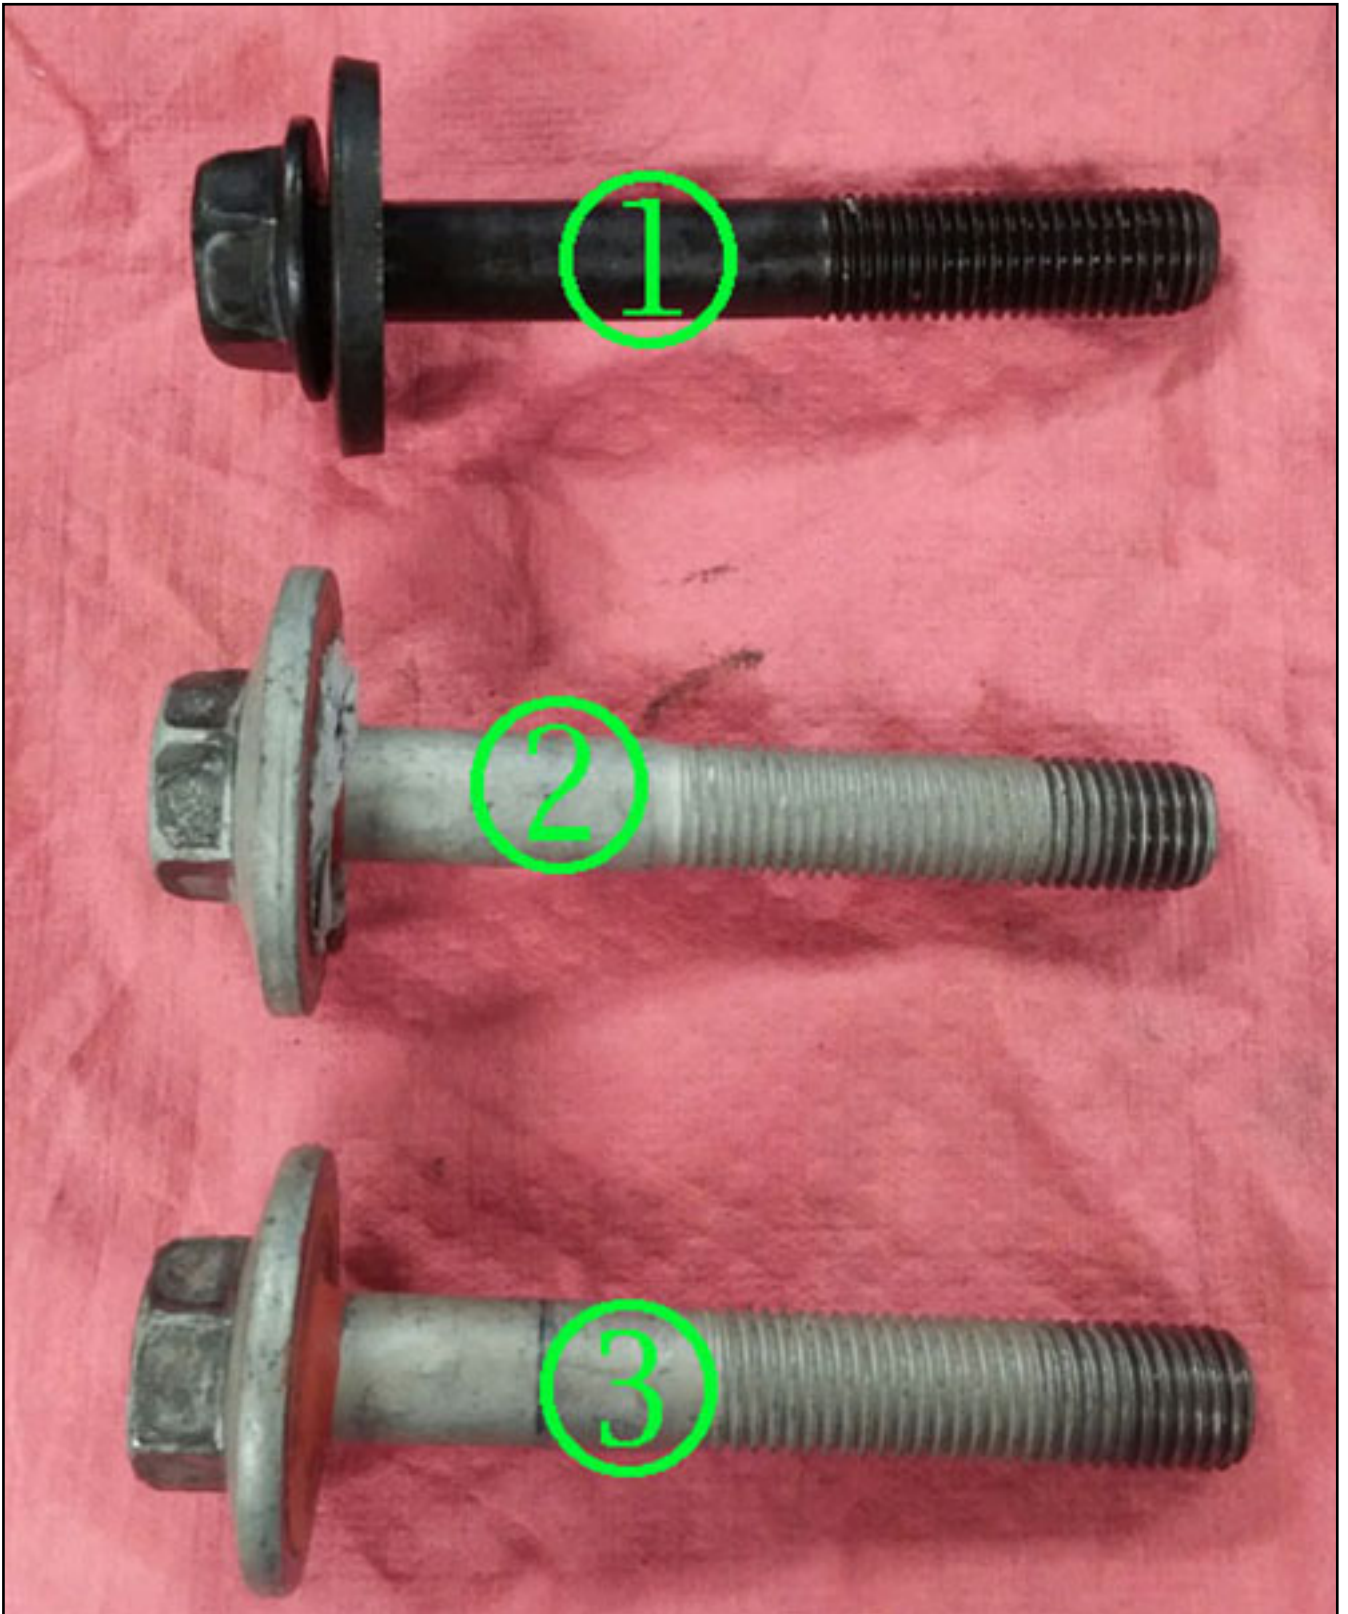
Fig. 24

If a Gen 4 bolt is used in a Gen5 engine, it will result in an oil leak.

The bolts (Fig. 24) shown below are:

Bolt 1– Gen 5 engine

Bolt 2 – Gen 5 engine
Bolt 3 – Gen 4 engine
