2014 Corvette: GM TechLink: Oil Leak after the Harmonic Balancer is Removed

Subject: Oil Leak after the Harmonic Balancer is Removed

Model and Year: 2014 Corvette

Source: GM TechLink

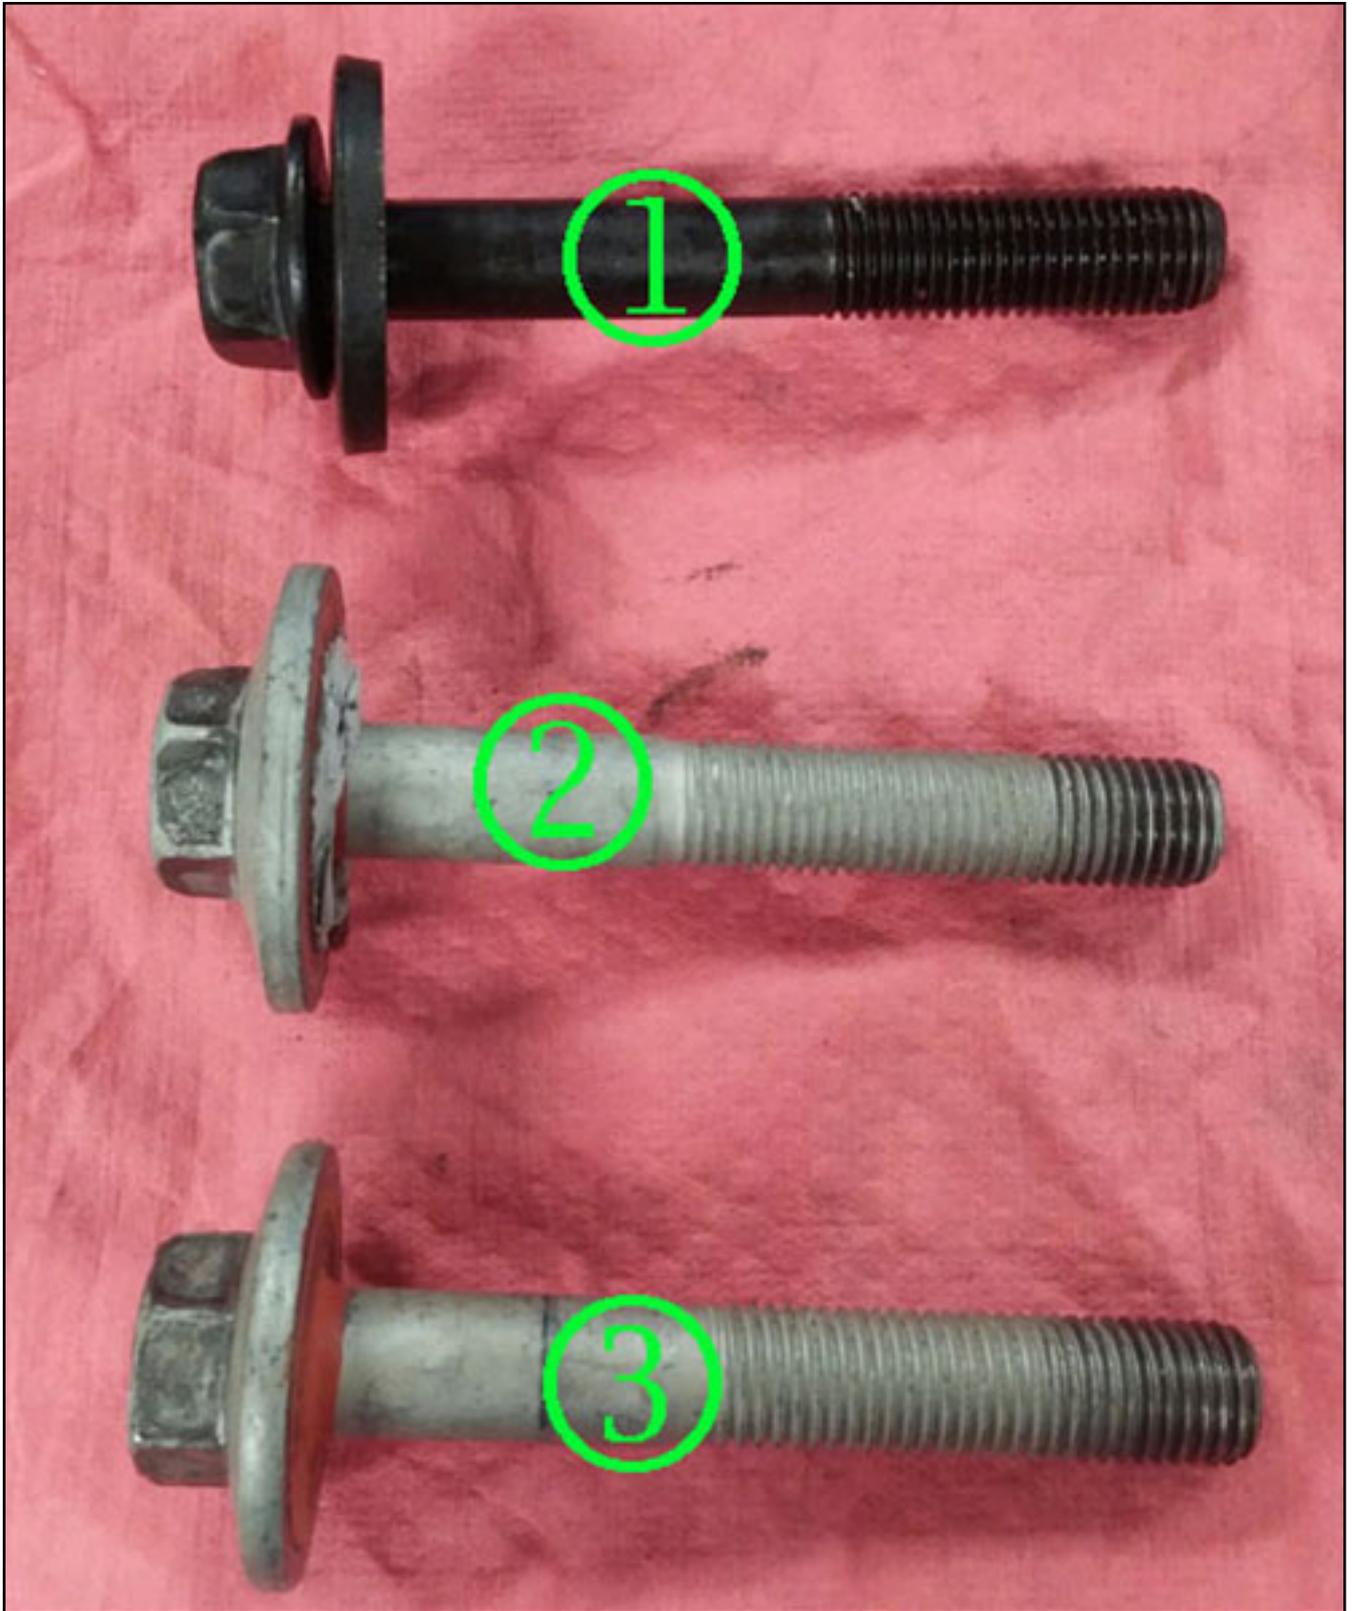
Fig. 24

If a Gen 4 bolt is used in a Gen5 engine, it will result in an oil leak.

The bolts (Fig. 24) shown below are:

Bolt 1– Gen 5 engine

Bolt 2 – Gen 5 engine
Bolt 3 – Gen 4 engine

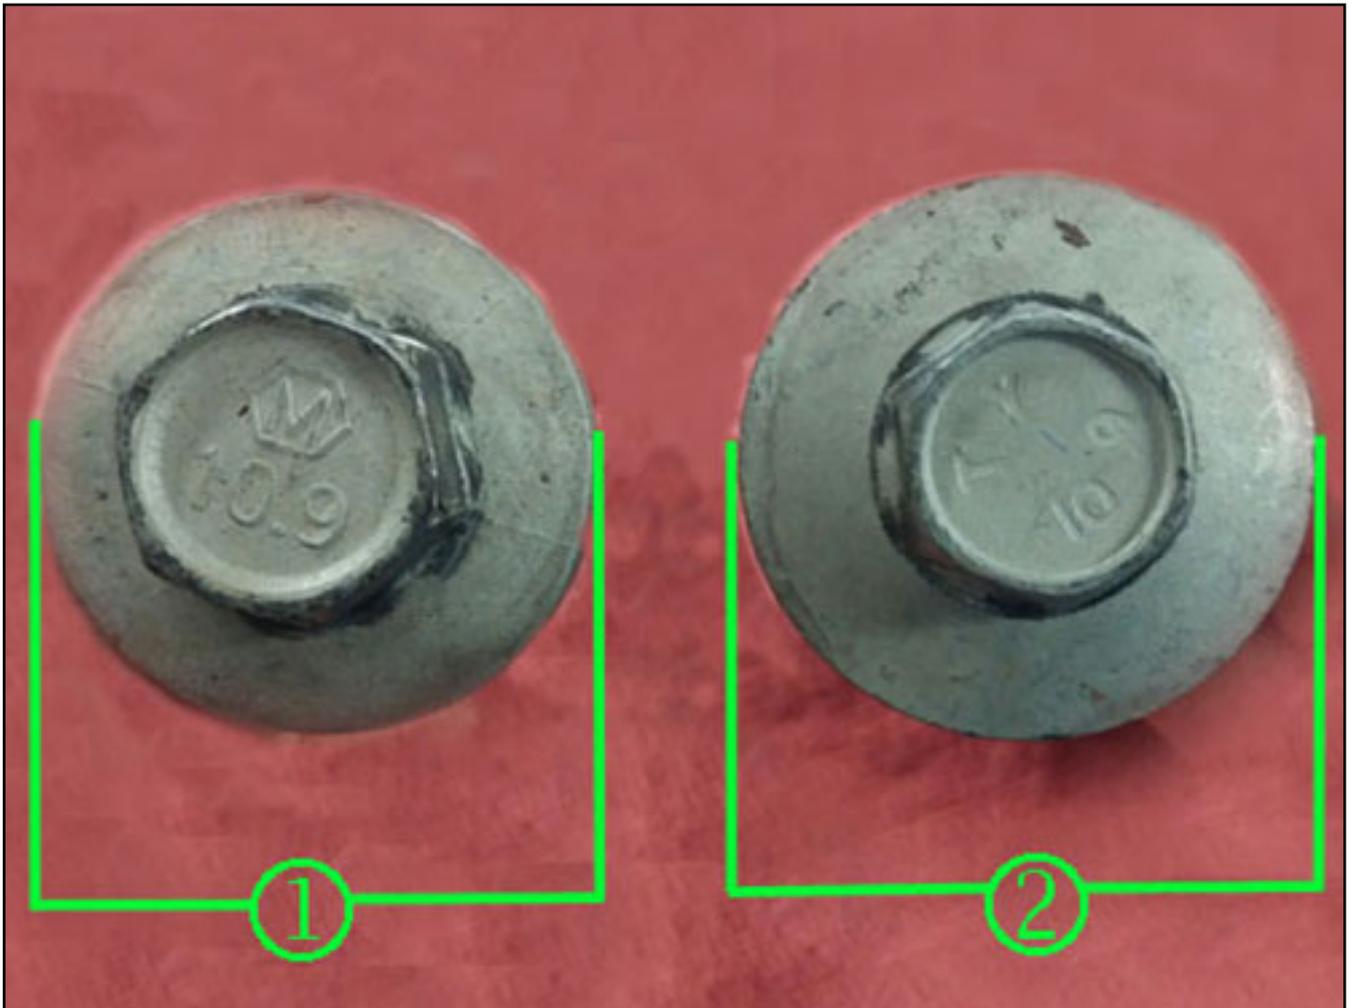
Fig. 25

Bolt measurements (Fig. 25) are:

Bolt 1 – 1 piece Gen 4 bolt: 1.869 in. (47.5 mm) at the flange

Bolt 2 – 1 piece Gen 5 Bolt: 2.055 in. (52.2 mm) at the flange

TIP: The LT1 engine dry sump uses a longer bolt due to the oil pump that is used on this system.
