# 2014 Corvette: GM TechLink: Oil Leak after the Harmonic Balancer is Removed

**Subject:** Oil Leak after the Harmonic Balancer is Removed

**Model and Year:** 2014 Corvette

**Date:** December 17, 2014

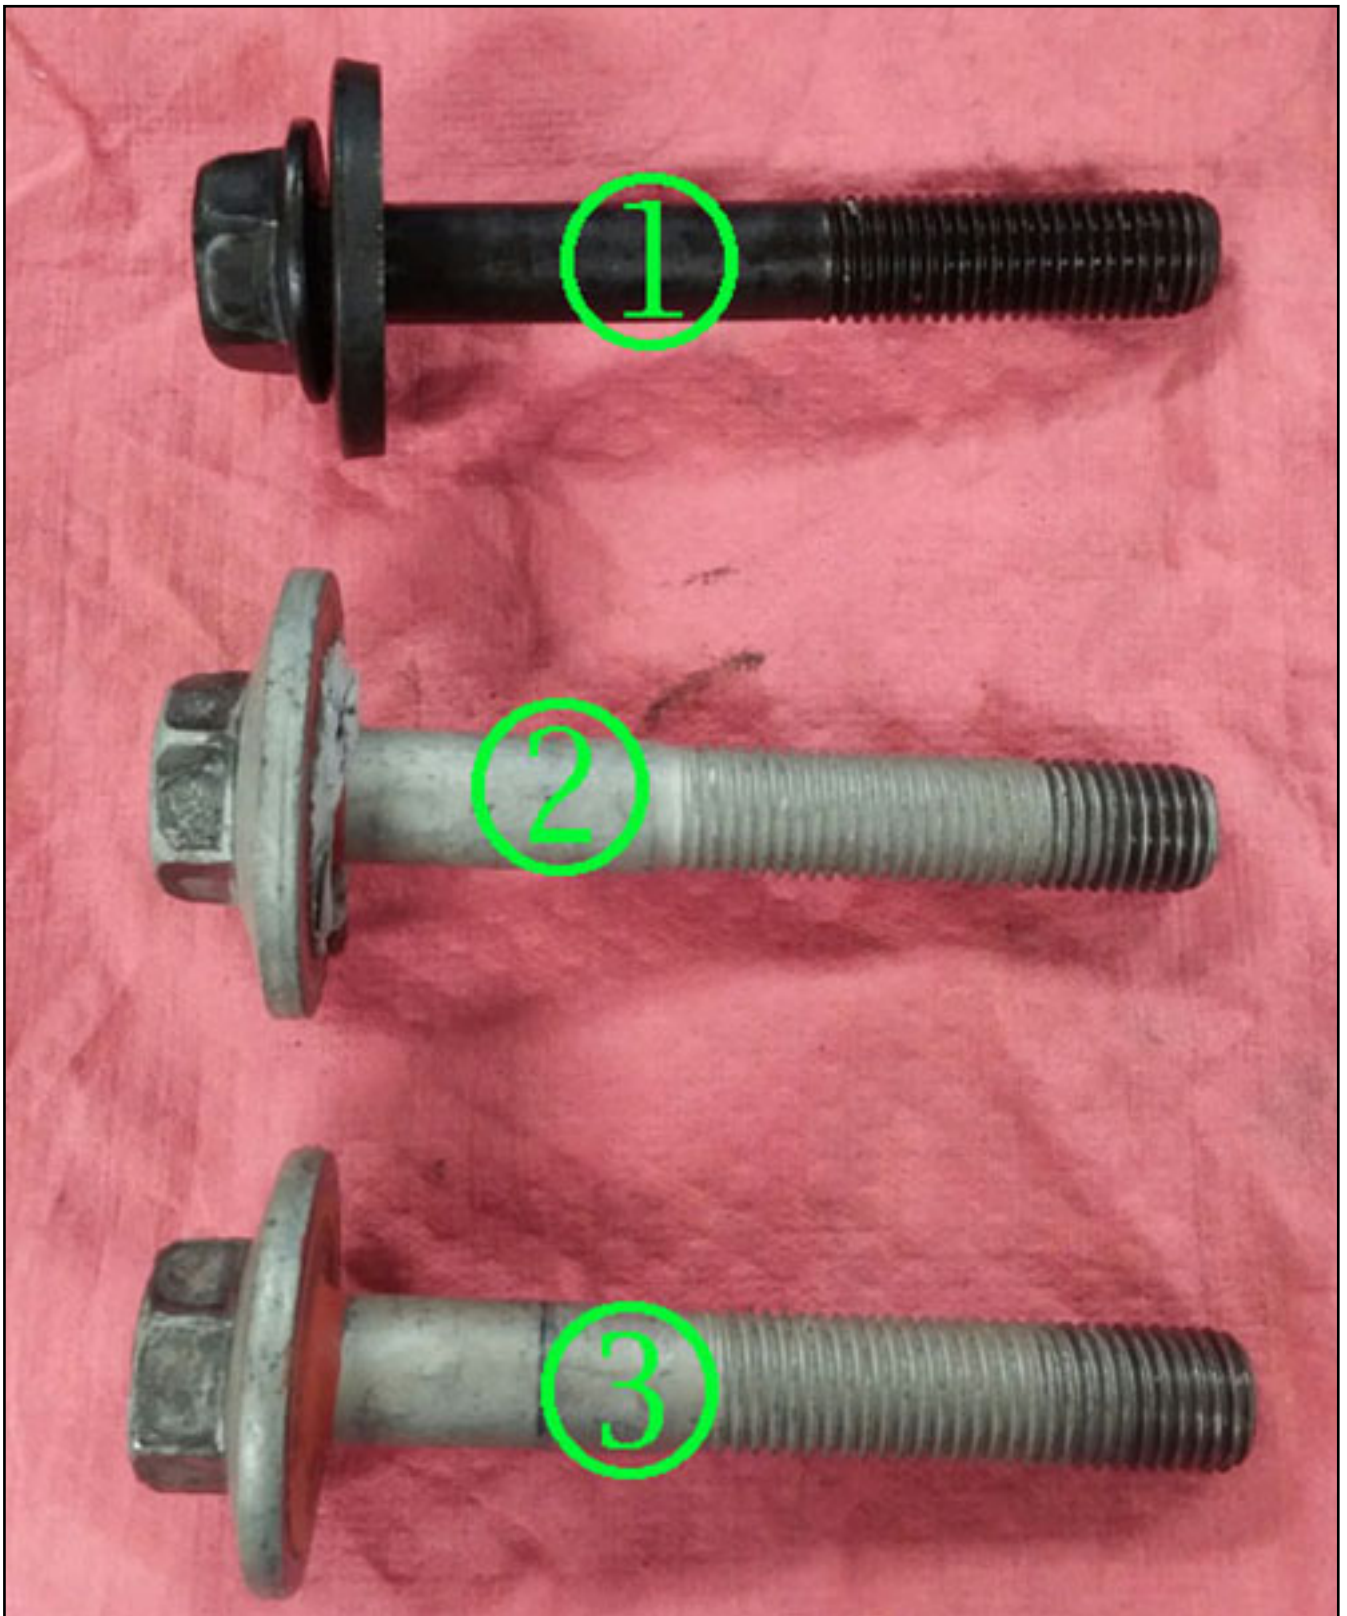
**Fig. 24**

If a Gen 4 bolt is used in a Gen5 engine, it will result in an oil leak.

The bolts (Fig. 24) shown below are:

Bolt 1– Gen 5 engine

Bolt 2 – Gen 5 engine  
Bolt 3 – Gen 4 engine

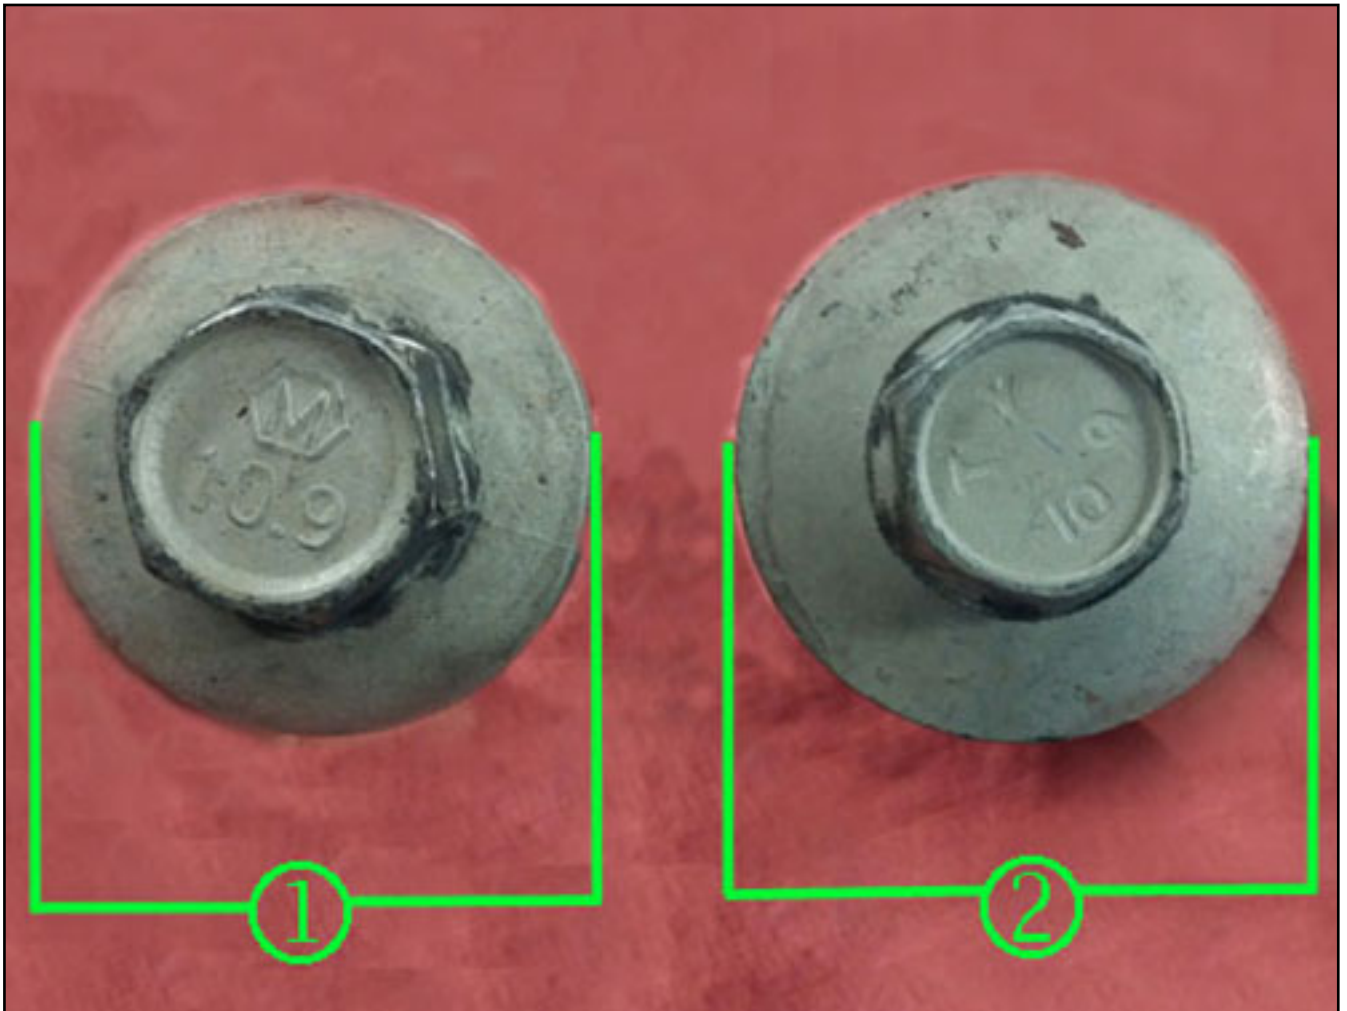
**Fig. 25**

Bolt measurements (Fig. 25) are:

Bolt 1 – 1 piece Gen 4 bolt: 1.869 in. (47.5 mm) at the flange

Bolt 2 – 1 piece Gen 5 Bolt: 2.055 in. (52.2 mm) at the flange

**TIP:** The LT1 engine dry sump uses a longer bolt due to the oil pump that is used on this system.
