1961 Corvette: Chevrolet Product Engineering Technical Information: Spark Plug Electrode Interference With Piston

Subject: Spark Plug Electrode Interference With Piston

Model and Year: 1961 Corvette Models Equipped with Fuel Injection

Bulletin Number: Page 3-4 - Section VI - Group 2

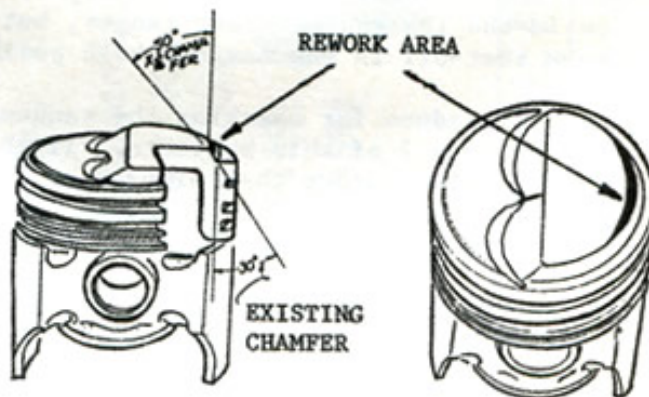
An interference condition between the spark plug ground electrode and piston dome may occur on 1961 Corvette Models equipped with fuel injection. This interference results in a bent electrode which causes insufficient spark plug gap, engine miss and subsequent poor performance.

Reworking Piston Dome - 1961 Corvette Models Equipped
With Fuel Injection

The condition was corrected in Production effective 5-15-61 (engine date stamp F-0515) by removing 1/16" of the piston dome at the contact area as shown in the following sketch. The size of the area to be removed is approximately 1/16" thick, 1/8" wide and 1-1/2" long machined at a 50° angle. Only the top half of the dome chamfer should be removed with the lower portion remaining at the existing 30° angle.

In the event an 11:0-1 compression ratio engine equipped with fuel injection is being overhauled or if the cylinder heads are removed, each piston dome should be filed or ground off approximately 1/16" to prevent spark plug electrode interference. If only the heads are removed, the pistons should be at TDC and grease applied to the top of the pistons to insure complete remove of filings.
