1961 Corvette: Chevrolet Product Engineering Technical Information: Spark Plug Electrode Interference With Piston

Subject: Spark Plug Electrode Interference With Piston

Model and Year: 1961 Corvette Models Equipped with Fuel Injection

Date: 7/8/61

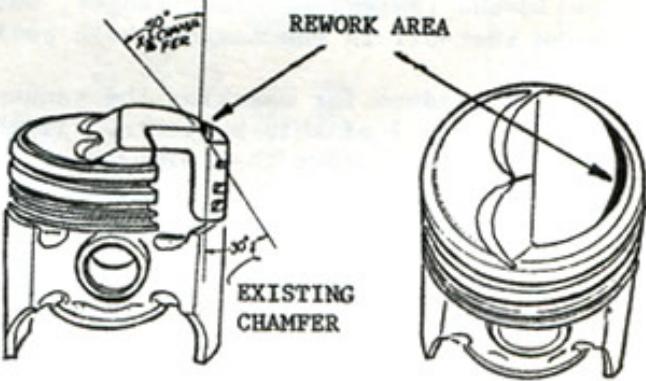
Reworking Piston Dome - 1961 Corvette Models Equipped
With Fuel Injection

An interference condition between the spark plug ground electrode and piston dome may occur on 1961 Corvette Models equipped with fuel injection. This interference results in a bent electrode which causes insufficient spark plug gap, engine miss and subsequent poor performance.

The condition was corrected in Production effective 5-15-61 (engine date stamp F-0515) by removing 1/16" of the piston dome at the contact area as shown in the following sketch. The size of the area to be removed is approximately 1/16" thick, 1/8" wide and 1-1/2" long machined at a 50° angle. Only the top half of the dome chamfer should be removed with the lower portion remaining at the existing 30° angle.

In the event an 11:0-1 compression ratio engine equipped with fuel injection is being overhauled or if the cylinder heads are removed, each piston dome should be filed or ground off approximately 1/16" to prevent spark plug electrode interference. if only the heads are removed, the pistons should be at TDC and grease applied to the top of the pistons to insure complete remove of filings.
