1961 Corvette: Chevrolet Product Engineering Technical Information: Spark Plug Electrode Interference With Piston

Subject: Spark Plug Electrode Interference With Piston
Model and Year: 1961 Corvette Models Equipped with Fuel Injection
Source: Chevrolet Service and Mechanical Department - Technical
Information - 1961 Product Data Book
Bulletin Number: Page 3-4 - Section VI - Group 2
Date: 7/8/61

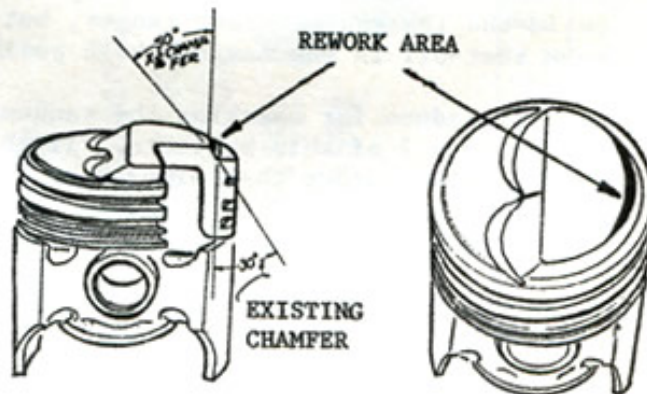
Reworking Piston Dome - 1961 Corvette Models Equipped With Fuel Injection

An interference condition between the spark plug ground electrode and piston dome may occur on 1961 Corvette Models equipped with fuel injection. This interference results in a bent electrode which causes insufficient spark plug gap, engine miss and subsequent poor performance.

The condition was corrected in Production effective 5-15-61 (engine date stamp F-0515) by removing 1/16" of the piston dome at the contact area as shown in the following sketch. The size of the area to be removed is approximately 1/16" thick, 1/8" wide and 1-1/2" long machined at a 50° angle. Only the top half of the dome chamfer should be removed with the lower portion remaining at the existing 30° angle.

In the event an 11:0-1 compression ratio engine equipped with fuel injection is being overhauled or if the cylinder heads are removed, each piston dome should be filed or ground off approximately 1/16" to prevent spark plug electrode interference. if only the heads are removed, the pistons should be at TDC and grease applied to the top of the pistons to insure complete remove of filings.

Whenever engine replacement is required, either partial or fitted blocks or if service pistons are being installed, the pistons should be reworked prior to installation.
