# 1961 Corvette: Chevrolet Product Engineering Technical Information: Spark Plug Electrode Interference With Piston

**Subject:** Spark Plug Electrode Interference With Piston  
**Model and Year:** 1961 Corvette Models Equipped with Fuel Injection  
**Source:** Chevrolet Service and Mechanical Department - Technical  
Information - 1961 Product Data Book  
**Bulletin Number:** Page 3-4 - Section VI - Group 2  
**Date:** 7/8/61

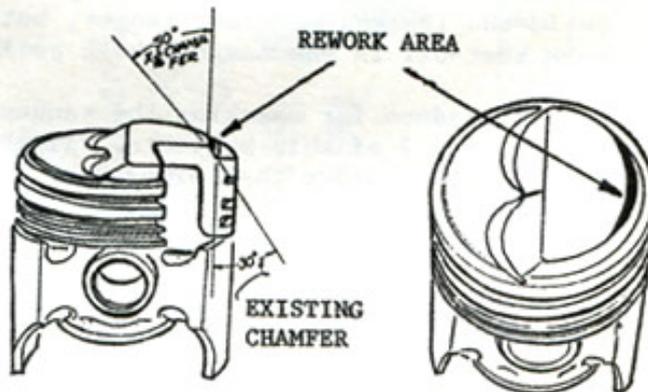
An interference condition between the spark plug ground electrode and piston dome may occur on 1961 Corvette Models equipped with fuel injection. This interference results in a bent electrode which causes insufficient spark plug gap, engine miss and subsequent poor performance.

The condition was corrected in Production effective 5-15-61 (engine date stamp F-0515) by removing 1/16" of the piston dome at the contact area as shown in the following sketch. The size of the area to be removed is approximately 1/16" thick, 1/8" wide and 1-1/2" long machined at a 50° angle. Only the top half of the dome chamfer should be removed with the lower portion remaining at the existing 30° angle.

Reworking Piston Dome - 1961 Corvette Models Equipped With Fuel Injection

In the event an 11:0-1 compression ratio engine equipped with fuel injection is being overhauled or if the cylinder heads are removed, each piston dome should be filed or ground off approximately 1/16" to prevent spark plug electrode interference. if only the heads are removed, the pistons should be at TDC and grease applied to the top of the pistons to insure complete remove of filings.

Whenever engine replacement is required, either partial or fitted blocks or if service pistons are being installed, the pistons should be reworked prior to installation.
