1961 Corvette: Chevrolet Product Engineering Technical Information: Spark Plug Electrode Interference With Piston

Subject: Spark Plug Electrode Interference With Piston
Model and Year: 1961 Corvette Models Equipped with Fuel Injection
Source: Chevrolet Service and Mechanical Department - Technical
Information - 1961 Product Data Book
Bulletin Number: Page 3-4 - Section VI - Group 2
Date: 7/8/61

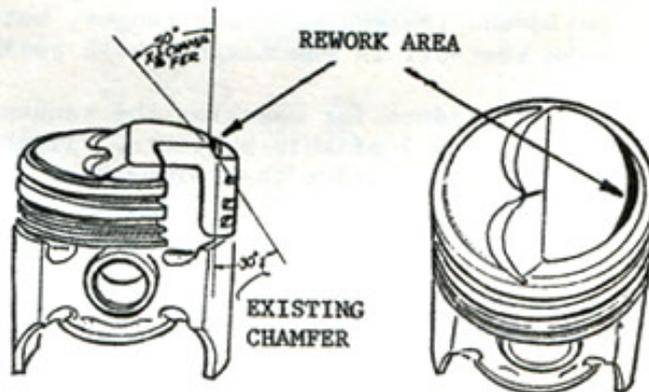
An interference condition between the spark plug ground electrode and piston dome may occur on 1961 Corvette Models equipped with fuel injection. This interference results in a bent electrode which causes insufficient spark plug gap, engine miss and subsequent poor performance.

The condition was corrected in Production effective 5-15-61 (engine date stamp F-0515) by removing 1/16" of the piston dome at the contact area as shown in the following sketch. The size of the area to be removed is approximately 1/16" thick, 1/8" wide and 1-1/2" long machined at a 50° angle. Only the top half of the dome chamfer should be removed with the lower portion remaining at the existing 30° angle.

Reworking Piston Dome - 1961 Corvette Models Equipped With Fuel Injection

In the event an 11:0-1 compression ratio engine equipped with fuel injection is being overhauled or if the cylinder heads are removed, each piston dome should be filed or ground off approximately 1/16" to prevent spark plug electrode interference. if only the heads are removed, the pistons should be at TDC and grease applied to the top of the pistons to insure complete remove of filings.

Whenever engine replacement is required, either partial or fitted blocks or if service pistons are being installed, the pistons should be reworked prior to installation.
