# 1958 Corvette: Service Bulletin: Electric Windshield Wiper Information

**Subject:** Electric Windshield Wiper Information

**Model and Year:** 1958 Passenger Cars and Trucks

**Bulletin No:** DR #359

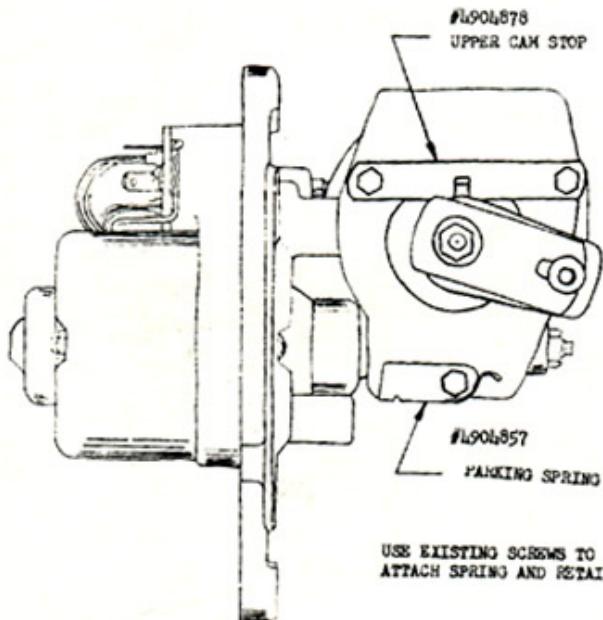
FIGURE #1.

In some cases the wiper motor, after being shut off, may over travel the effective length of the parking cam and continue to run in a reverse direction. This condition may occur even though the blades are properly positioned as covered in TSB #508, DR #359.

If the right hand blade slaps against the moulding excessively even though the blade is correctly positioned and parks properly, the upper cam stop is probably bent or broken. This damage can occur if the mechanism is coated with ice when the wiper is turned on.

SKETCH SHOWING INSTALLATION OF PARKING SPRING AND  
CAM STOP ON 1956 ELECTRIC WINDSHIELD WIPERS.

A parking spring has been released for production and service which enables the motor to shut off without depending on the resistance of the wiper blades. The spring is designed to clear the revolving arm in the "ON" position and stop the arm in the "PARK" position when switch is turned off. Figure #1 shows installation of parking spring.

A more durable replacement cam stop is available for service. Figure #1 shows details of installation. The existing tab must be bent flat before installation of the new stop.
